Monitoring the physical effects of boat wakes on shorelines in the Derwent River Estuary

Report to:
Derwent Estuary Program

By:
Chris Sharples

April 2022

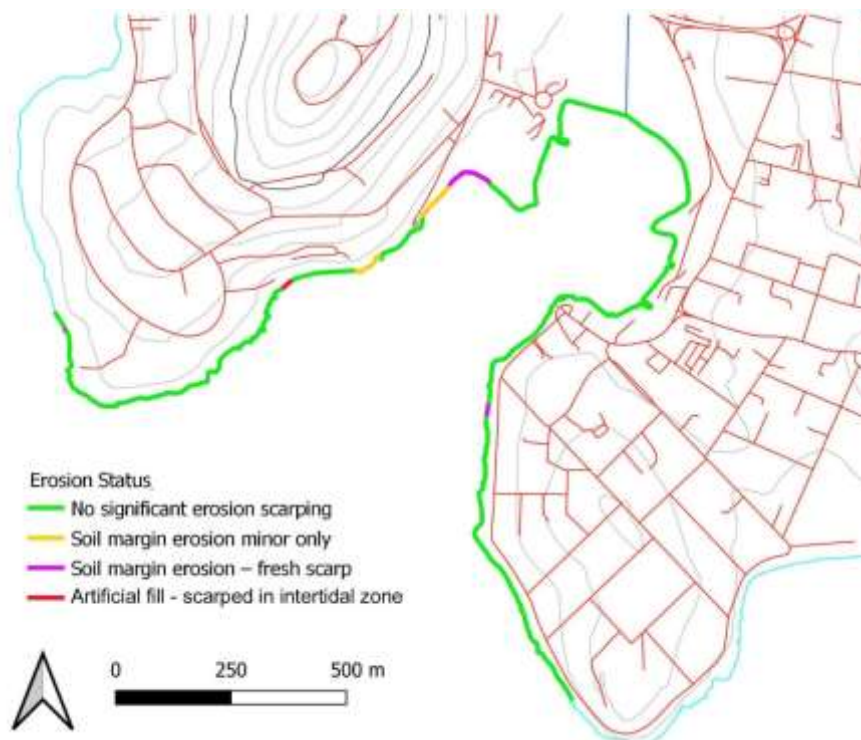
As demonstrated by Figure 3 below, there were only minor indications of fresh or “active” shoreline erosion (inferred to caused by storm swell or wind-waves) around the Kangaroo Bay shoreline prior to the introduction of the ferry service and photo monitoring described here. Most of this was erosion of soil margins over hard bedrock above the High-Water Mark (and thus implicitly caused by infrequent storm wave events).

Figure 3: Kangaroo Bay shoreline erosion status prior to regular ferry service. Ground-mapped by C. Sharples, August 2021.

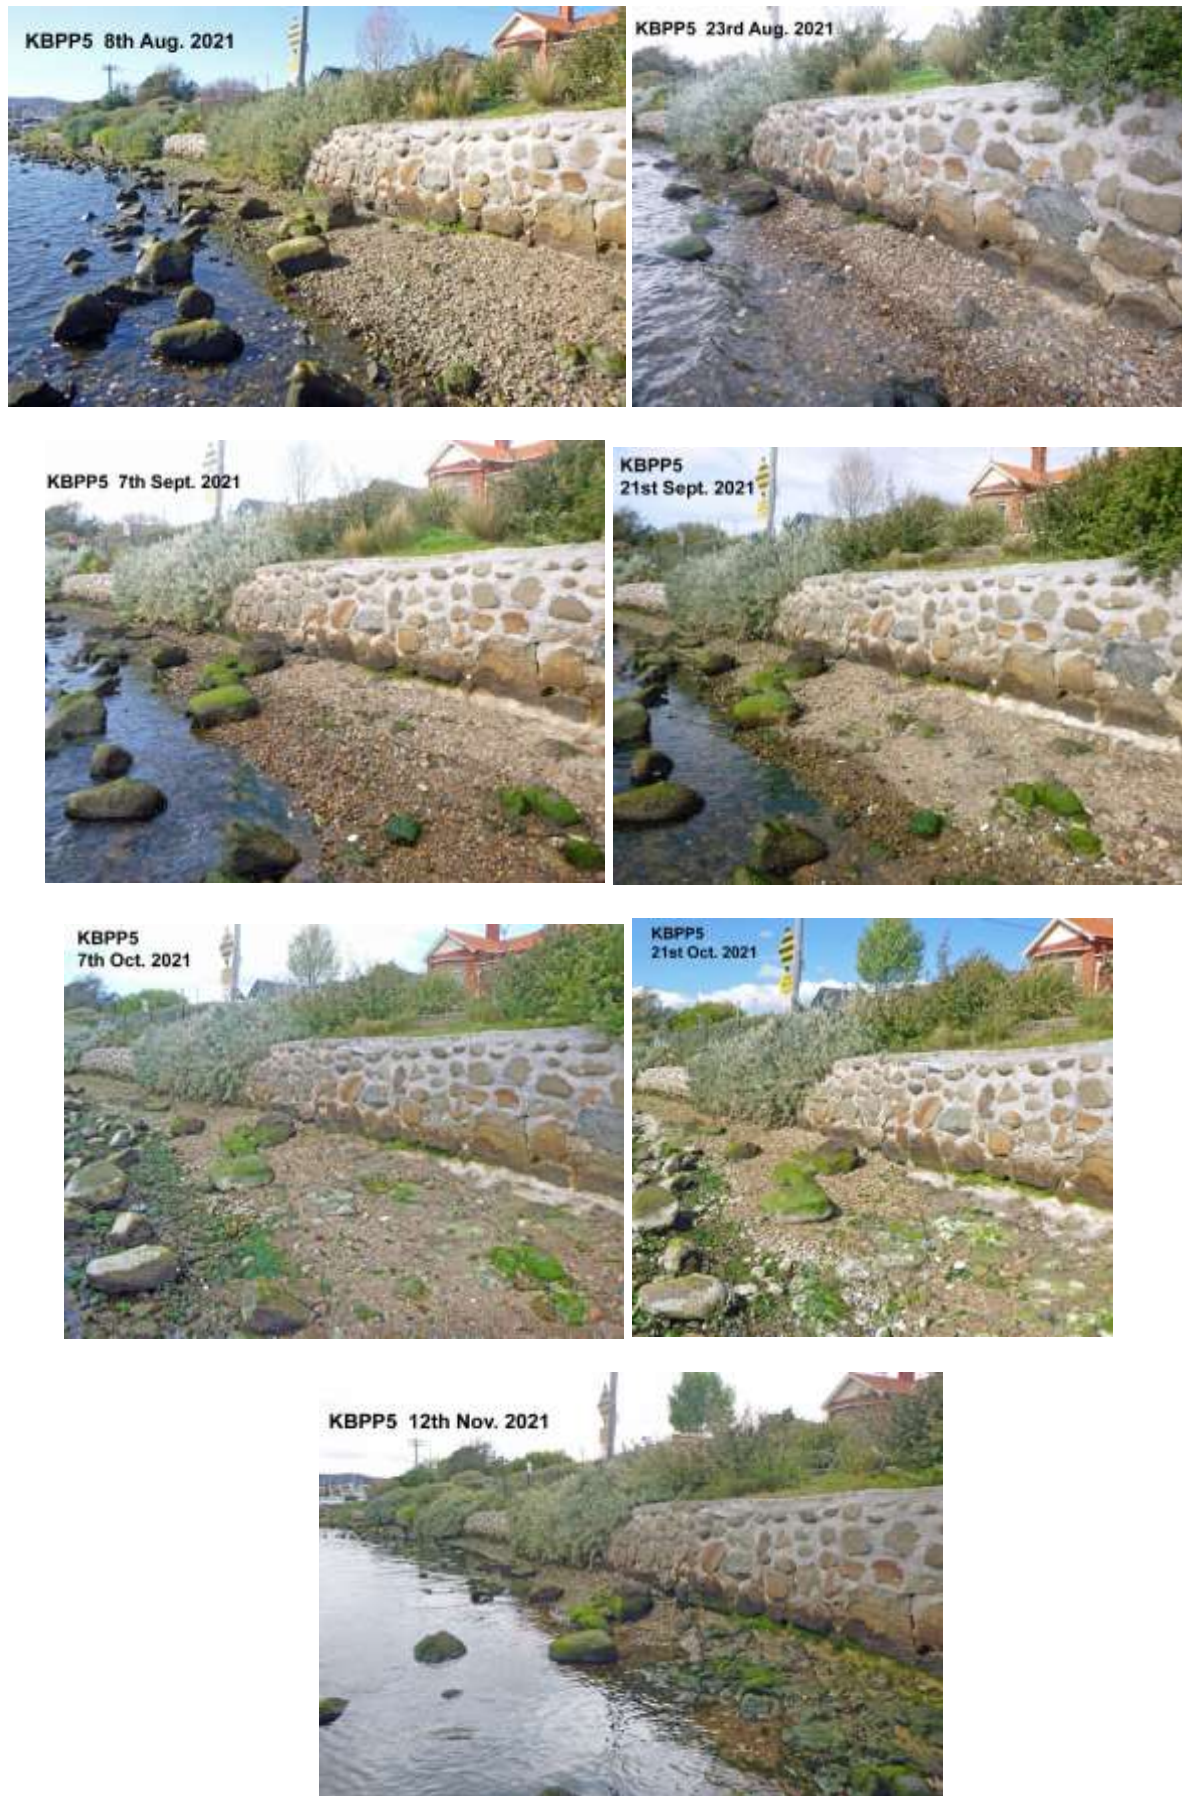
Progressive net changes to cobble veneers at one site may be a response to the introduction of ferry boat wakes. The photo-monitoring at KBPP5 has demonstrated a progressive and non-reversing net reduction in the extent of cobble veneers in the intertidal zone at this site over the 3-month monitoring period (see Figure 9). Of the 13 monitoring sites, this is the only one which demonstrates a significant change that is time-correlated with – and hence might be caused by – the introduction of new ferry wakes on 9th August 2021.

Figure 9: Comparison of the whole sequence of KBPP5 (leftwards view) monitoring photos throughout the trial monitoring period. The earliest (8th Aug.) photo shows a dominantly cobble foreshore, but following photos show a progressive loss of the cobble beach (veneer) and progressively increasing exposure of underlying dolerite bedrock, particularly towards the lower right-hand side of each photo. Zoom in to examine details of photos.

Unfortunately, the photographic record of the site begins only the day before the introduction of the new ferry. Ideally it would be useful to know whether the cobble veneer was constant (similar to the initial photos) or changing significantly over a period of at least some months prior to the ferry start date. In any case, it is necessary to ask whether ferry wakes might plausibly cause the observed changes, or whether other known processes at the site may plausibly cause them instead. In this respect, it is notable that site KBPP5 is probably the site most sheltered from both wind-waves and swell-waves entering Kangaroo Bay (see Figure 8), and hence has not shown the windstorm-related erosion pattern and timing seen at KBPP9 and 11 (see above). It is possible that the boat wakes introduced on 9th August 2021 have subsequently been the most energetic waves affecting the KBPP5 shore and have consequently resulted in a redistribution of cobble veneers into a new equilibrium with the new wave regime.

A test of the possibility that boat wakes may be a cause of the observed redistribution of cobbles will be (a) whether the observed changes persist while regular boat wakes of the scale observed since 9th Aug. 2021 continue; and (b) whether any temporary or permanent interruption to the boat wakes results in the cobbles reverting to their former distribution as seen on 8th August 2021 (Figure 9).

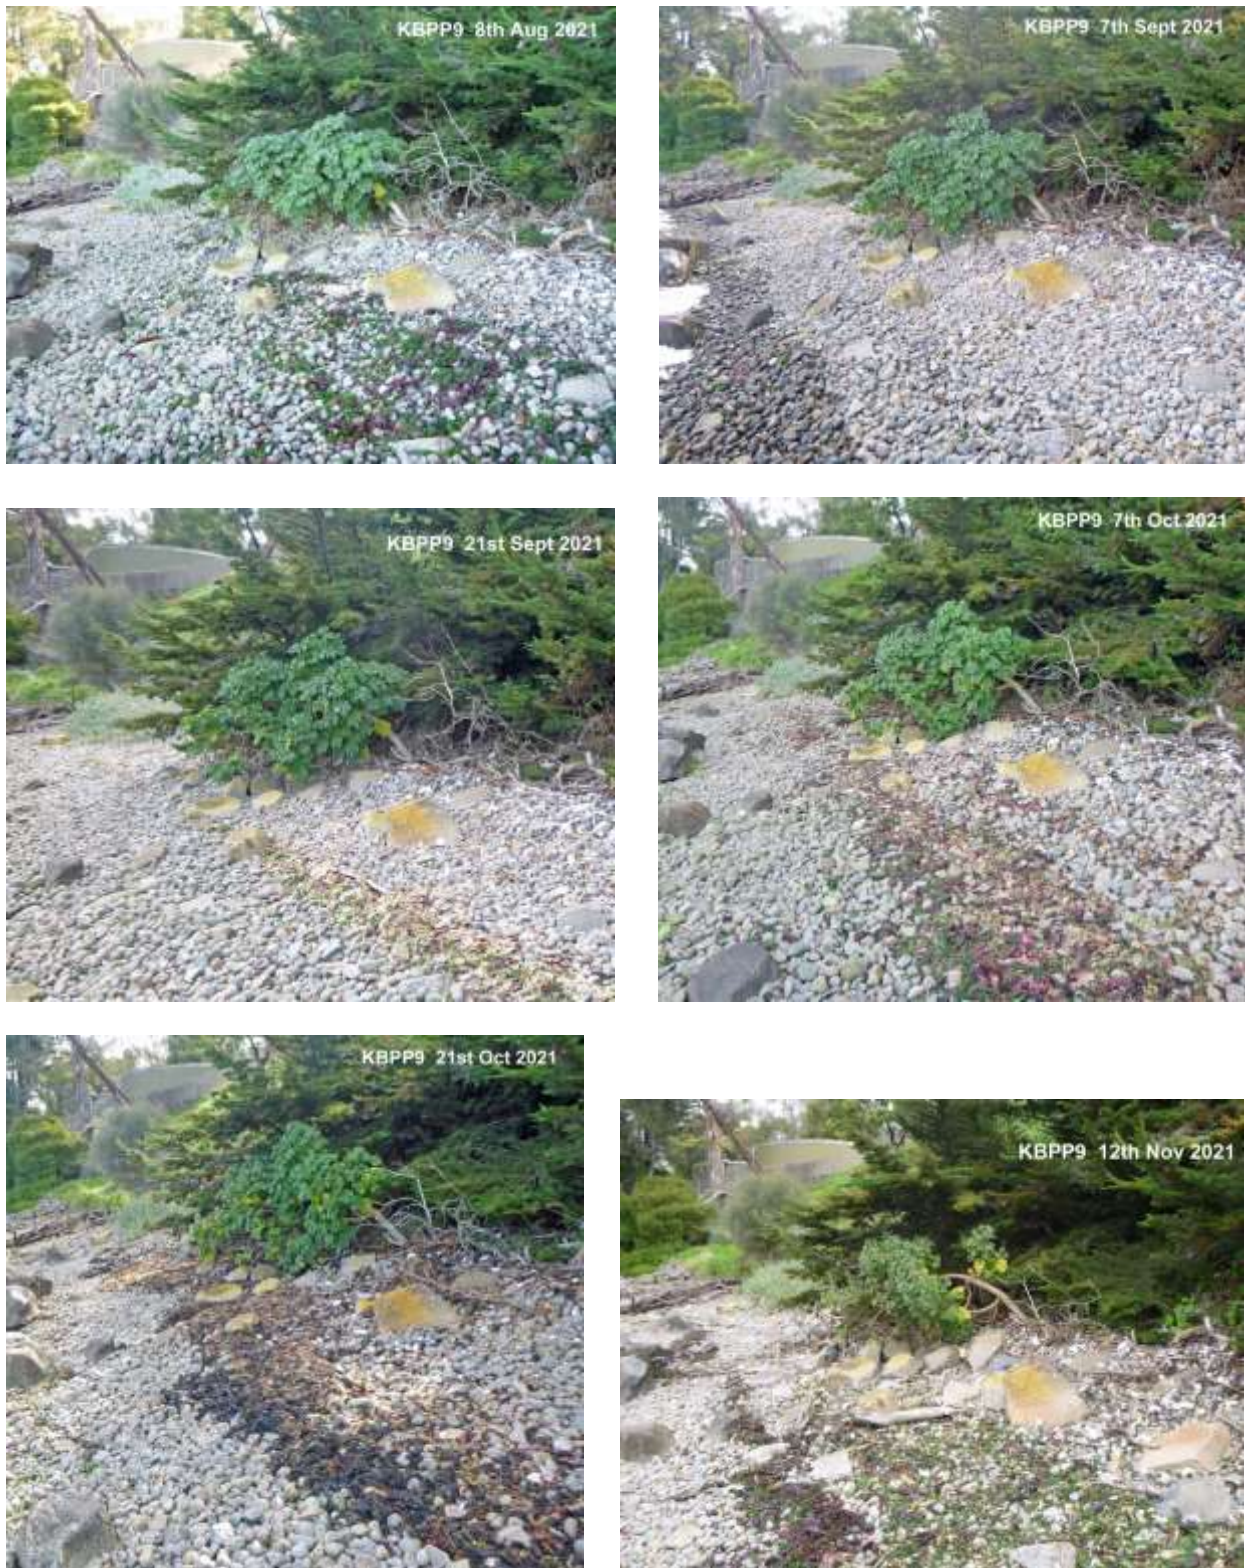
Time-correlated changes to cobble beaches observed at two sites most exposed to south-westerly wind-wave storms. At two cobble beach sites (KBPP9 and KBPP11) only minor cobble movements are detectable up until the 21st October 2021 photos, however the next and last photos (12th November 2021) demonstrate a significant lowering of the cobble beach surface, with increased exposure of boulders and underlying bedrock surfaces (see Figure 10 and Figure 11). These changes are inferred to be the result of energetic wave backwash dragging cobbles down the beach profile towards the sea (since no other transport direction for the “missing” cobbles appears plausible). These sites on the north shore of Kangaroo Bay are highly exposed to long southerly to south-westerly fetches across the Derwent estuary, and several windstorms from that direction occurred in the Hobart region during the 21st Oct – 12th Nov. period¹. Public wind hazard alerts were issued for several windstorms during this period. Hence, the timing and spatial patterning of cobble beach changes at KBPP9 and 11 suggest that these were most likely the result of these sites being particularly exposed to energetic wind waves locally-generated by a cluster of south-westerly storm wind events during October – November 2021.

Figure 10: Comparison of the whole sequence of KBPP9 (leftwards view) monitoring photos throughout the trial monitoring period. Note that no photos were taken at this site during the 3rd week of August (2nd monitoring run) due to lack of permission. Other than varying amounts of seaweed wrack on the cobble beach there is little change to the cobble and boulder beach from the first (pre-ferry) monitoring photo (8th Aug) until the second-last photo (21st Oct). However, between 21st Oct and 12th Nov there is a lowering (erosion) of the cobble beach resulting in greater exposure (but no significant movement) of the larger boulders in the beach. Zoom in to examine details of photos.

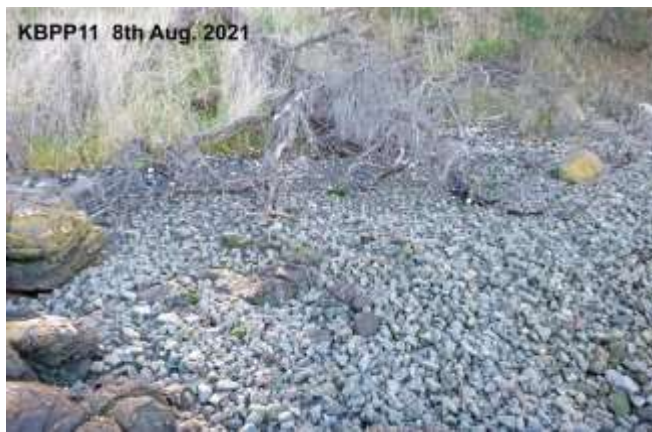
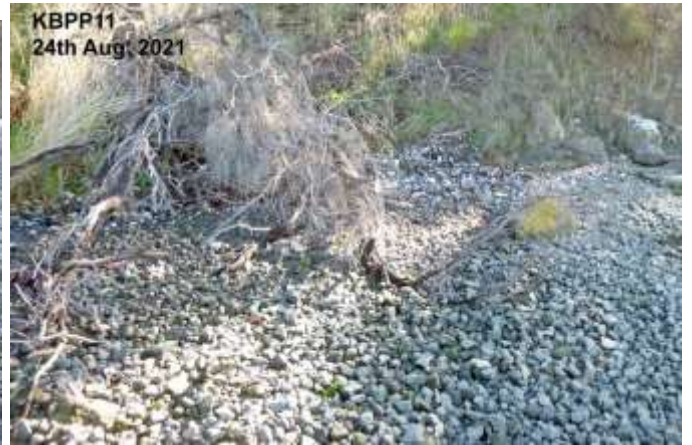
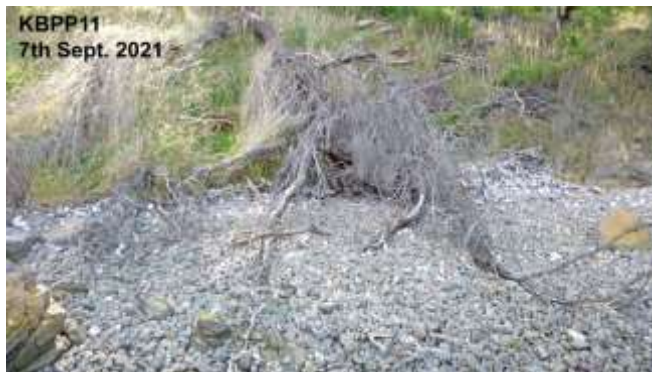
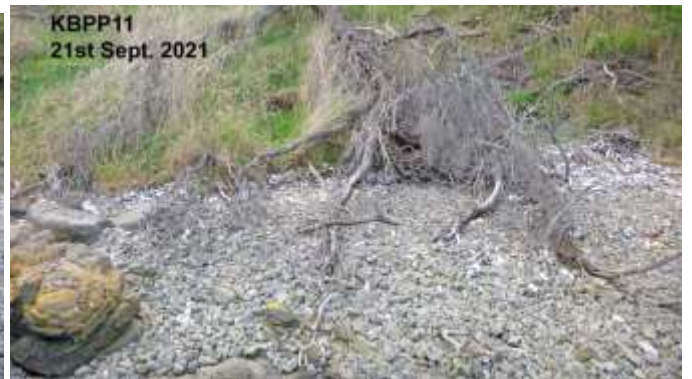
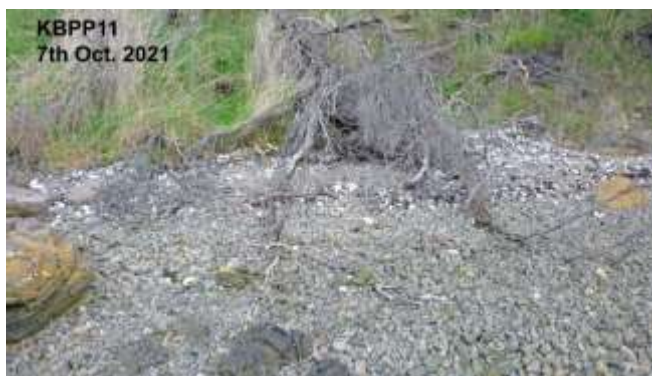
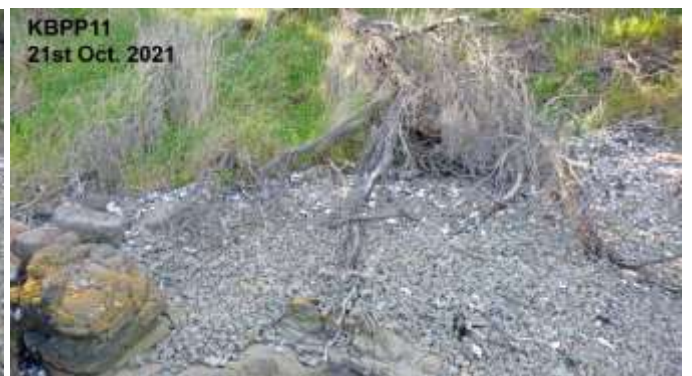
Figure 11: Comparison of the whole sequence of KBPP11 (onshore view) monitoring photos throughout the trial monitoring period. This sequence shows negligible to minor changes in cobble cover between 8th Aug. and 21st October 2021, then major removal of cobbles and exposure of bedrock between 21st October and 12th November 2021. Zoom in to examine details of photos.

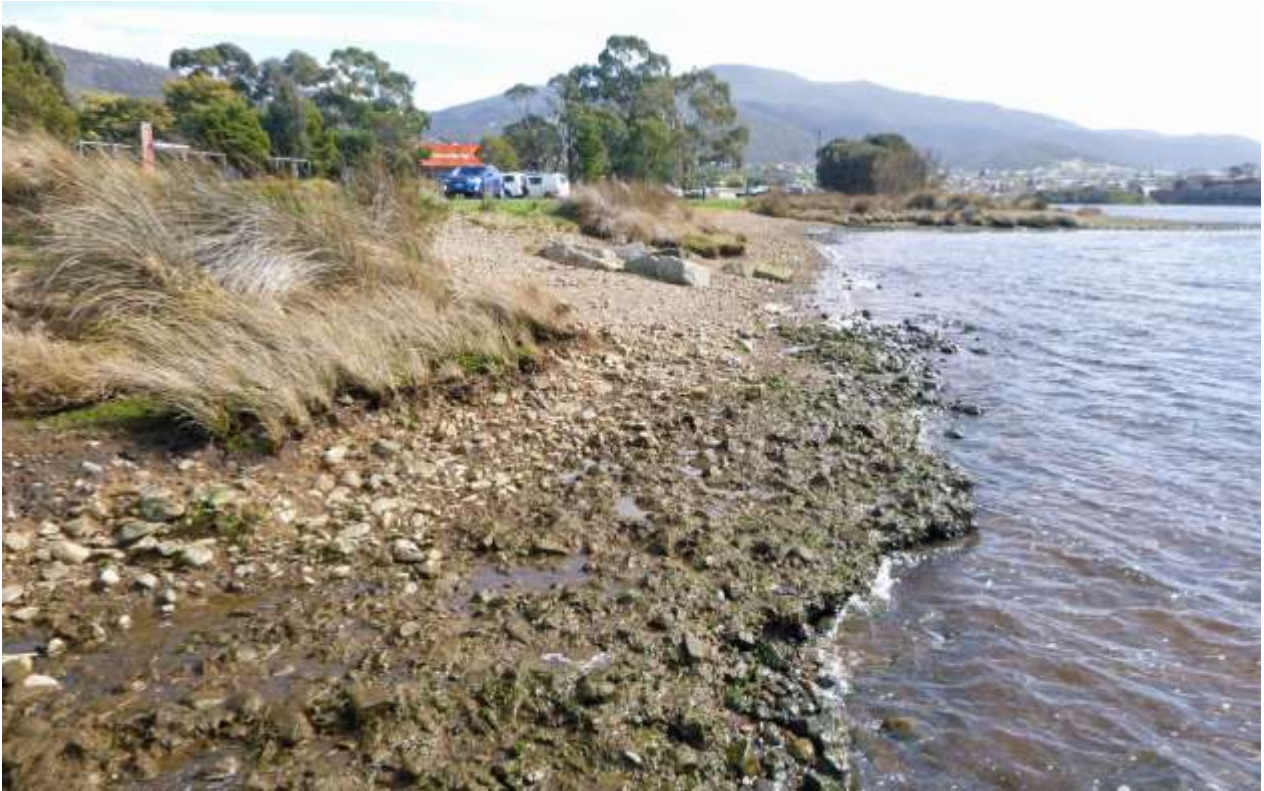
Figure 14: Eroding soft dark cohesive cobbly substrate at Montrose Shoreline. Photo taken close to monitoring photo point MSPP3, showing scarps eroded into the substrate material by wave action at two different levels (upper: vegetation line and lower: waterline at the time this photo was taken). Wave excavation of the obvious rounded cobbles and pebbles from their dark finer-grained cohesive matrix is a likely source of the loose cobble berms (beaches) or ridges also found along this shore (see Figure 15 below).

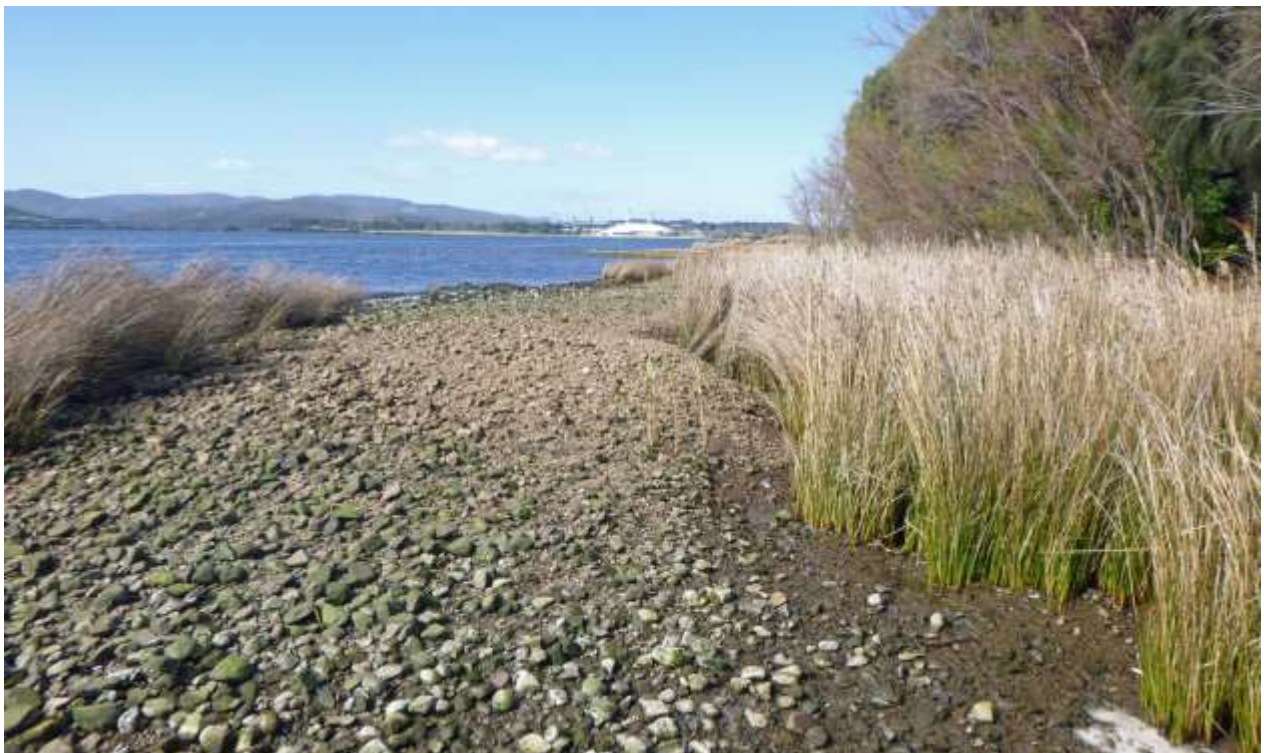
Figure 15: Loose pebble and cobble beach ridge or berm over cobbles in a dark cohesive silty-clay matrix on the Montrose Shoreline. View looking south from close to monitoring photo point MSPP1, showing a loose light-coloured cobble ridge which can be seen to have moved from left to right, engulfing vegetation as wave action pushed the loose mass landwards. These loose cobble ridges seem to have appeared mostly after 2012, possibly as a result of increased wave action excavating cobbles from the underlying dark cohesive silty-clay matrix as seen in Figure 14 above. Photo by Chris Sharples, 6th September 2021.

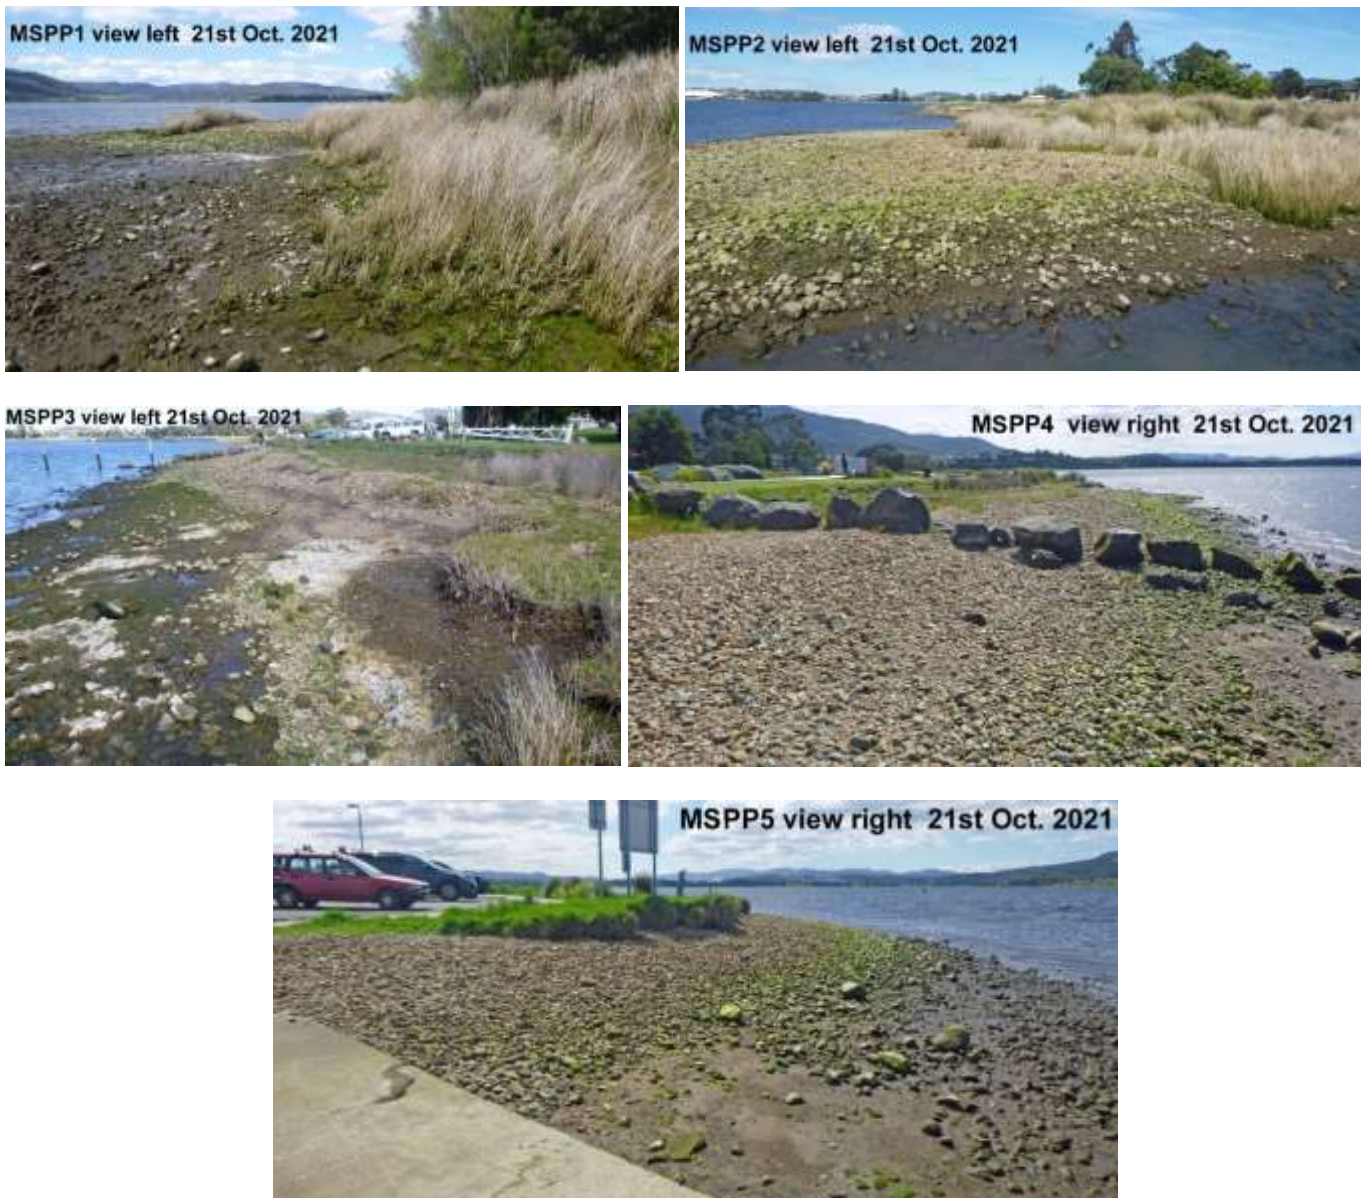
Figure 17: One view from each of the five 21st October 2021 Montrose Shore Photo-monitoring viewpoints showing aspects of the features A to D identified on aerial photos and described in section 3.3 below. Top left: Photo point MSPP1 view L to air photo feature A; Top Right: Photo point MSPP2 view L to air photo feature B; Middle left: Photo point MSPP3 view L to air photo feature C; Middle right: Photo point MSPP4 view R to air photo feature C; Bottom: Photo point MSPP5 view R to air photo feature D. See Appendix 3 for reproductions of all Montrose Bay monitoring photos for 21st October 2021.

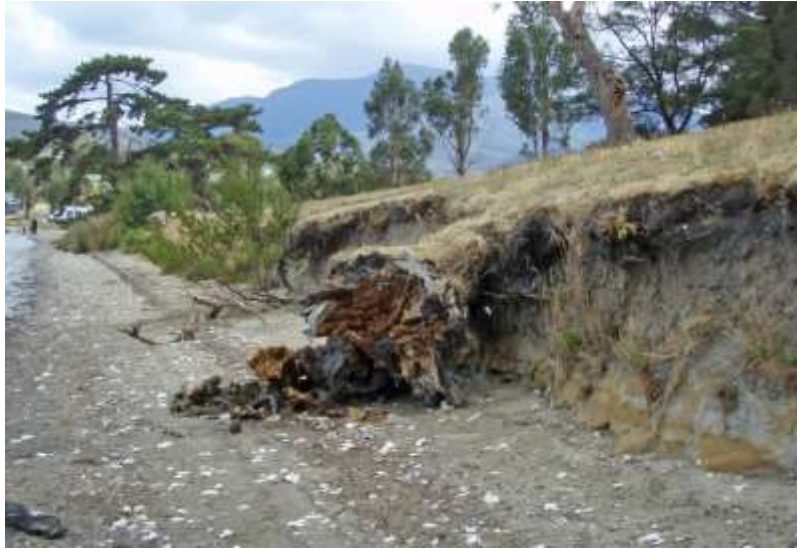
Figure 21: Current soil margin erosion status behind the eastern half of Cornelian Bay Beach. Although a narrow sandy beach is present at this location, the overlying eroding material is not a coastal dune, but rather is a clayey terrestrial soil horizon undergoing storm wave attack at its seawards margin. Photo by Chris Sharples (January 2022)

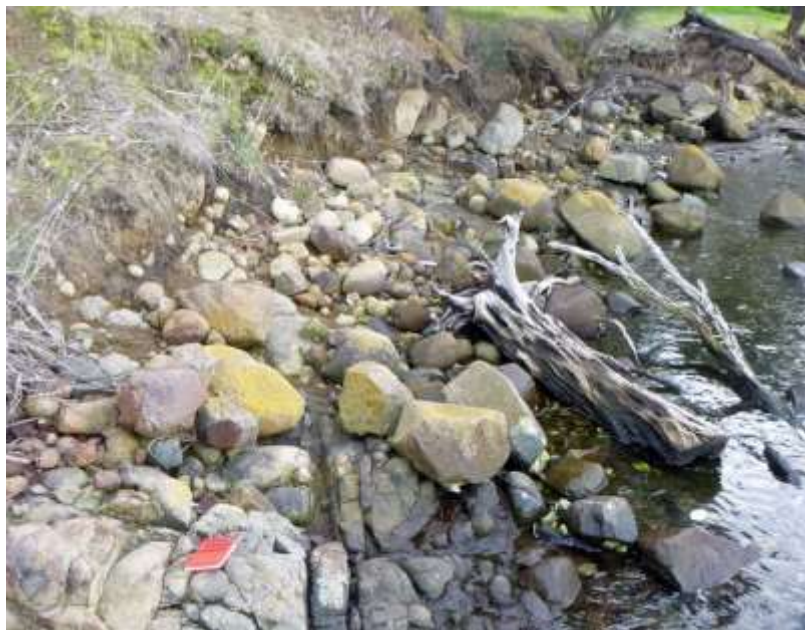
Figure 22: Recent soil margin erosion on a hard rock (dolerite bedrock) shore in north-eastern Kangaroo Bay. Although this site would typically be classified as an erosion-resistant hard-rock bedrock shore, it is likely that erosion of the overlying soil under conditions of a rising sea-level will be able to proceed a significant distance landwards before the underlying bedrock slope becomes too high and steep to permit further erosion.

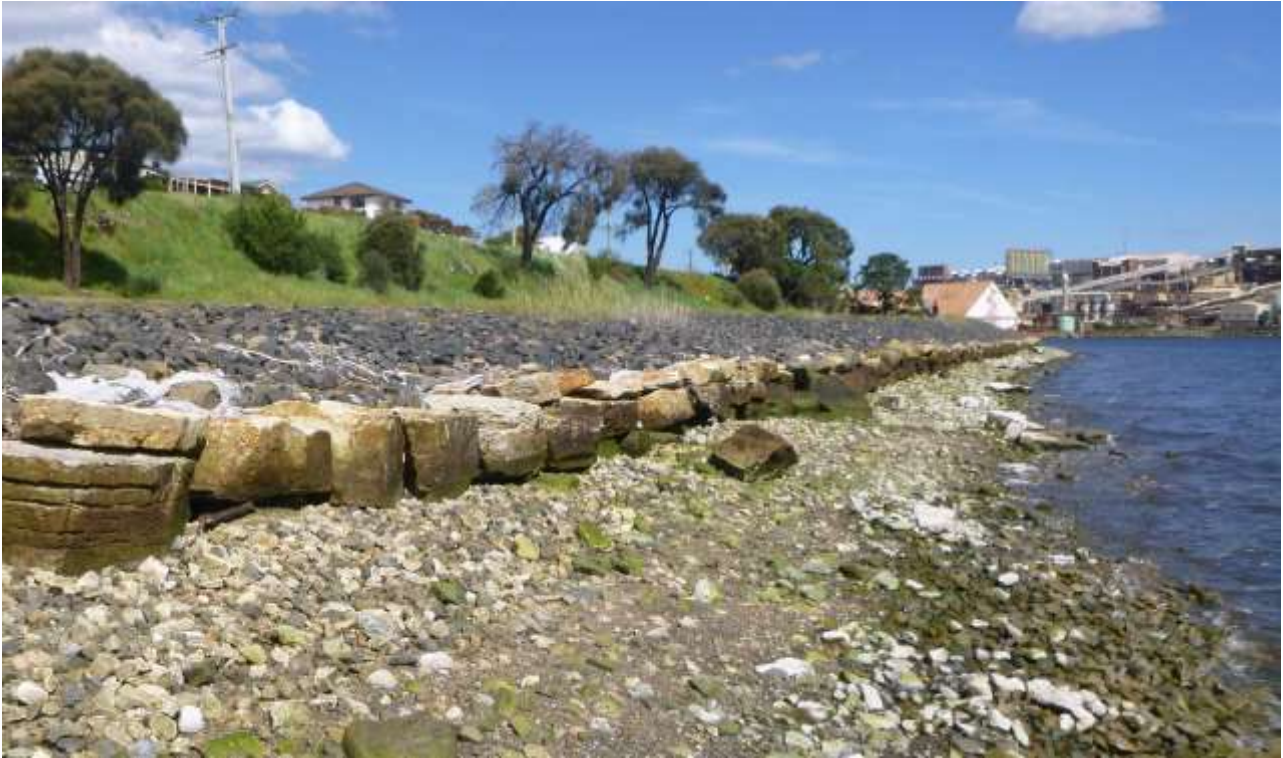
Figure 23: New seawall constructed circa 2020 at East Risdon, Derwent Estuary. This robust boulder wall protects a shore at Saunderson's Road (East Risdon), which was previously exhibiting significant erosion in the cobble-grade artificial fill visible above and below the new boulder wall. This material was previously directly exposed to the wake waves generated by the Mona Roma ferries which pass through this narrow reach of the Derwent Estuary several times a day. Photo by C. Sharples (21st October 2021).

However, Clarence Council was aware of the erosion and repaired it with an improved artificial stone revetment circa 2019 or 2020 (see Figure 23 above).

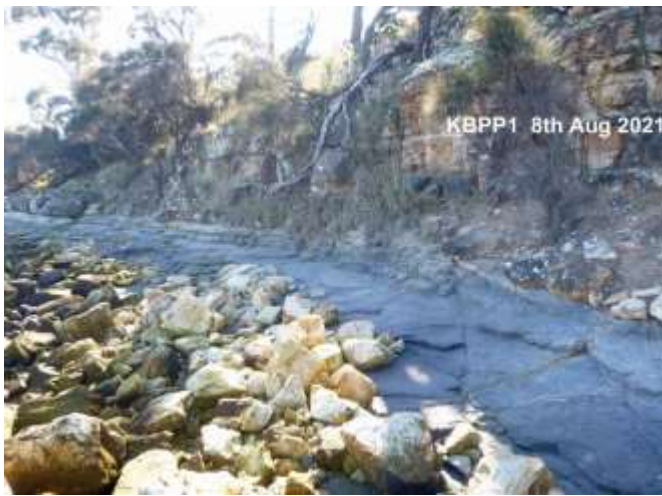
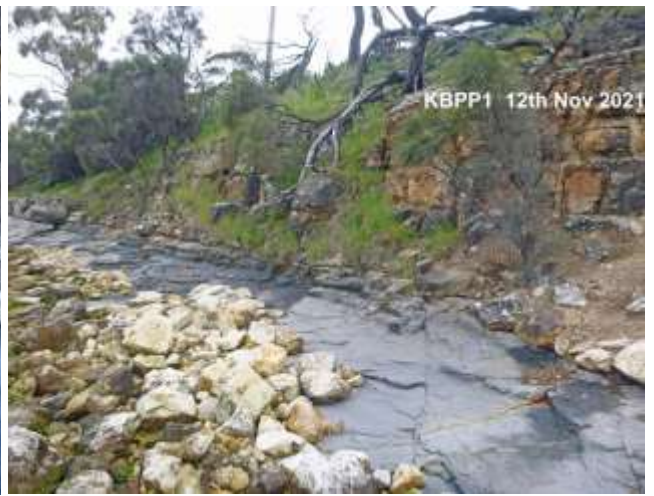
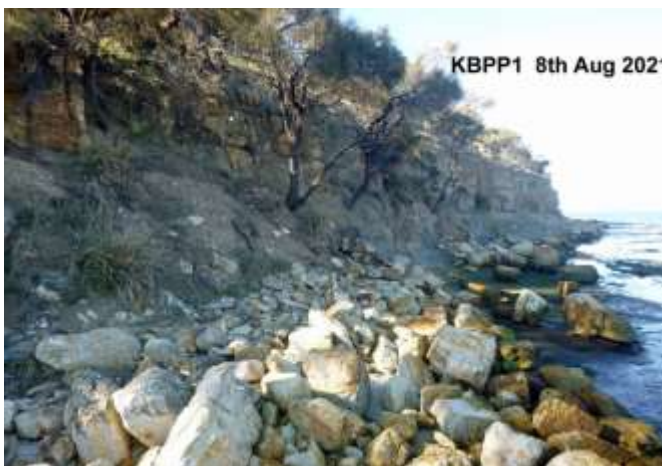
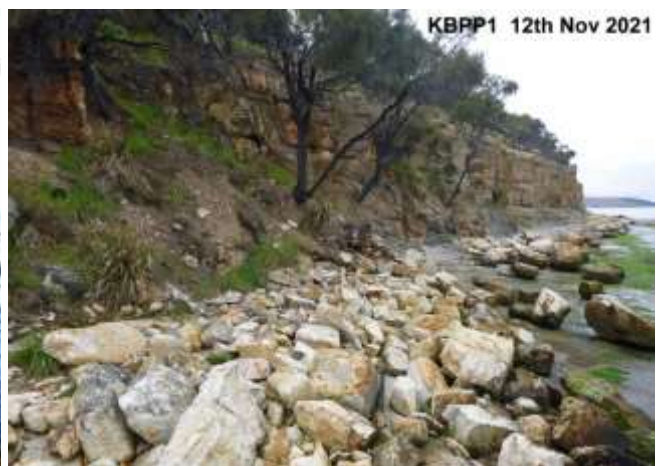
Figure 29: First (8th Aug 2021) and last (12th Nov 2021) photos taken at Kangaroo Bay photo point KBPP1. First photos in LH column, last photos in RH column. Views top to bottom are leftwards, onshore, and rightwards. No significant changes detected between first and last photos.

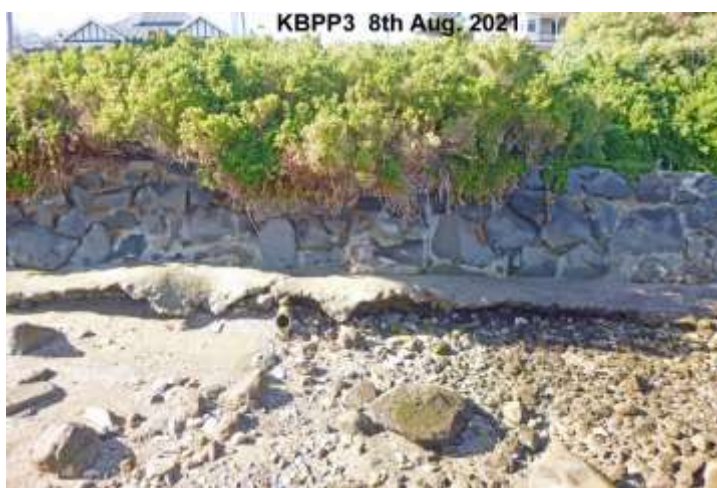
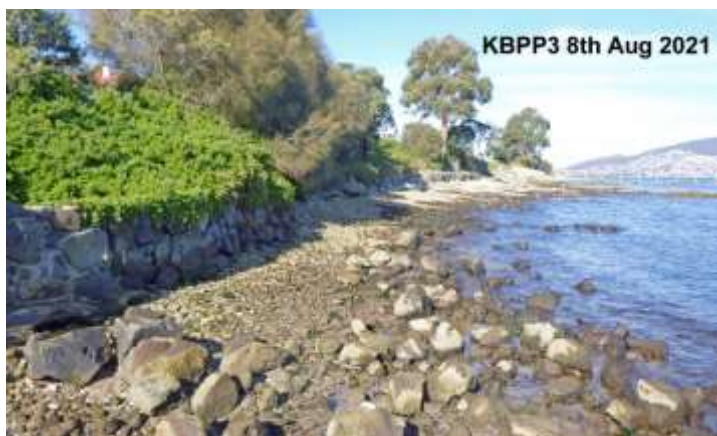
Figure 31: First (8th Aug 2021) and last (12th Nov. 2021) photos taken at Kangaroo Bay photo point KBPP3. First photos in LH column, last photos in RH column. Views top to bottom are leftwards, onshore, and rightwards. Changes between first and last photos are negligible, although a great deal of sand and cobbles at this site could be susceptible to wave action.

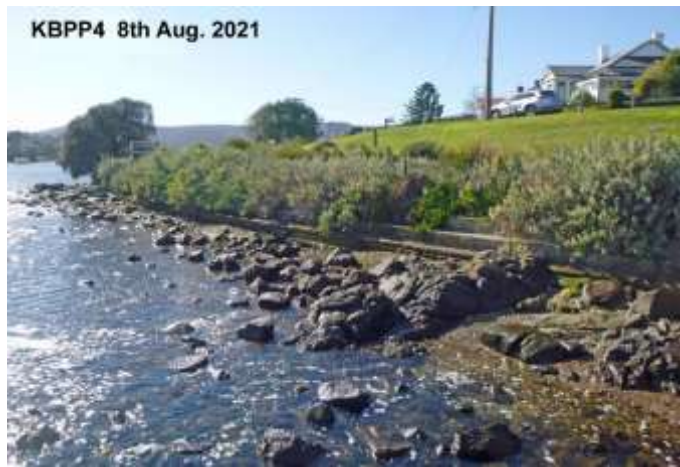
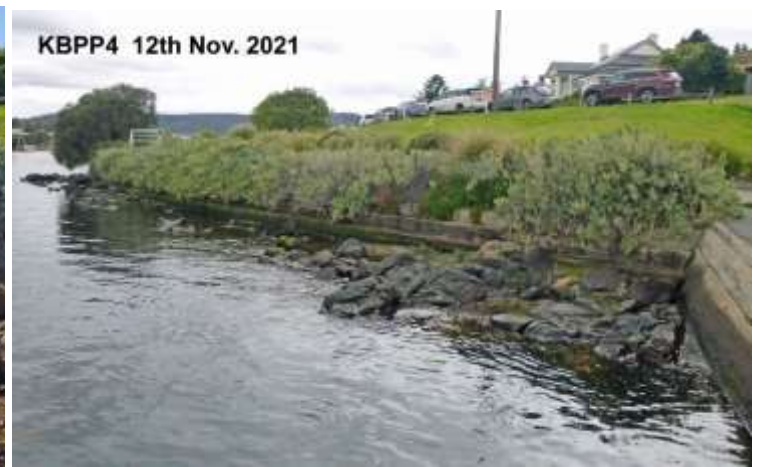
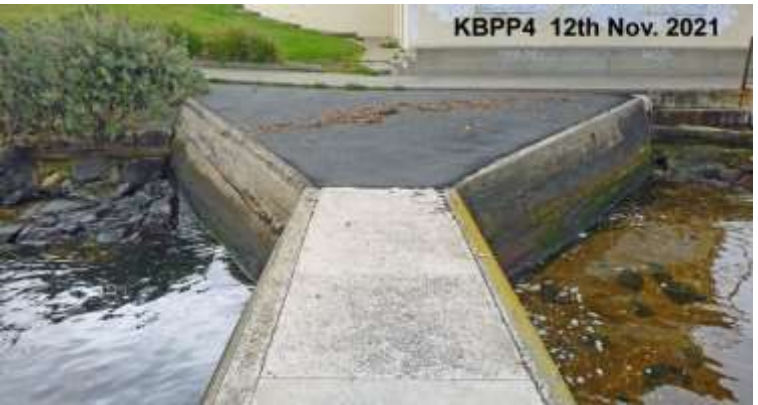
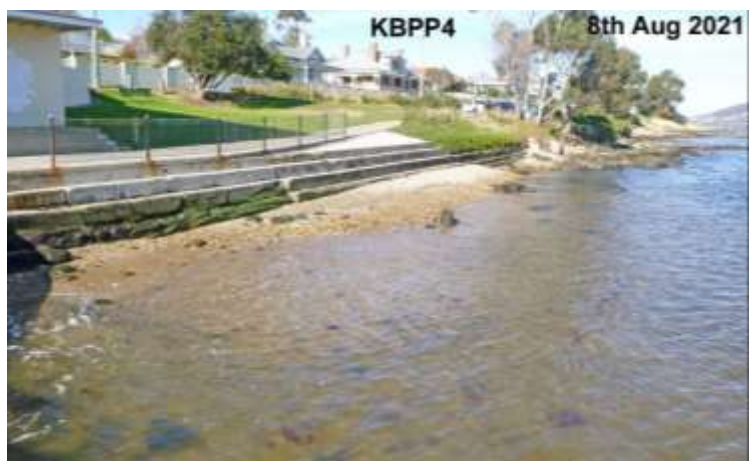
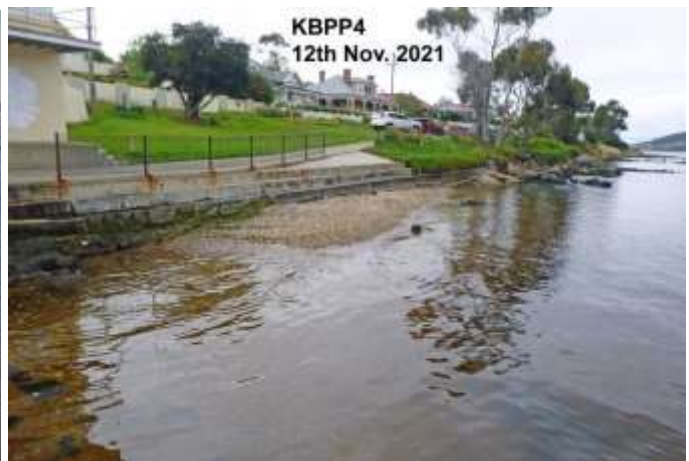
Figure 32: First (8th Aug. 2021) and last (12th Nov. 2021) photos taken at Kangaroo Bay photo point KBPP4. First photos in LH column, last photos in RH column. Views top to bottom are leftwards, onshore, and rightwards. Note that the last photos (12th Nov) were taken at too high a tidal level to allow proper examination of soft shoreline components present at this site. A lower tidal level than shown here is desirable for monitoring photos.

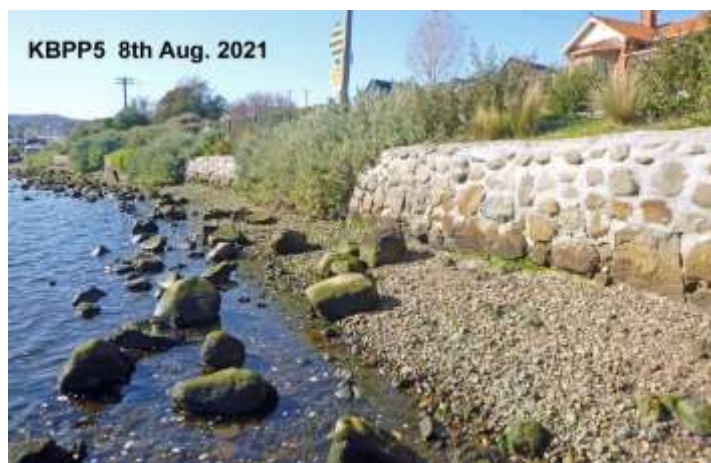
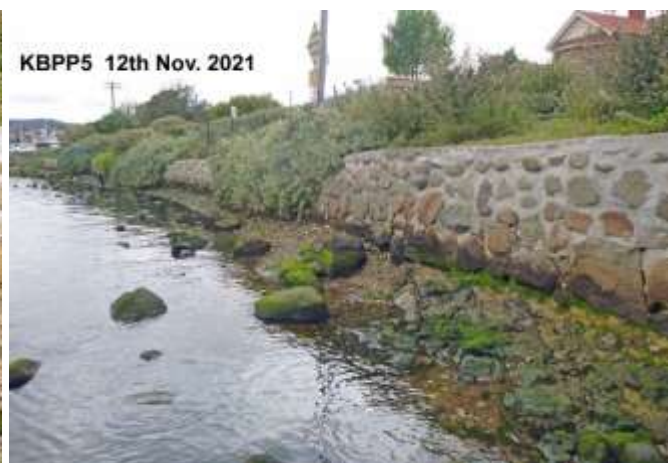
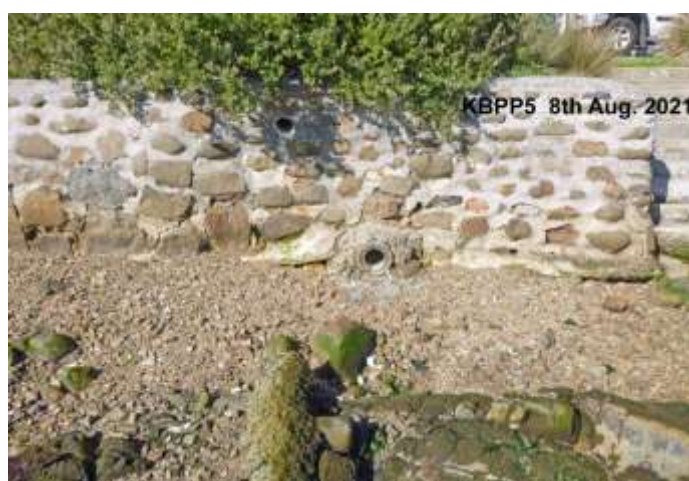
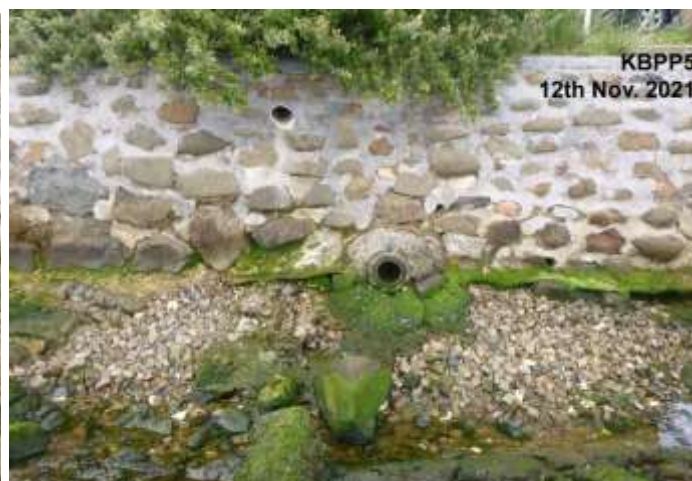
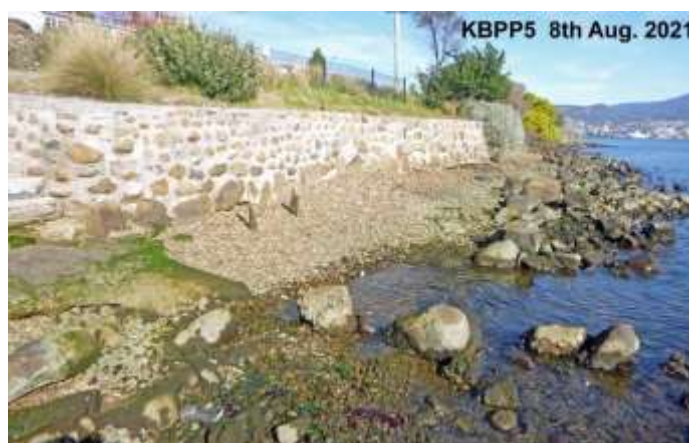
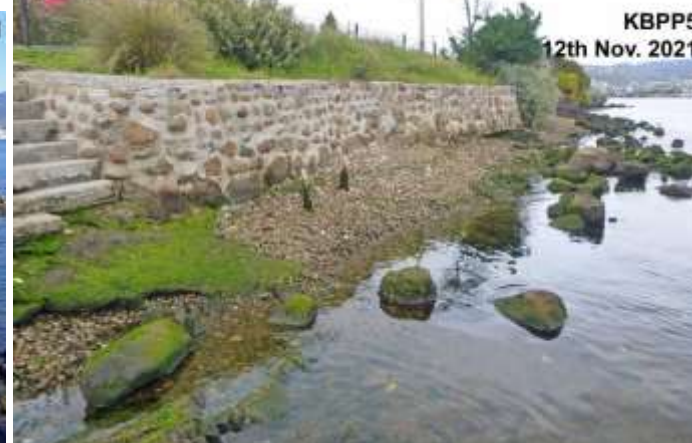
Figure 33: First (8th Aug. 2021) and last (12th Nov. 2021) photos taken at Kangaroo Bay photo point KBPP5. First photos in LH column, last photos in RH column. Views top to bottom are leftwards, onshore, and rightwards. A notable depletion of the intertidal cobble veneer over the dolerite bedrock is especially noticeable in the final view leftwards as compared to the first view leftwards (top images).

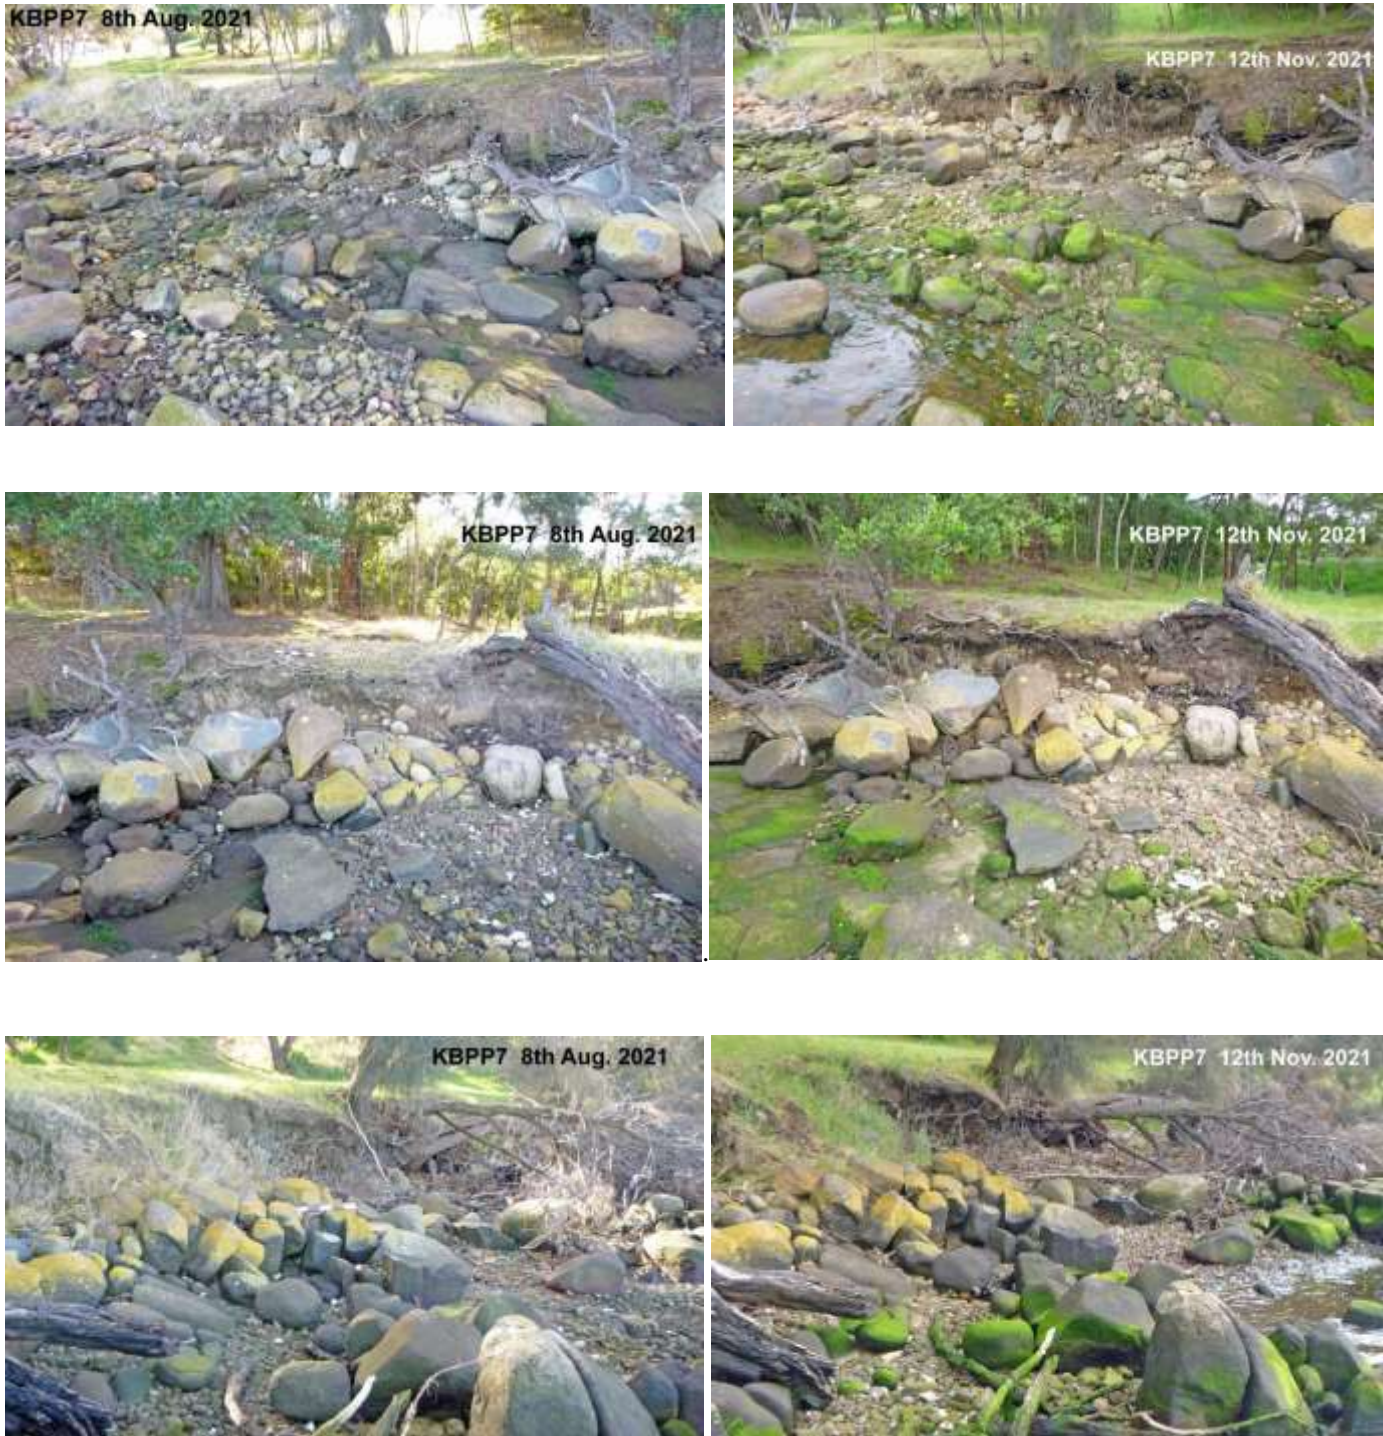
Figure 35: First (8th Aug. 2021) and last (12th Nov. 2021) photos taken at Kangaroo Bay photo point KBPP7. First photos in LH column, last photos in RH column. Views top to bottom are leftwards, onshore, and rightwards. No discernible change evident.

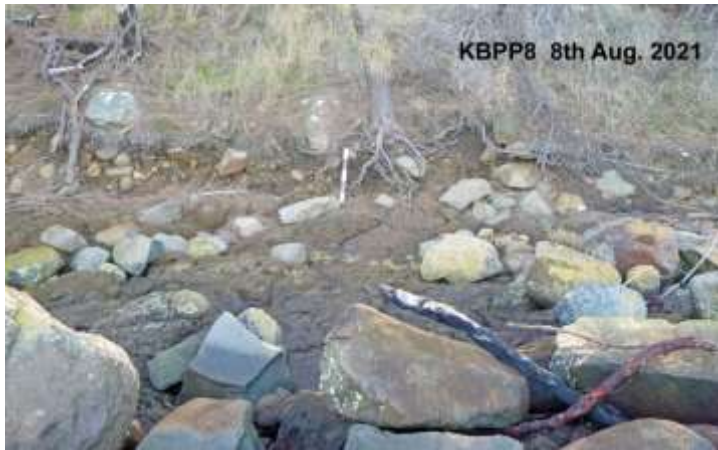
Figure 36: First (8th Aug. 2021) and last (12th Nov. 2021) photos taken at Kangaroo Bay photo point KBPP8. First photos in LH column, last photos in RH column. Views top to bottom are leftwards, onshore, and rightwards. No detectable change.
