Monitoring the physical effects of boat wakes on shorelines in the Derwent River Estuary

Report to:
Derwent Estuary Program

By:
Chris Sharples

April 2022

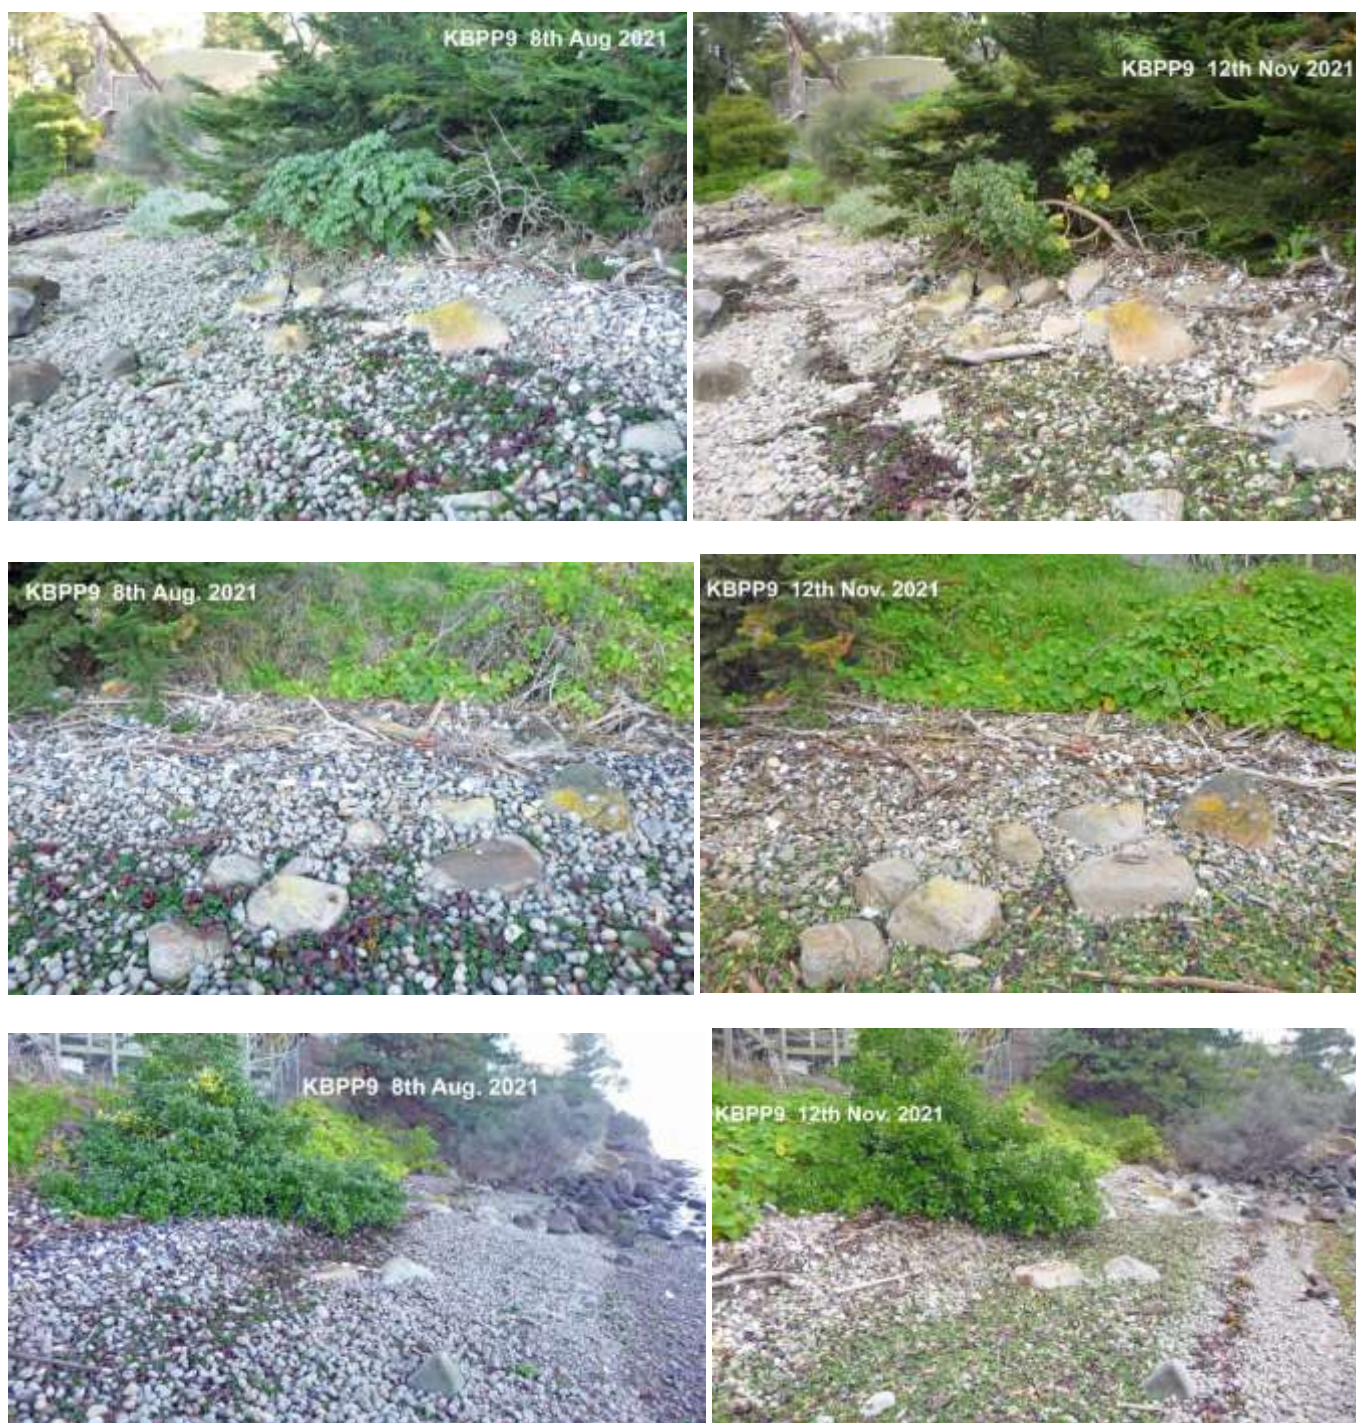
Figure 37: First (8th August 2021) and last (12th Nov. 2021) photos taken at Kangaroo Bay photo point KBPP9. First photos in LH column, last photos in RH column. Views top to bottom are leftwards, onshore, and rightwards. Minor cobble beach lowering is evident in the lefthand 12th Nov. view, suggesting energetic storm wave backwash has dragged cobbles down the beach profile. However, the onshore and righthand views show little change, with bits of the same wrack (flotsam) evident at the top of the beach in both the August and November onshore views, suggesting storm waves did not reach the back of the beach in that location (only a few metres from the lefthand view).

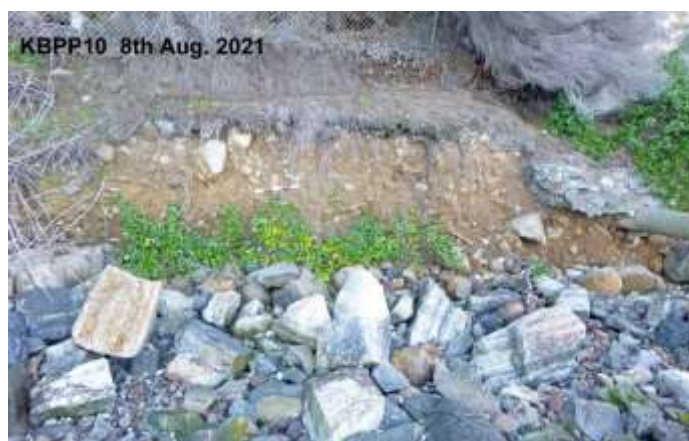
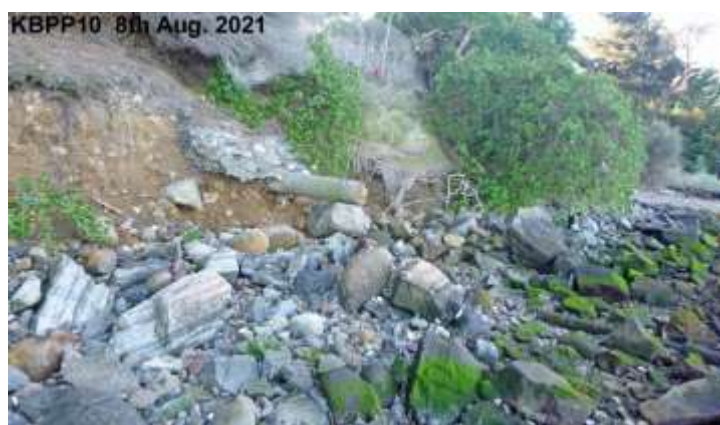
Figure 38: First (8th Aug. 2021) and last (12th Nov. 2021) photos taken at Kangaroo Bay photo point KBPP10. First photos in LH column, last photos in RH column. Views top to bottom are leftwards, onshore, and rightwards. No changes detected between 8th August and 12th November 2021.

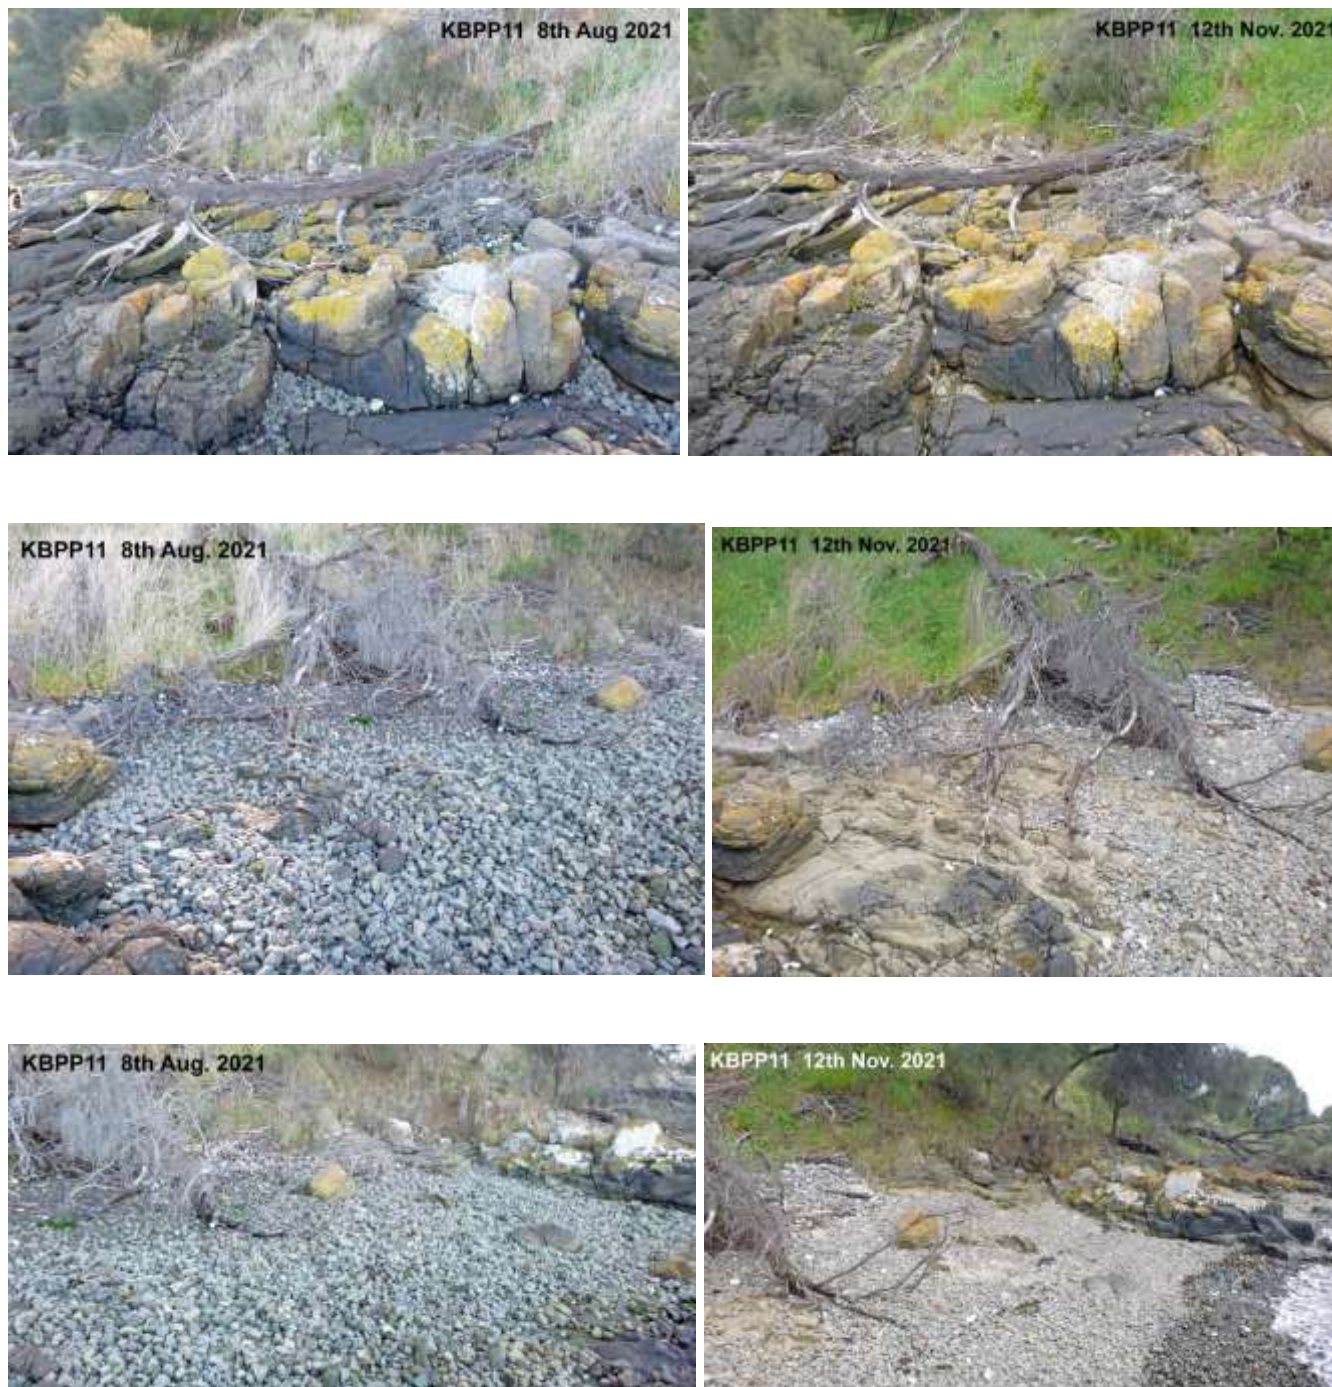
Figure 39: First (8th Aug. 2021) and last (12th Nov. 2021) photos taken at Kangaroo Bay photo point KBPP11. First photos in LH column, last photos in RH column. Views top to bottom are leftwards, onshore, and rightwards. Comparison of the two onshore views demonstrates removal of a significant amount of cobbles (exposing underlying bedrock) which have probably been moved seawards by energetic storm wave backwash.

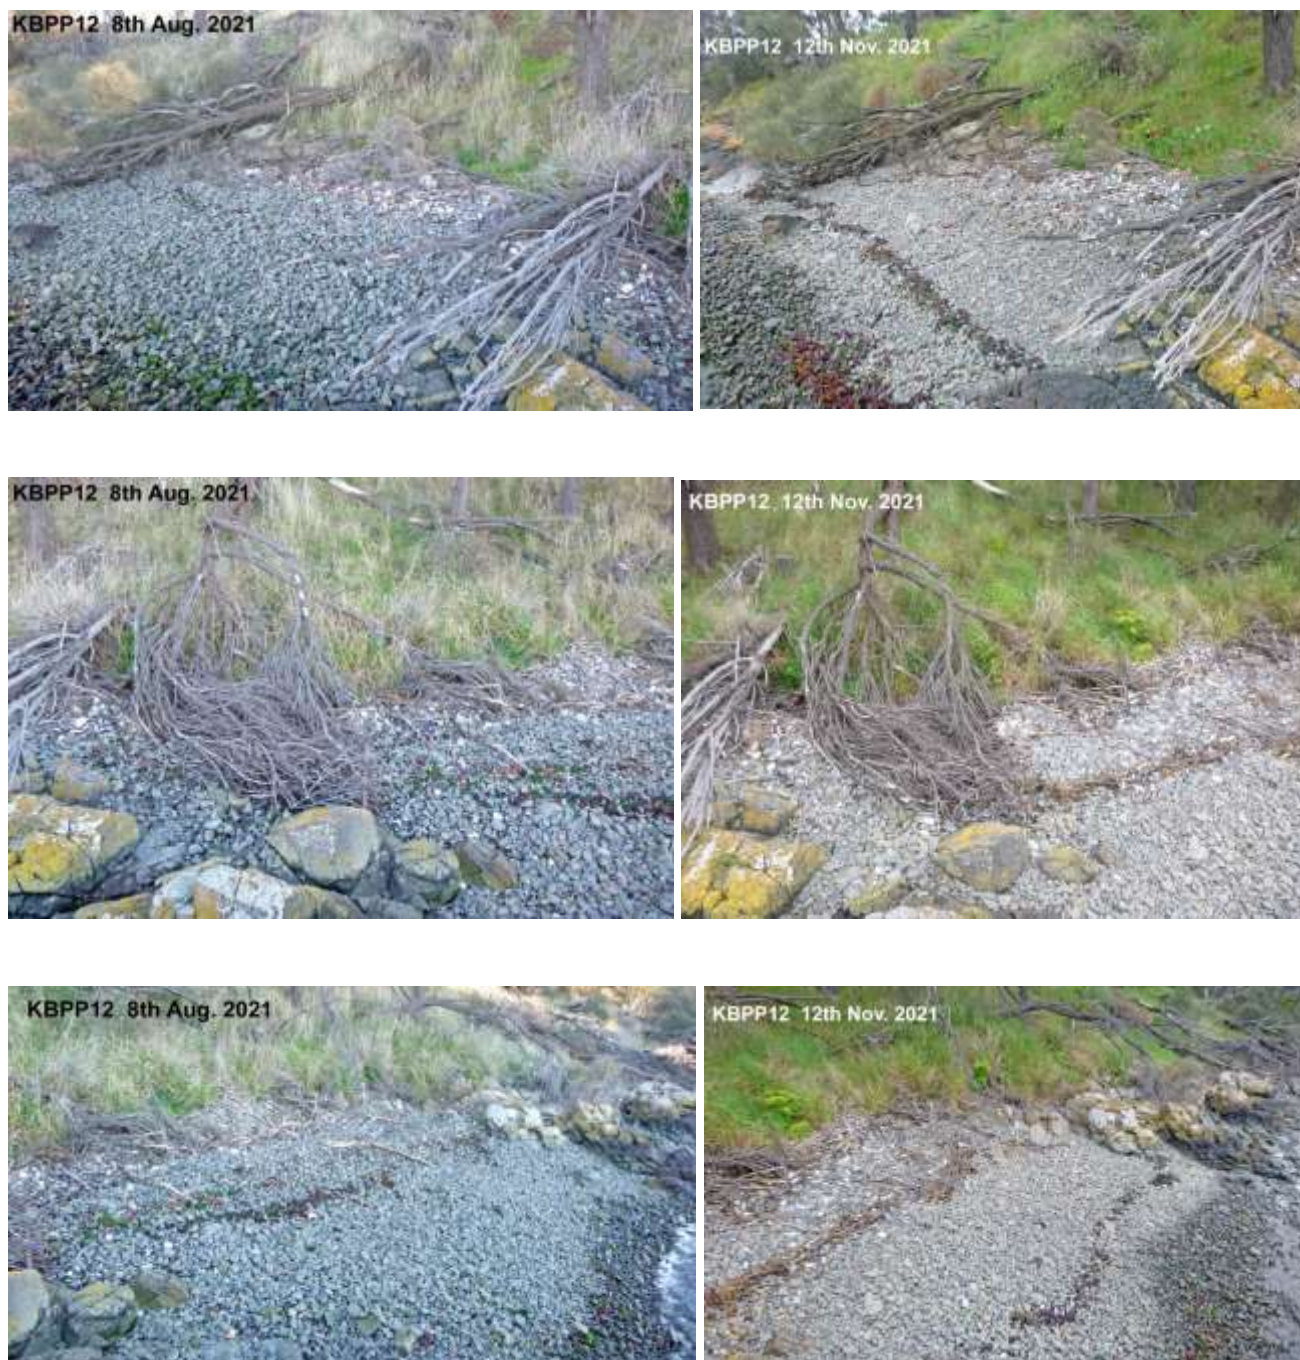
Figure 40: First (8th August 2021) and last (12th Nov. 2021) photos taken at Kangaroo Bay photo point KBPP12. First photos in LH column, last photos in RH column. Views top to bottom are leftwards, onshore, and rightwards. Negligible change detected despite large area of cobble beach at this site. This suggests that this site was more sheltered from the early November storm waves than otherwise comparable sites such as KBPP11 and KBPP9.

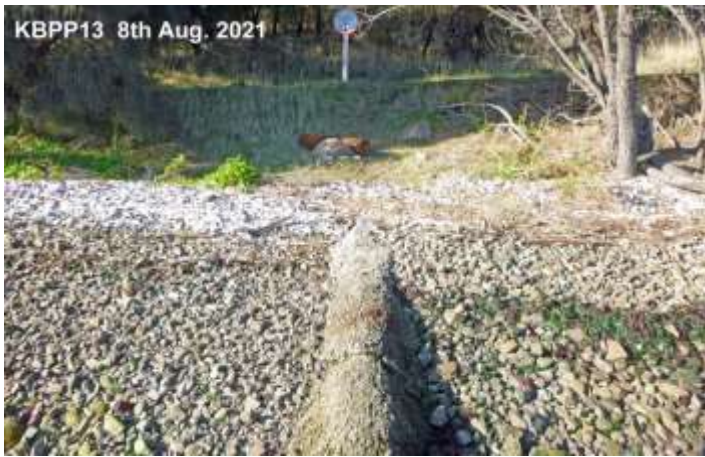
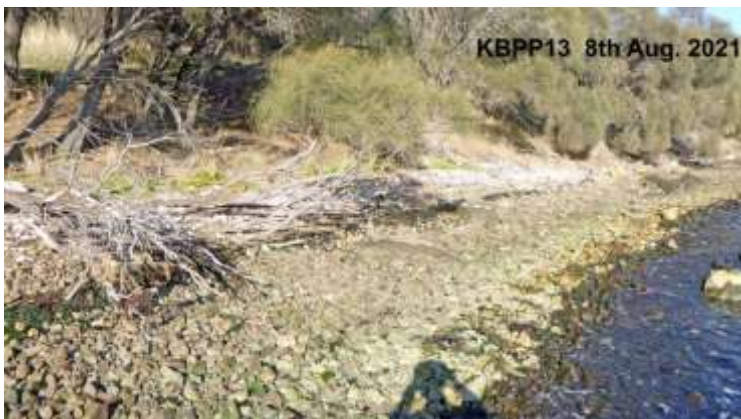
Figure 41: First (8th Aug. 2021) and last (12th Nov. 2021) photos taken at Kangaroo Bay photo point KBPP13. First photos in LH column, last photos in RH column. Views top to bottom are leftwards, onshore, and rightwards. Negligible changes to the cobble beach or soil margin are evident, however the last photos show that several large logs have washed up on this shore; this suggests stronger wave activity prior to the last photo.

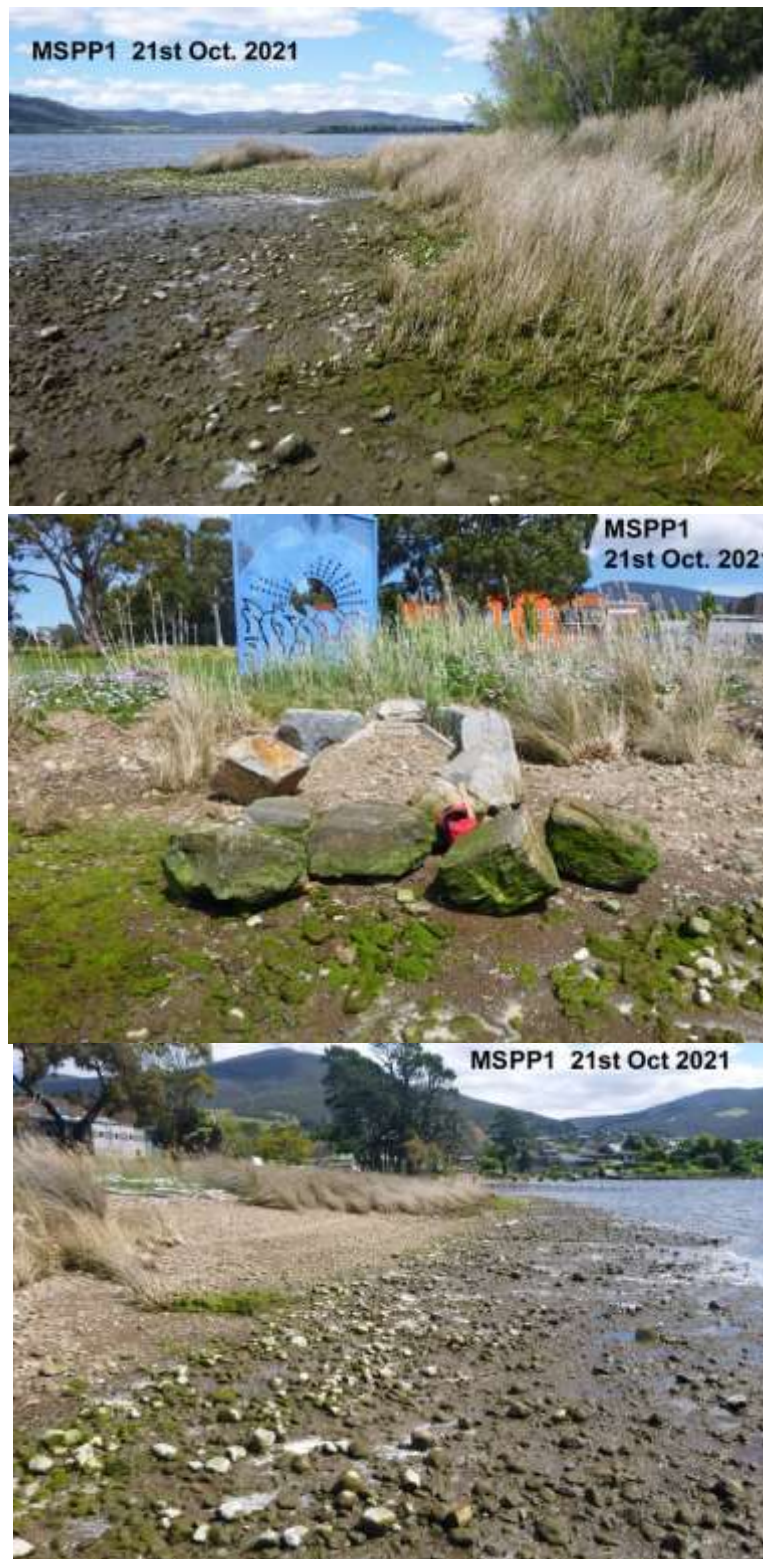
Figure 43: Initial monitoring photos from Montrose Shore photo monitoring point MSPP1. Initial monitoring photos dated 21st October 2021 (views leftwards, onshore, and rightwards). This photo point is directly seawards of stormwater drainage outlet or culvert which at the date of these photos was completely blocked by cobble-grade shoreline sediments inferred to have been washed shoreward by wave action (see onshore view). Note that a ring of boulders around the culvert have not prevented the cobbles being washed into the culvert. Zoom in for better photo details.

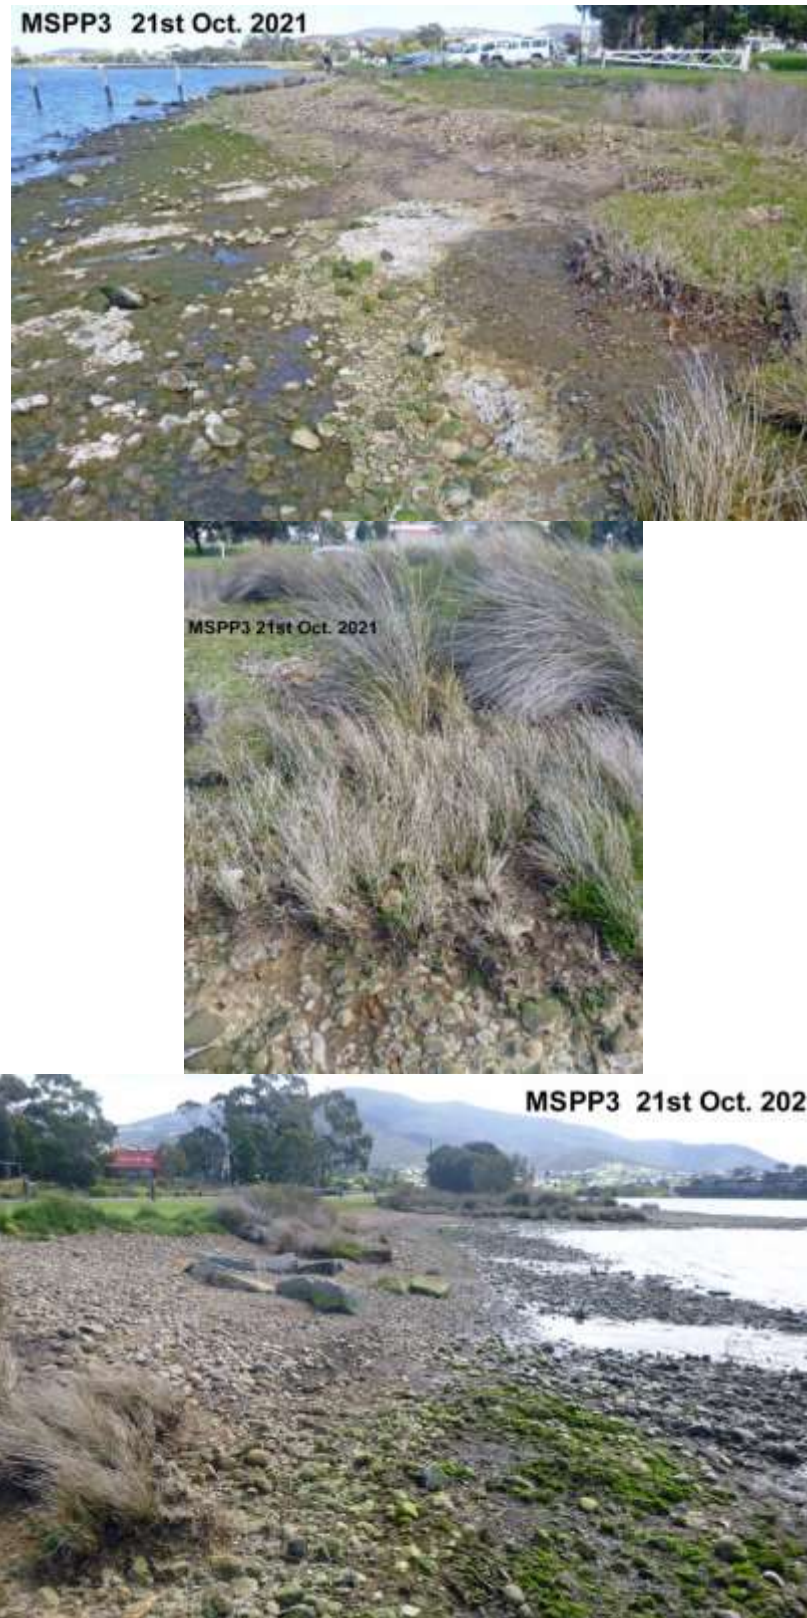
Figure 45: Initial monitoring photos from Montrose Bay photo monitoring point MSPP3. Initial monitoring photos dated 21st October 2021 (views leftwards, onshore, and rightwards). This photo point is near a stormwater drainage outlet or culvert (rightwards view, between boulders) which at the date of these photos was completely blocked by cobble-grade shoreline sediments inferred to have been washed shoreward by wave action. Zoom in for better photo details.

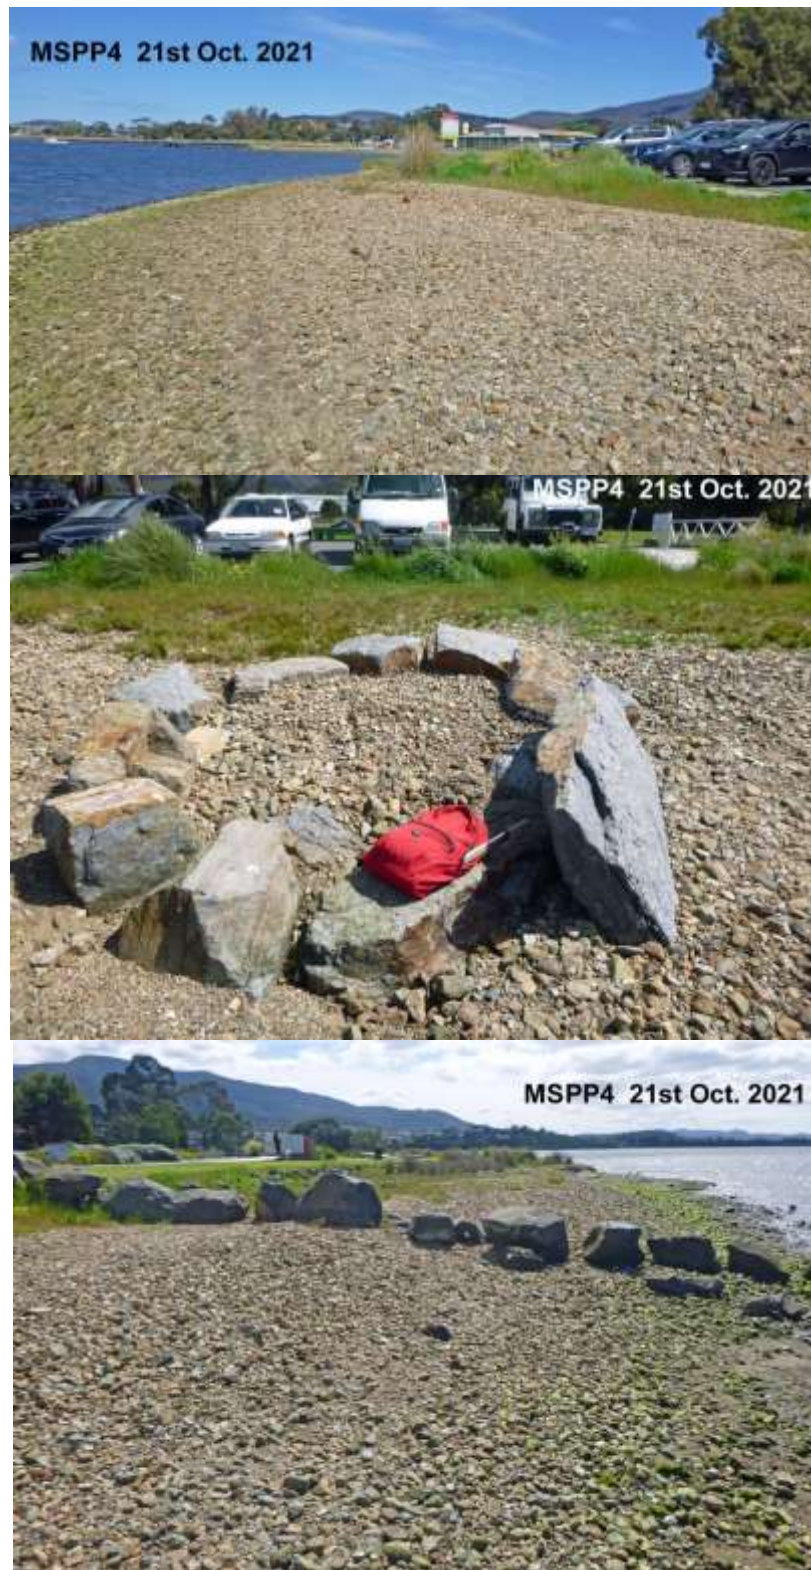
Figure 46: Initial monitoring photos from Montrose Bay photo monitoring point MSPP4. Initial monitoring photos dated 21st October 2021 (views leftwards, onshore, and rightwards). This photo point is directly seawards of (inferred) stormwater drainage outlet or culvert which at the date of these photos was completely buried by cobble-grade shoreline sediments inferred to have been washed shoreward by wave action (see onshore view). Note that a ring of boulders around the culvert have not prevented the cobbles being washed into the culvert. Zoom in for better photo details.
