# Recreational Water Quality Program

Annual Report 2018-19

Derwent Estuary  
Program

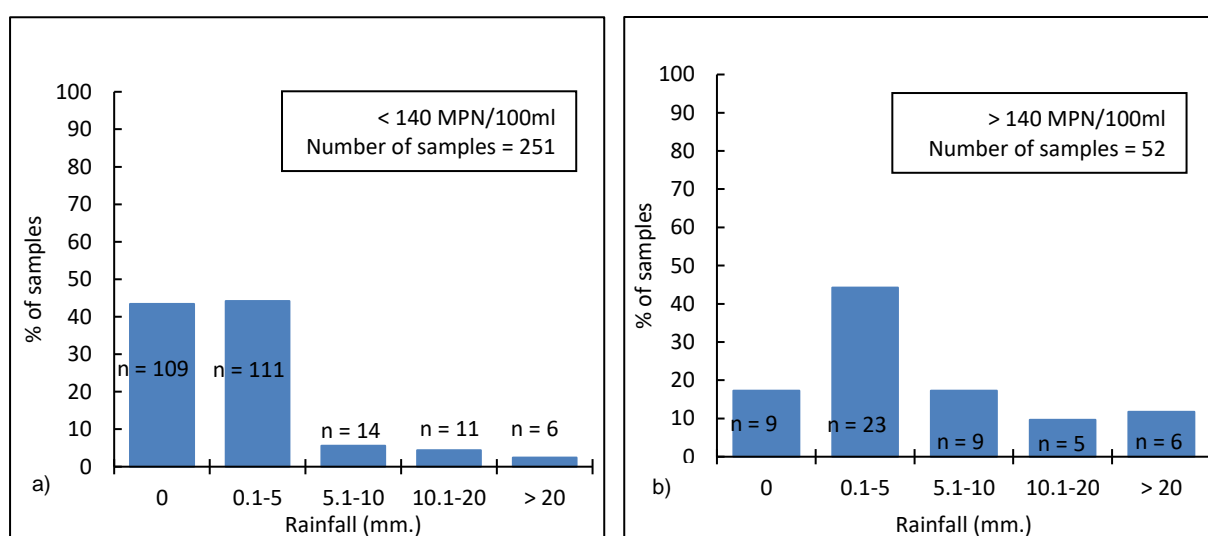
**Figure 4-2** Proportion of samples < 140 MPN 100 ml<sup>-1</sup> (a), and > 140 MPN 100 ml<sup>-1</sup> (b), that respond to rainfall. Graphs include all enterococci samples collected at swimming sites during the 2018-19 RWQ season.

**Group 1.** 43 % of the enterococci results (all < 140 MPN 100 ml<sup>-1</sup>) occurred when no rain fell in the preceding 48 hours (Figure 4-2). The other results showed that:

**Group 2.** 83 % of enterococci values (all > 140 MPN 100 ml<sup>-1</sup>) occurred when some rain fell in the preceding 48 hours (Figure 4-2):

Estuary-wide (at swimming sites) there appears to be a response of high enterococci results (> 140 MPN) to rainfall. 83 % of these high results occurred when rain fell in the preceding 48 hours. However, high rainfall (> 10 mm) didn't guarantee high enterococci, as 6 % of low enterococci results occurred when preceding rainfall was > 10 mm. See Appendix B 10.2.2 for all enterococci results when preceding rainfall was > 10 mm. As described above, rainfall recorded on the day of sampling was included in the analyses. This means that rainfall may have fallen after the sampling was conducted, and therefore, the effect of rain could be overestimated. The decision to include 48 hours of rainfall data is based on the DEP recommendations to not swim for 'several days' following heavy rain, as well as to capture significant rainfall events (> 10 mm) that may have occurred more than 24 hours prior to sampling.
