Derwent Estuary Recreational Water Quality Program

Annual Report 2019-20

Derwent Estuary
Program

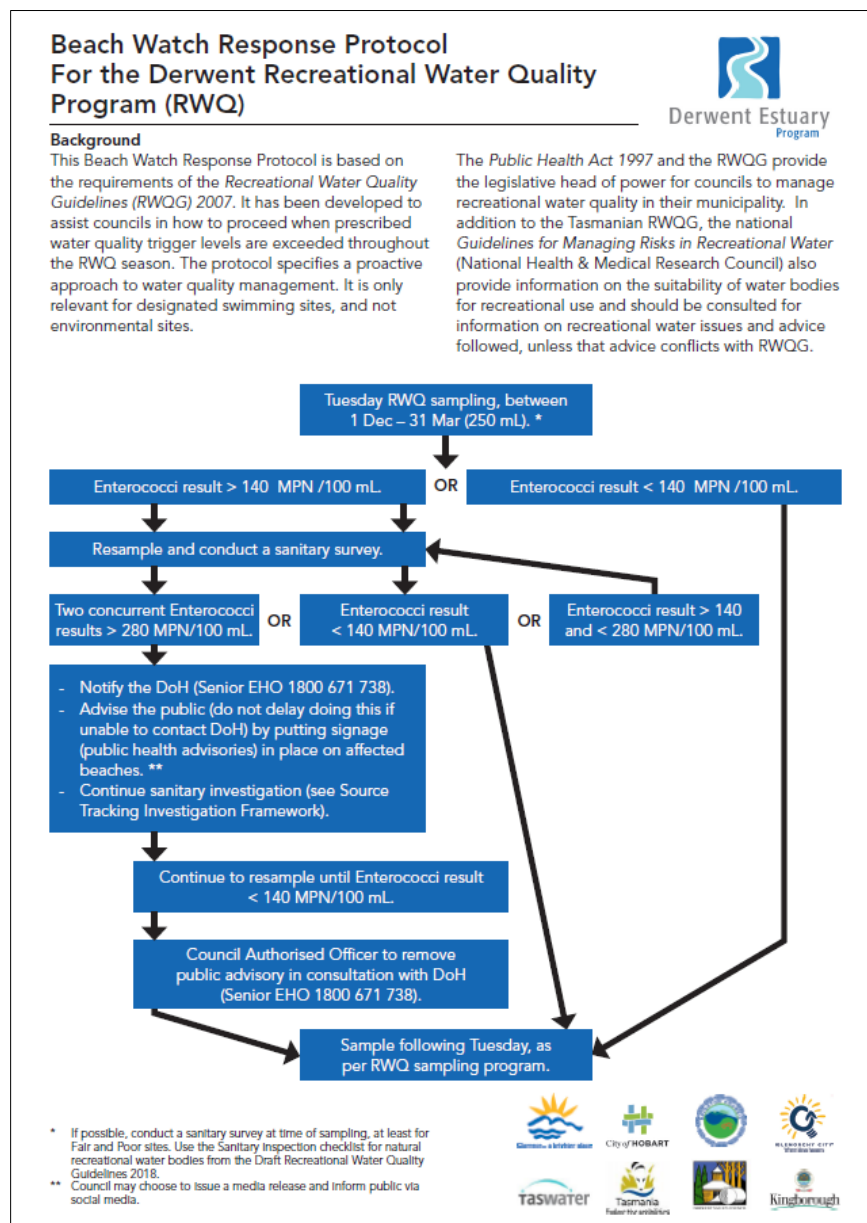
Figure 1.1. Response Protocol. Flowchart of how to respond to RWQ sample results.

A recommendation from last season, was a step-by-step guide of how to respond to high RWQ sample results. With the help from DoH and input from council partners, DEP has produced a Response Protocol, which can help guide the required response by councils to the various enterococci results of their RWQ sampling. The Protocol is a flowchart outlining what to do when the results fall within particular ranges, e.g. exceeds guideline trigger levels (Figure 1.1).

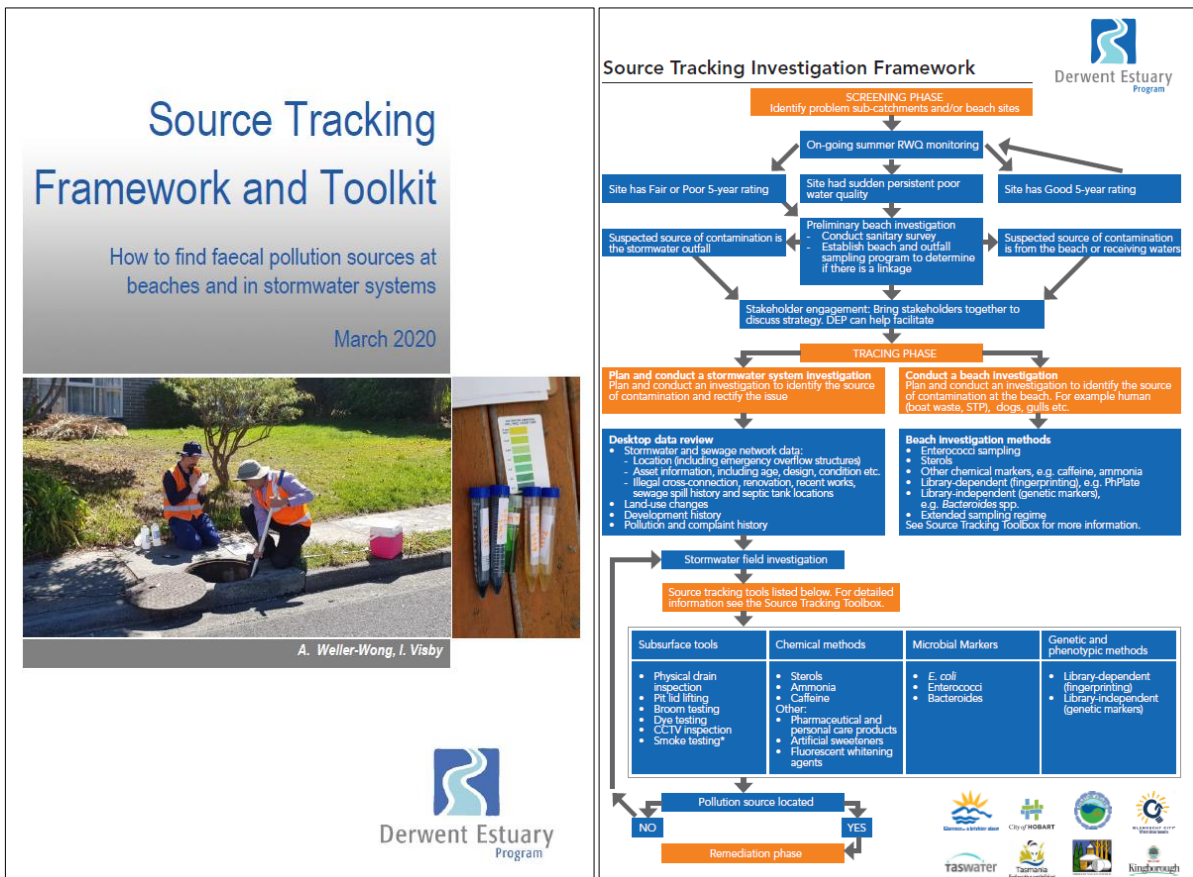
Figure 1.2. Source Tracking Framework and Tool Kit. Left: frontpage of manual. Right: framework and flowchart of how to conduct a source tracking investigation.

Also, on the back on recommendations from last year's RWQ season, the DEP is thrilled to share its new *Source Tracking Framework and Tool Kit*, which is a manual that provides practical assistance to local councils and others searching for faecal pollution sources at recreational swimming beaches and in stormwater systems. The information includes a flow chart to help investigators find the pollution source by taking them through easy-to-follow screening, tracing and remediation phases, and then provides detailed information about subsurface infrastructure investigation tools, water quality indicators, and microbial source tracking methods (Figure 1.2).

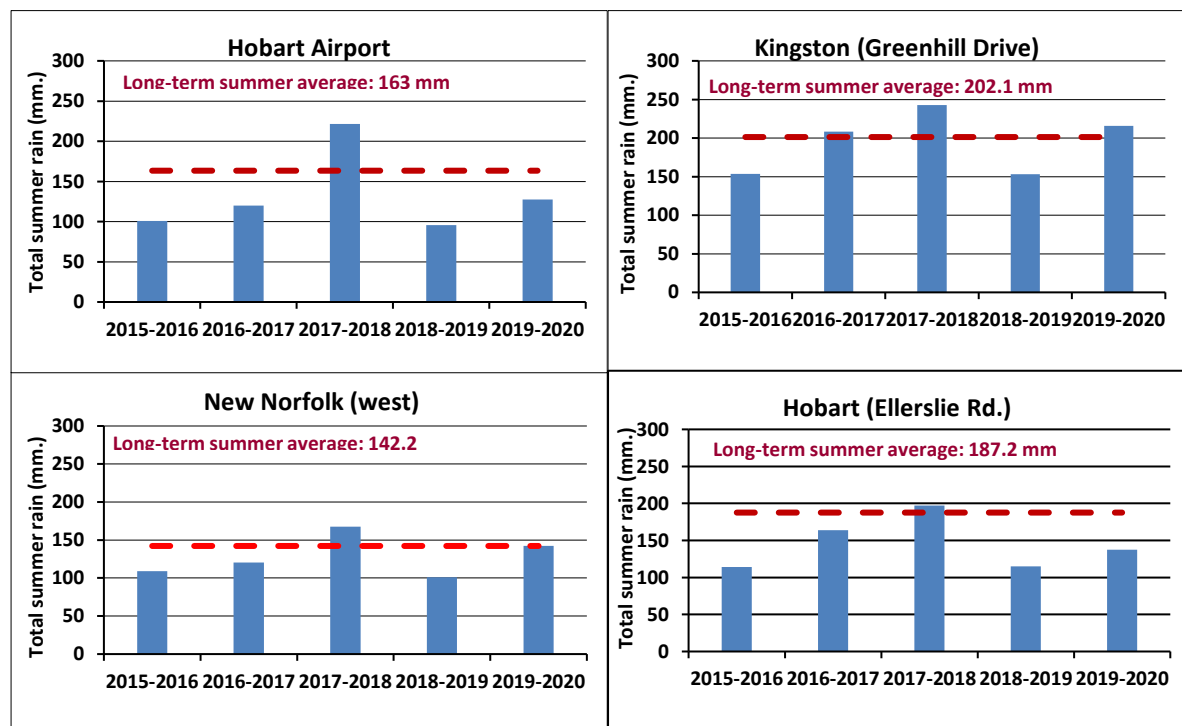
Figure 4.1 Total rainfall (in mm.) at four weather stations in the Derwent estuary catchment during the last five RWQ program seasons (between December and March), as recorded by the Bureau of Meteorology (2020). The long-term average rainfall for the period is indicated in red text and by dotted line.

Whilst there is variation in amount of rain recorded at each of the BOM weather stations, the general trend has been the same at each of the four stations over the last five years. The above-average rainfall recorded in the 2017-18 predominantly fell in a heavy three-day rainfall event in early December, otherwise that season was largely dry too. Overall, summers are wetter in the Kingston catchment than anywhere else in the estuary (Figure 4.1).

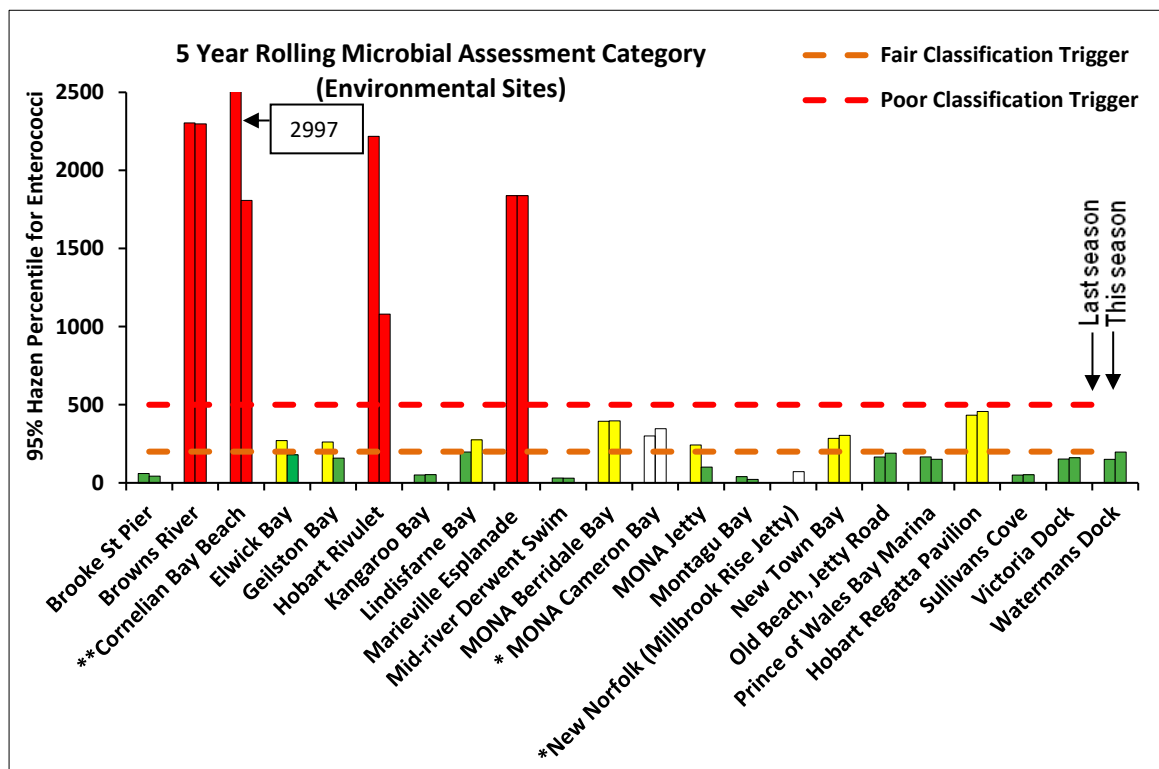
Figure 4.6 Comparison of rolling 5-year Hazen percentile enterococci result for Environmental Sites. Each site is presented as a pair of results, where the left bar represents 2018-19 RWQ season results, while the right bar represents 2019-20 season result. Green denotes Good (< 200 MPN 100 mL⁻¹), yellow denotes Fair (200 - 500 MPN 100 mL⁻¹), red denotes Poor (> 500 MPN 100 mL⁻¹), and the classification trigger lines are indicated with dotted lines. * indicates > five years of data available. **Cornelian Bay is monitored intermittently, when conditions allow, thus those results are less robust.

The water quality at the Environmental Sites during the 2019-20 sampling season were significantly better than the previous season. However, there were still 18 occurrences where the enterococci trigger level of 140 MPN 100 mL⁻¹ was exceeded, but this was 33 occurrences less than the previous RWQ season (Appendix 9.3.2, Weller-Wong and Visby, 2019). At the end of the season 12 sites were graded as Good, four as Fair, four as poor and two yet to be classified due to an incomplete 5-year data-set (Figure 4.5, Figure 4.6).

This year's results led to three sites upgrading from Fair to Good: Elwick Bay, Geilston Bay and MONA jetty, but unfortunately a decline to Fair for Lindisfarne Bay (Figure 4.6), after three seasons in the Green. Other significant improvements were seen, though not leading to ratings change, at Cornelian Bay and at Hobart Rivulet. Sampling at Cornelian Bay is intermittent due to tide levels and conditions, which makes the data from the site less robust. But Hobart Rivulet is sampled weekly and experienced a change to the 95th Hazen percentile figure from 2218 to 1080, which is a substantial jump in the right direction (Table 1).

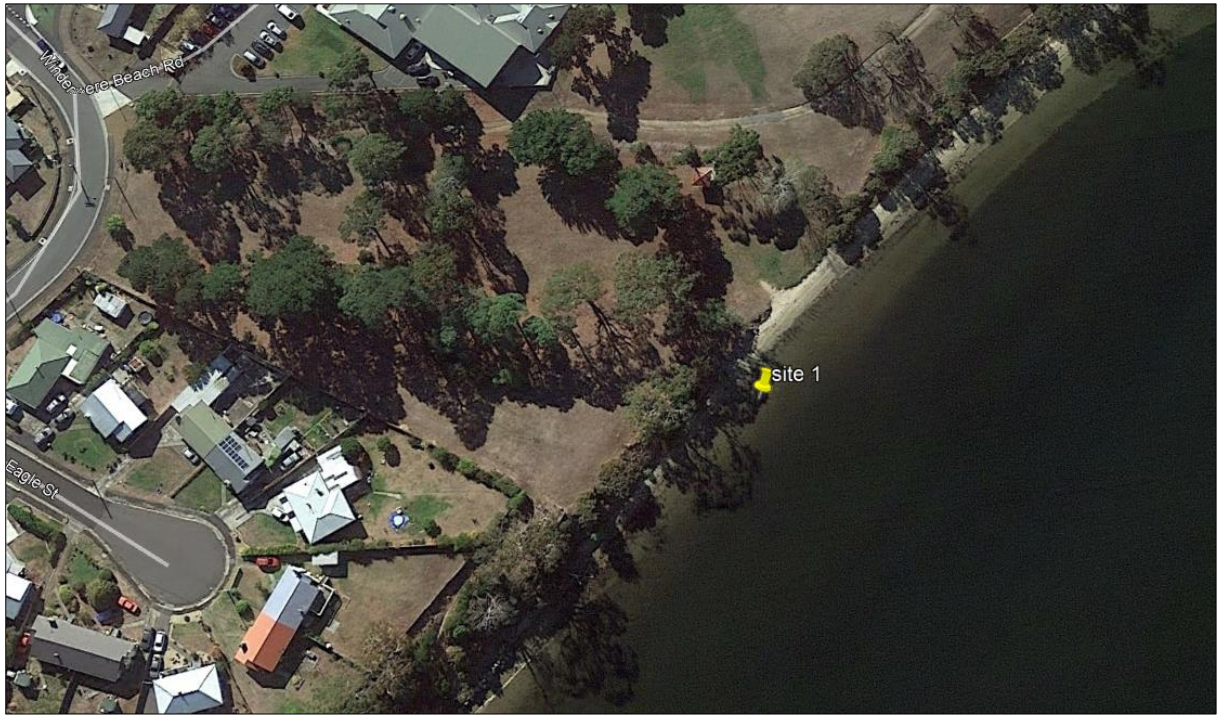
Figure 9.1. Location of the site sampled for the RWQ inter-calibration exercise on 26 November 2019 at Windermere Beach.

Site 1 was off the beach by the Knights Point Reserve (Figure 9.1). Site 2 was going to be at the southern end of the beach by one of the stormwater outfalls, but as there was no flow this plan was abandoned on the day.
