Derwent Estuary Recreational Water Quality Program

Annual Report 2021-22

Derwent Estuary
Program

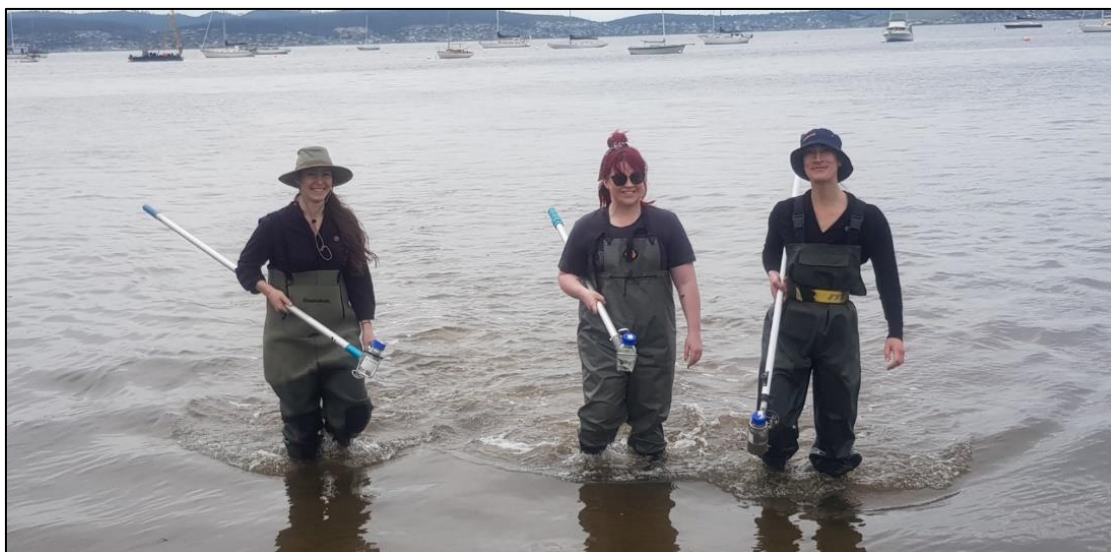
Figure 3-2. EHOs sampling together as part of the annual inter-calibration exercise, at Marieville Esplanade on 23 November 2021.

The exercise is also a good opportunity to talk about any concerns and finer details of sampling both by new and more experienced samplers, and good questions are always

brought up for discussion. For a full report on this season's inter-calibration exercise, and for answers to some more in-depth questions raised, see Appendix 9.1. The next inter-calibration exercise will be conducted in November 2022.

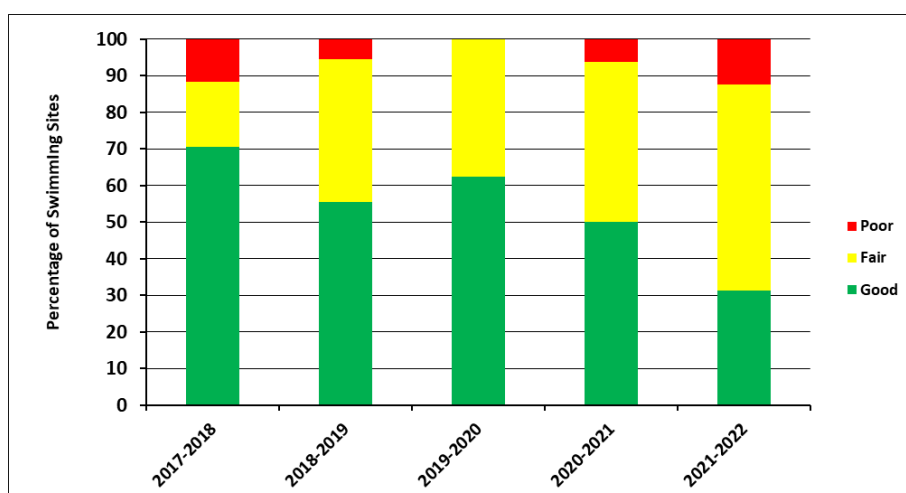
Figure 4-1 Proportion of Swimming Sites graded as Good, Fair, and Poor in the last five RWQ seasons. Note that proportions are only based on those sites with five years of data available.

At the end of this season, five sites were graded as Good, nine sites graded as Fair, two as Poor, and four sites yet to be classified. The sites that dropped in their rating were Bellerive Beach (west), Kingston Beach (mid), New Norfolk (Esplanade) – all changing from Good to Fair; and Kingston Beach (north) changing from Fair to Poor (Figure 4-1, Figure 4-2). No swimming sites improved their ratings this year. Councils are strongly urged to view Fair sites as an early warning of risk of further decline in local water quality.

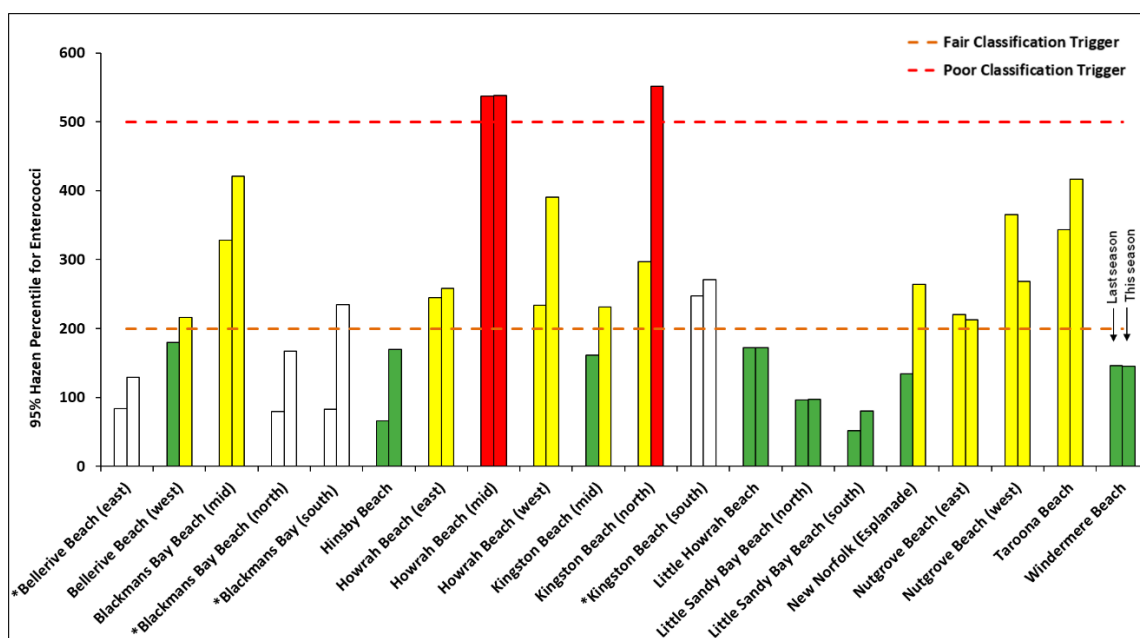
Figure 4-2: Comparison of rolling 5-year Hazen percentile enterococci result for swimming sites. Each site is presented as a pair of results, where the left bar represents 2020-21 RWQ season results, while the right bar represents 2021-22 season result. Green denotes Good (< 200 MPN 100 mL⁻¹), yellow denotes Fair (200 - 500 MPN 100 mL⁻¹), red denotes Poor (> 500 MPN 100 mL⁻¹), and the classification trigger lines are indicated with dotted lines. * indicates that less than five years of data is available, thus those results are less robust.

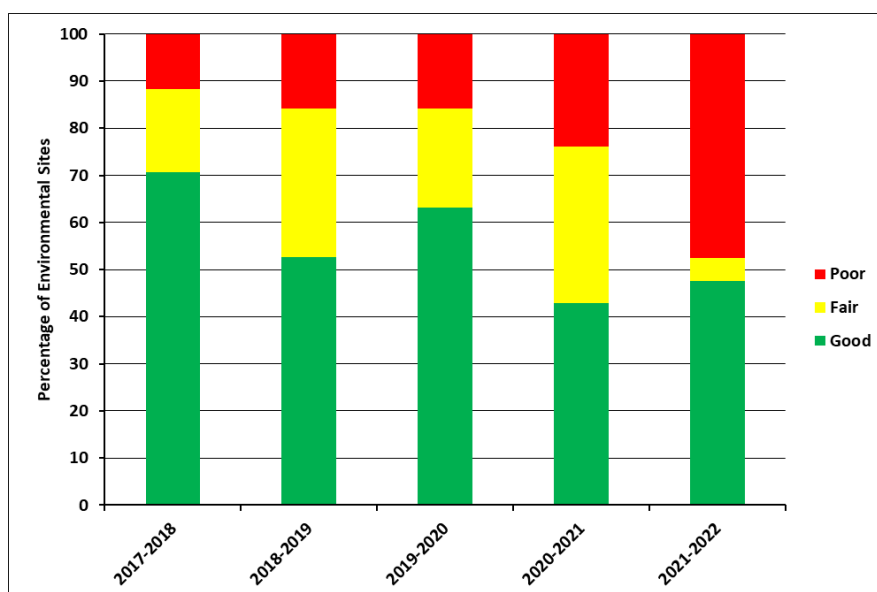
Figure 4-3 Proportion of Environmental Sites graded as Good, Fair, and Poor in the last five RWQ seasons. Note that proportions are only based on those sites with five years of data available.

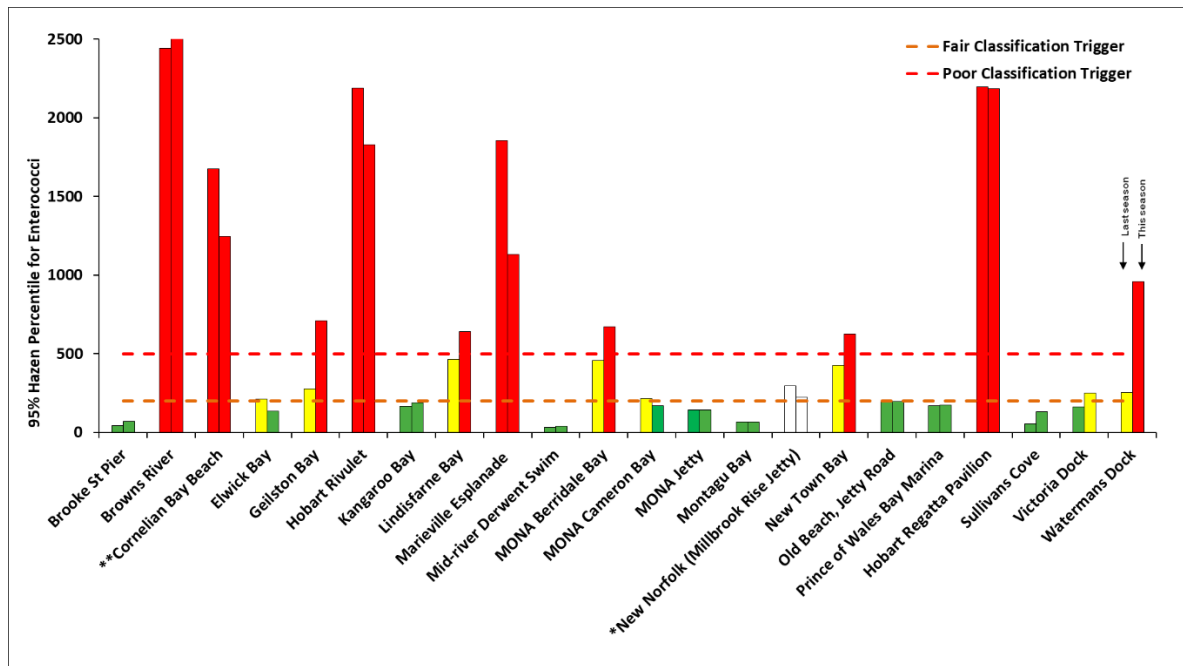
Figure 4-4 Comparison of rolling 5-year Hazen percentile enterococci result for the environmental sites. Each site is presented as a pair of results, where the left bar represents 2020-21 RWQ season results, while the right bar represents 2021-22 season result. Green denotes Good (< 200 MPN 100 mL⁻¹), yellow denotes Fair (200 - 500 MPN 100 mL⁻¹), red denotes Poor (> 500 MPN 100 mL⁻¹), and the classification trigger lines are indicated with dotted lines. * indicates > five years of data available. **Cornelian Bay is monitored intermittently, when conditions allow, thus those results are less robust.

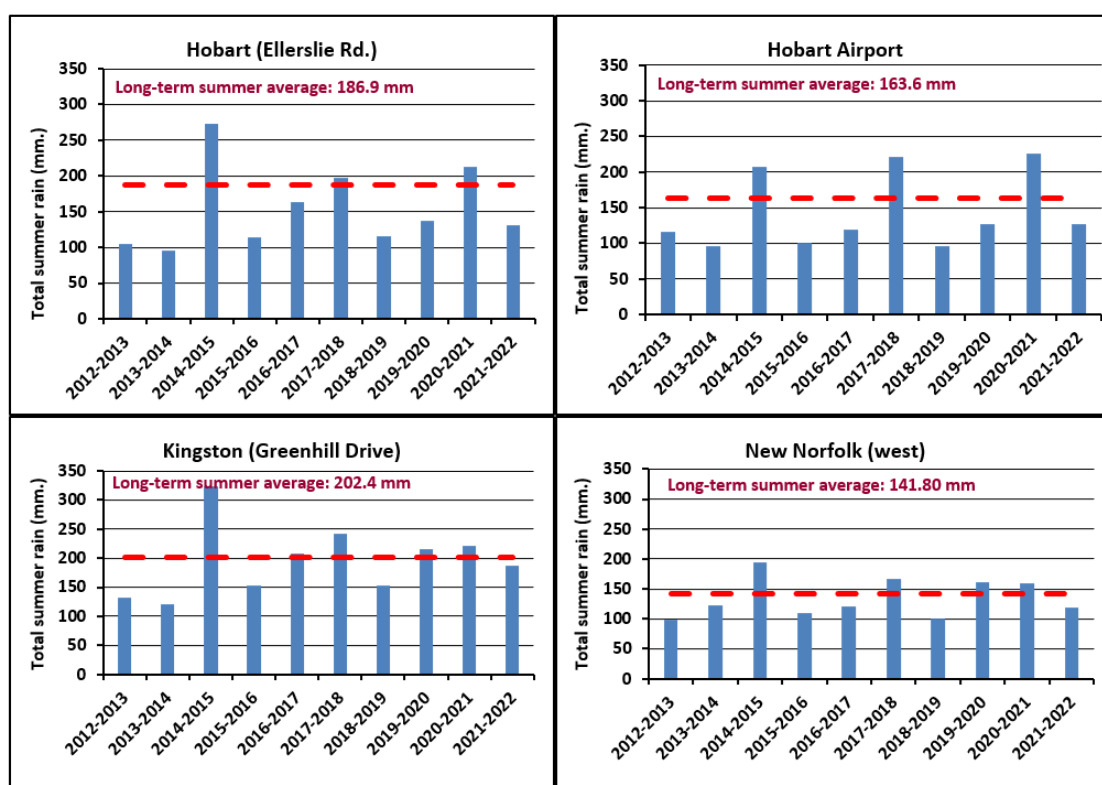
Figure 4-5 Total rainfall (in mm) at four weather stations in the Derwent estuary catchments during the last ten RWQ program seasons (between December and March), as recorded by the Bureau of Meteorology (2022). The long-term average rainfall is indicated in red text and by dotted line.

Rainfall varies considerably across the estuary. Rainfall data collected and reported by the Bureau of Meteorology (BoM) at four weather stations throughout the Derwent estuary catchments are used to compare rainfall during each RWQ season (December to March) against the long-term average rainfall for that period. Observations of daily rainfall are nominally made at 9 am and record the total for the previous 24 hours. Hobart (Ellerslie Road), Kingston (Greenhill Drive), Hobart Airport and New Norfolk (west) have been selected as representative of RWQ sampling sites in the Derwent estuary. Long-term averages for the summer months are currently ranging between 141.80 mm at New Norfolk and 202.40 mm at Kingston, the latter generally experiencing more rain than the other sites. During the 2021-22 RWQ season, total rainfall was below average for all four stations (Figure 4-5).

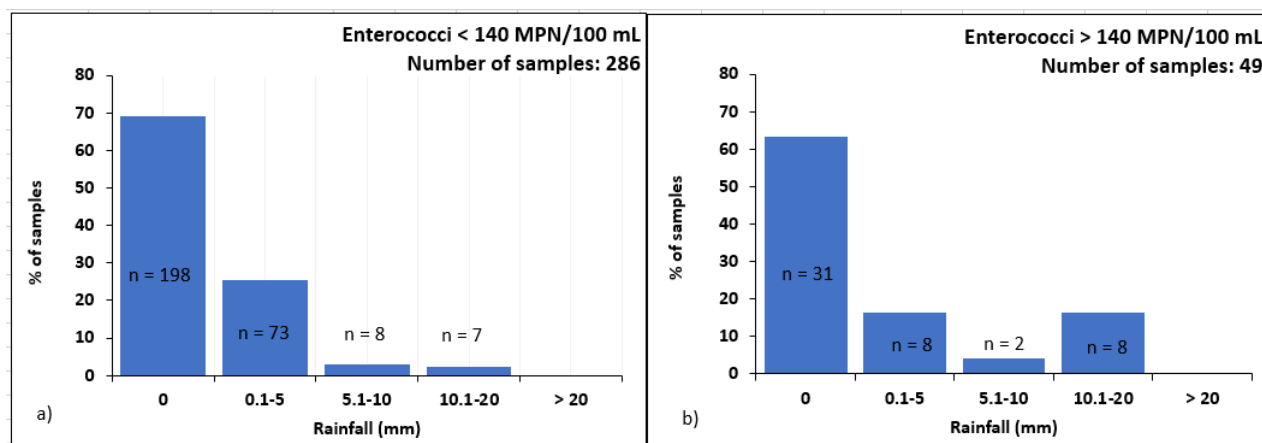
Figure 4-6. (a) Proportion of enterococci sample results < 140 MPN 100 ml⁻¹ and (b) > 140 MPN 100 ml⁻¹ matched with rainfall data from four BoM stations across the estuary. Graphs include all samples collected at swimming sites during the 2021-22 RWQ season. n = number of samples.

As Figure 4-6 shows, of the 335 swimming site samples collected this summer, 85 % of enterococci results (286 samples) were < 140 MPN 100 ml⁻¹. Rainfall did not appear to negatively influence most enterococci results, with 88 of all 106 rainfall events (> 1 mm rain) resulting in enterococci < 140 MPN 100 ml⁻¹; including 15 samples taken when rainfall of between 5 and 20 mm was recorded.

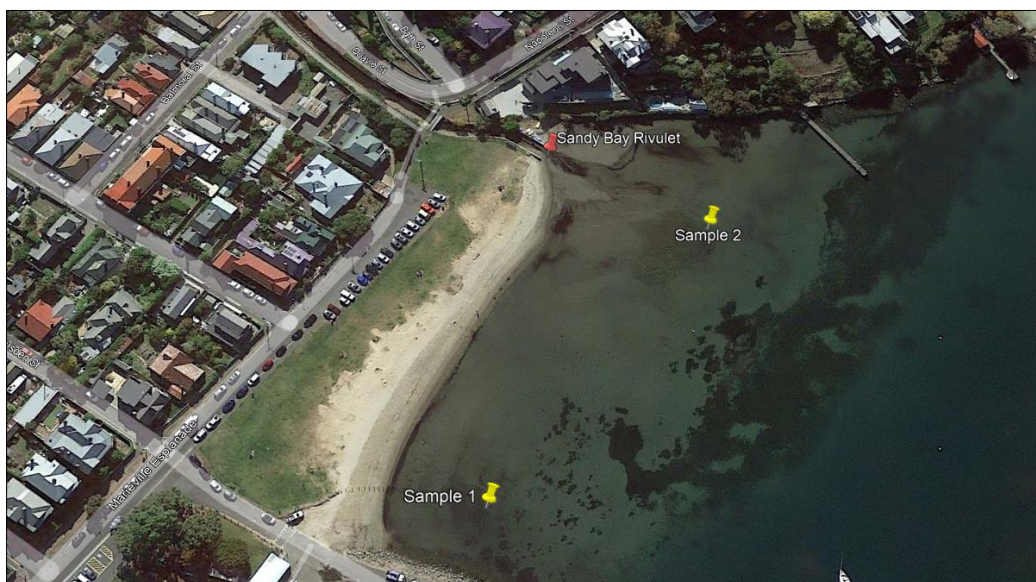
Figure 9-1. Location of the three sites sampled for the RWQ inter-calibration exercise on 23 November 2021 at Marieville Esplanade, Sandy Bay.

Sample 1 was taken at the regular RWQ sampling site at Marieville Esplanade, Sandy Bay. Sample 2 was obtained from Sandy Bay Rivulet. An additional sample was taken directly by the mouth of Sandy Bay Rivulet, to assess this as a potential source of contamination (Figure 9-1).
