Tributaries of the Derwent Estuary - Waterbug survey

Spring 2024

Prepared for: **Derwent Estuary Program Ltd**

by The Waterbug Company Pty Ltd

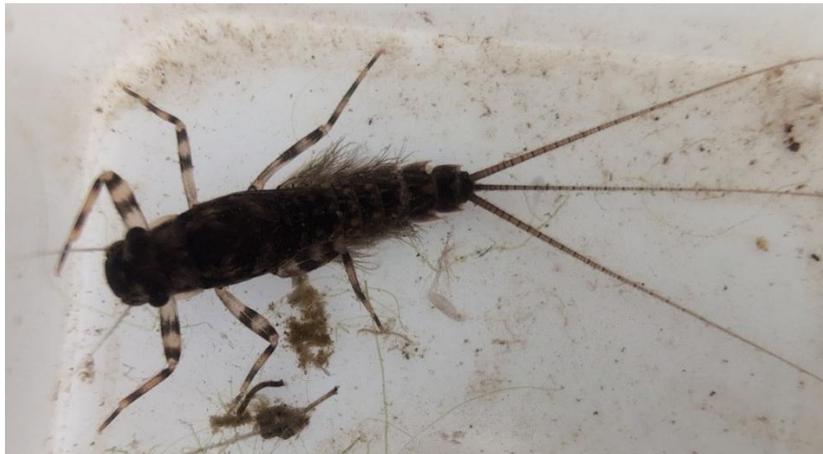
Figure 4 Mayflies are indicators of good ecological health in a waterway. This is a tinsel-gilled mayfly nymph (*Atalophlebia* sp.) from the lower site on the Lachlan River.

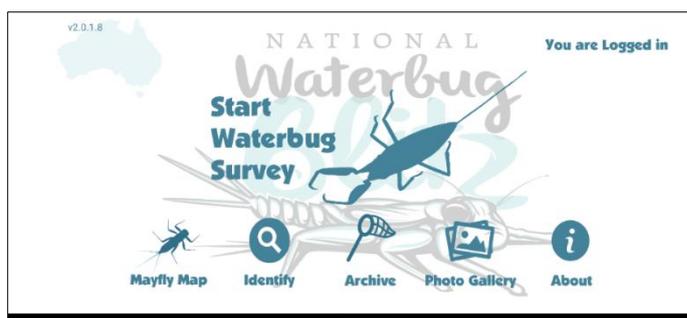
Figure 5 The Home screen from The Waterbug App.

The Waterbug App begins a sample after the user selects “Start Waterbug Survey” from the Home screen (Figure 5).

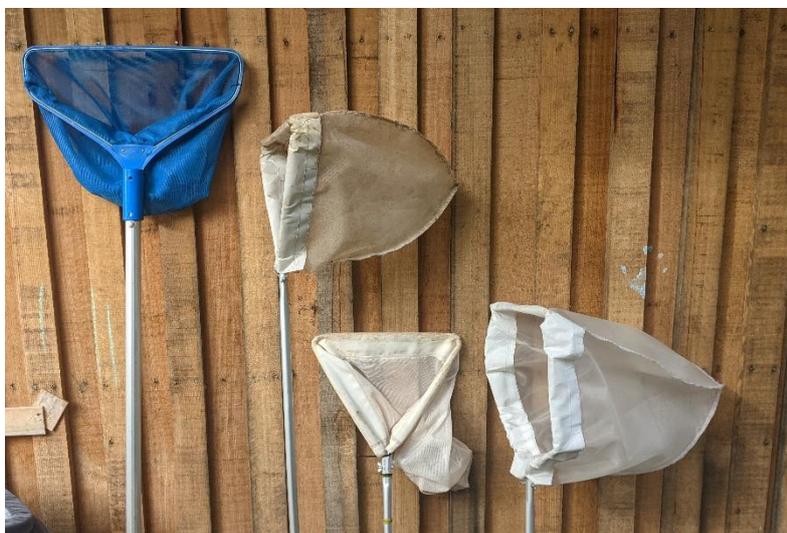
Figure 8 Nets used for river sampling. Note the flat base of the net that can be pressed against the stream bed.

These habitats are then sampled with a net (30cm base, square or triangular, mesh size 250-500micron - Figure 8), ensuring that a sample from each of the habitats is taken. Between 5 and 10 metres of stream should be sampled, if possible, but some sample MUST be taken from each of the habitats recorded in the previous step. The samples from each habitat are rinsed and then combined in a bucket.
