Monitoring the physical effects of boat wakes on shorelines in the Derwent River Estuary

Report to:
Derwent Estuary Program

By:
Chris Sharples

April 2022

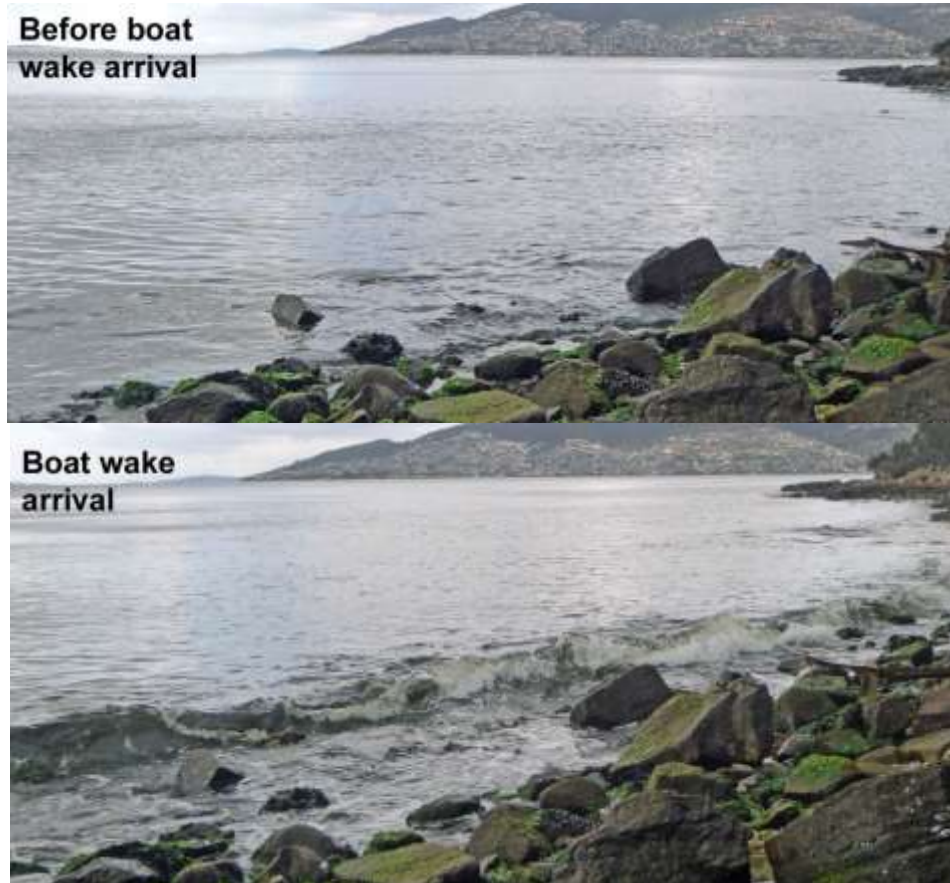
Figure 6: Commuter ferry boat wake viewed from the Kangaroo Bay north shore near photo point KBPP10 (see below and Appendix 1) during calm weather on 7th October 2021. The ferry (not visible) was about 200 metres offshore, travelling eastwards into Kangaroo Bay and beginning to slow down at the end of its river crossing. **Top:** Calm water before boat wake arrival. **Bottom:** Boat wake wave arrives at shore, a few seconds after top photo.

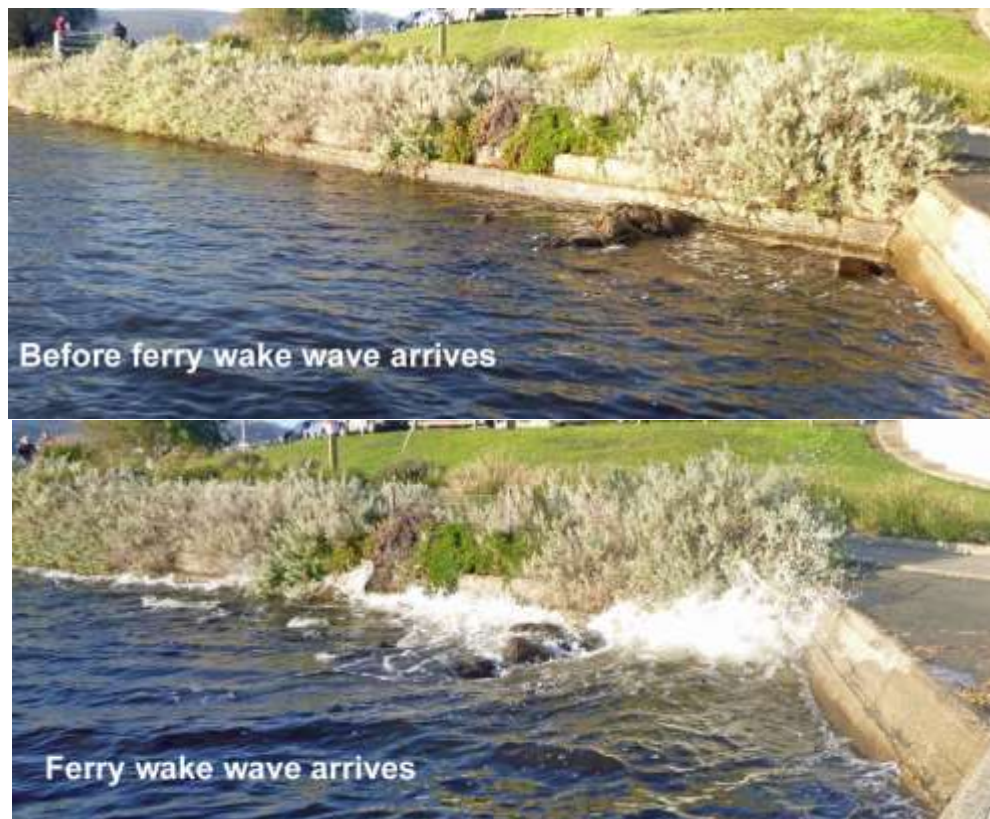
Figure 7: Commuter ferry boat wake viewed from the Kangaroo Bay South shore at photo point KBPP4 (see below and Appendix 1) close to high tide during calm weather on 17th August 2021. The ferry (not visible) was about 170 metres offshore, travelling eastwards into Kangaroo Bay and slowing down at the end of its river crossing. **Top:** Calm water before boat wake arrival. **Bottom:** Boat wake wave arrives at shore, a few seconds after top photo.

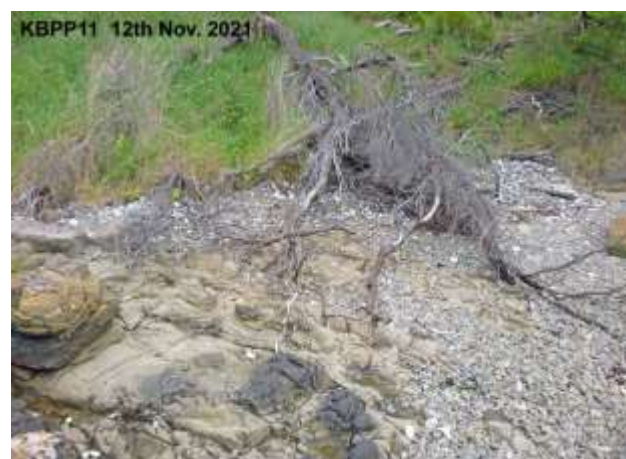
Time-correlated changes to cobble beaches observed at two sites most exposed to south-westerly wind-wave storms. At two cobble beach sites (KBPP9 and KBPP11) only minor cobble movements are detectable up until the 21st October 2021 photos, however the next and last photos (12th November 2021) demonstrate a significant lowering of the cobble beach surface, with increased exposure of boulders and underlying bedrock surfaces (see Figure 10 and Figure 11). These changes are inferred to be the result of energetic wave backwash dragging cobbles down the beach profile towards the sea (since no other transport direction for the “missing” cobbles appears plausible). These sites on the north shore of Kangaroo Bay are highly exposed to long southerly to south-westerly fetches across the Derwent estuary, and several windstorms from that direction occurred in the Hobart region during the 21st Oct – 12th Nov. period¹. Public wind hazard alerts were issued for several windstorms during this period. Hence, the timing and spatial patterning of cobble beach changes at KBPP9 and 11 suggest that these were most likely the result of these sites being particularly exposed to energetic wind waves locally-generated by a cluster of south-westerly storm wind events during October – November 2021.

Figure 11: Comparison of the whole sequence of KBPP11 (onshore view) monitoring photos throughout the trial monitoring period. This sequence shows negligible to minor changes in cobble cover between 8th Aug. and 21st October 2021, then major removal of cobbles and exposure of bedrock between 21st October and 12th November 2021. Zoom in to examine details of photos.

Unfortunately, the photographic record of the site begins only the day before the introduction of the new ferry. Ideally it would be useful to know whether the cobble veneer was constant (similar to the initial photos) or changing significantly over a period of at least some months prior to the ferry start date. In any case, it is necessary to ask whether ferry wakes might plausibly cause the observed changes, or whether other known processes at the site may plausibly cause them instead. In this respect, it is notable that site KBPP5 is probably the site most sheltered from both wind-waves and swell-waves entering Kangaroo Bay (see Figure 8), and hence has not shown the windstorm-related erosion pattern and timing seen at KBPP9 and 11 (see above). It is possible that the boat wakes introduced on 9th August 2021 have subsequently been the most energetic waves affecting the KBPP5 shore and have consequently resulted in a redistribution of cobble veneers into a new equilibrium with the new wave regime.

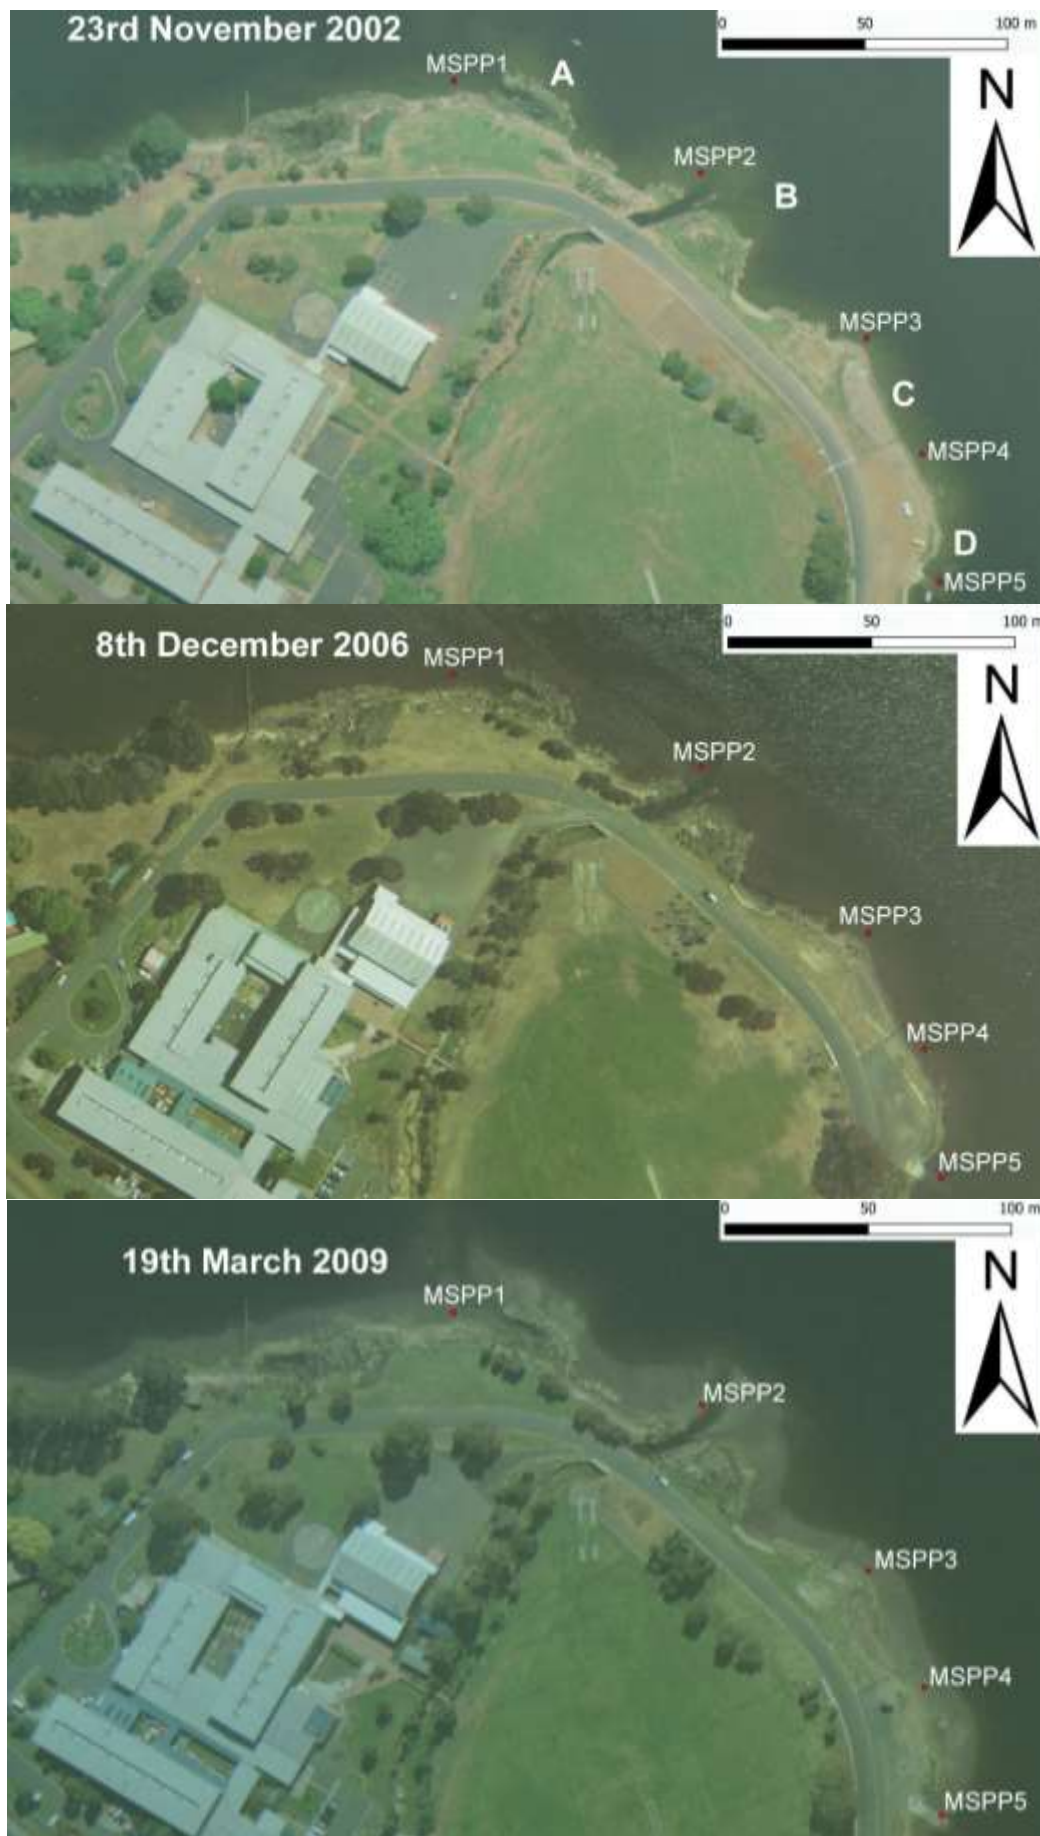
The intertidal shoreline area (between the high and low tide lines) in the Montrose Bay photo point monitoring area as shown on Figure 13, Figure 18, and Figure 19, is underlain by a cohesive but unlithified sediment comprising hard well-rounded cobbles and pebbles in a finer soft but cohesive dark grey silty-clay sediment. This is visible today at many points along the shore and is also visible as a distinct dark grey substrate making up most or all of the wave-washed intertidal zone on all the air photos (see the ground-level photos in Figure 17 for examples of this dark substrate in the lower shoreline areas of most of the photos). This material seems likely to correspond to the Quaternary alluvial terrace deposits (*Qpad*) which the Hobart 1:25,000 geological map sheet (Forsyth & Clarke 1999) depicts close to this location, however it is unclear whether it is properly this unit or *Qhmm* (man-made deposits), which are also depicted at the same location but are not described by (Forsyth & Clarke 1999).

Figure 18: Aerial photos of viewpoints area, Montrose Shore (2002, 2006 and 2009). The location of the five photo monitoring viewpoints whose set-up is described in section 6.2.2 above are indicated on each air photo. Top (2002) photo indicates four locations A – D described in text. Photos © DPIPWE. Zoom in for better detail.

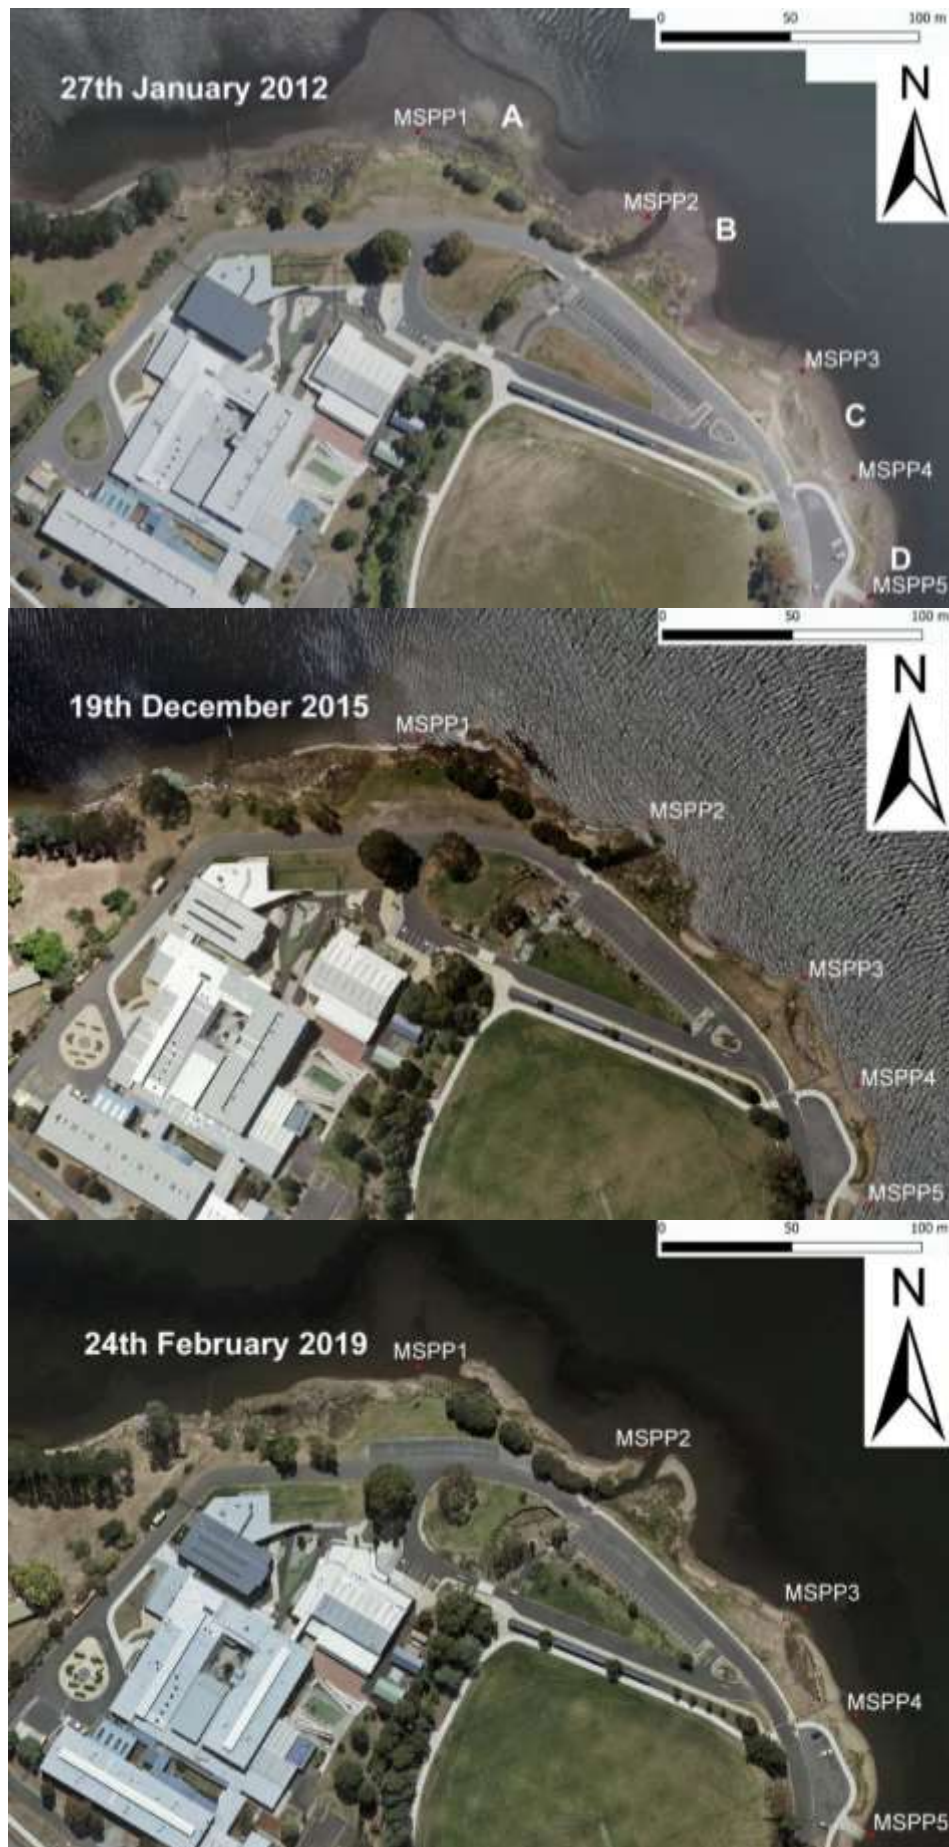
24th Feb. 2019 Near high tide, intertidal zone mostly under-water, but grey substrate faintly observable under water.	Highest (only) parts of darker cohesive cobbly substrate visible in low ridge, WITH more extensive pale coloured smooth-textured loose cobble accumulations visible. Landwards edge of loose cobbles has migrated up to 4 metres landwards since 2015 image.	Upper intertidal parts of dark substrate exposed and partly vegetated at shoreline, WITH a large beach ridge or berm of pale-coloured smooth-textured loose cobbles present over dark substrate in upper intertidal area. Underlying darker cohesive substrate faintly visible in lower intertidal area.	As at 19 th Dec. 2015 (above). Underlying darker cohesive substrate faintly visible in lower intertidal area, large pale cobble beach restricted to upper intertidal area.	As at 19 th Dec. 2015 (above). Underlying darker cohesive substrate faintly visible in lower intertidal area, large pale cobble beach restricted to upper intertidal area

Figure 19: Aerial photos of Montrose Shore study area (2012, 2015, 2019). The location of the five photo monitoring viewpoints whose set-up is described in section 6.2.2 above are indicated on each air photo. Top (2012) photo indicates 4 locations A – D described in text. Photos © DPIPWE. Zoom in for better detail.

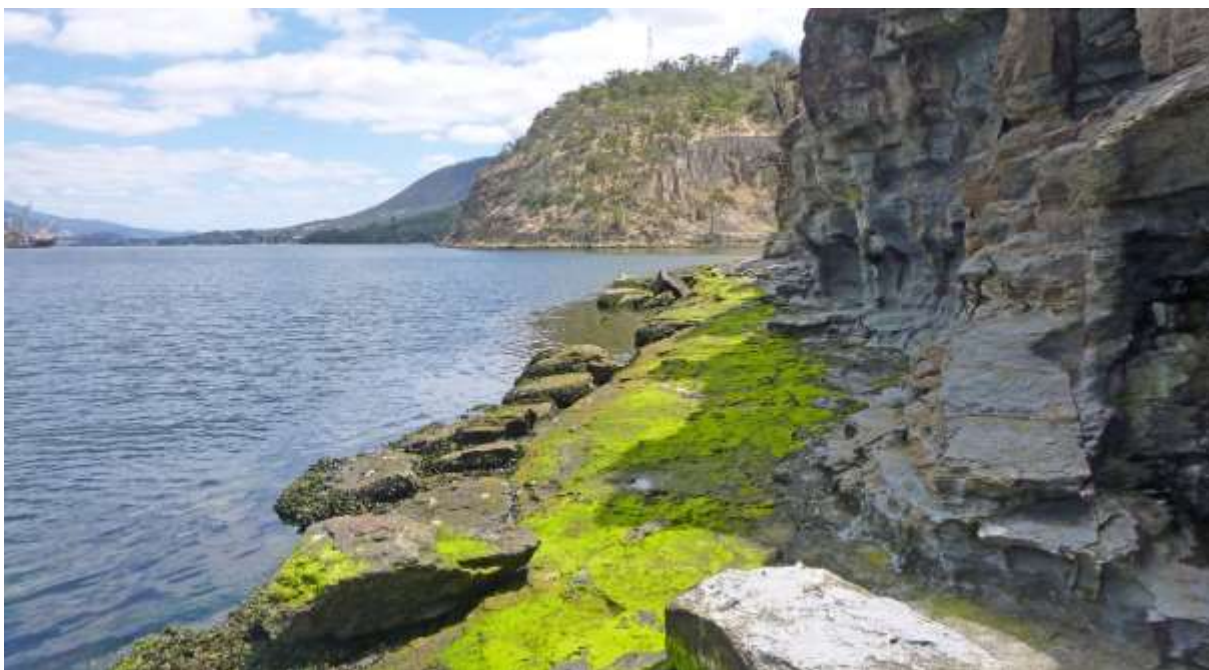
Figure 20: Resilient hard cliffed rocky shore with no soil mantle or other readily erodible material within reach of foreseeable wave action. Bedlam Wall (East Risdon area, Derwent Estuary). Shores such as this are unlikely to be significantly eroded by boat wakes in the foreseeable future. Photo by C. Sharples (25th Dec. 2020).

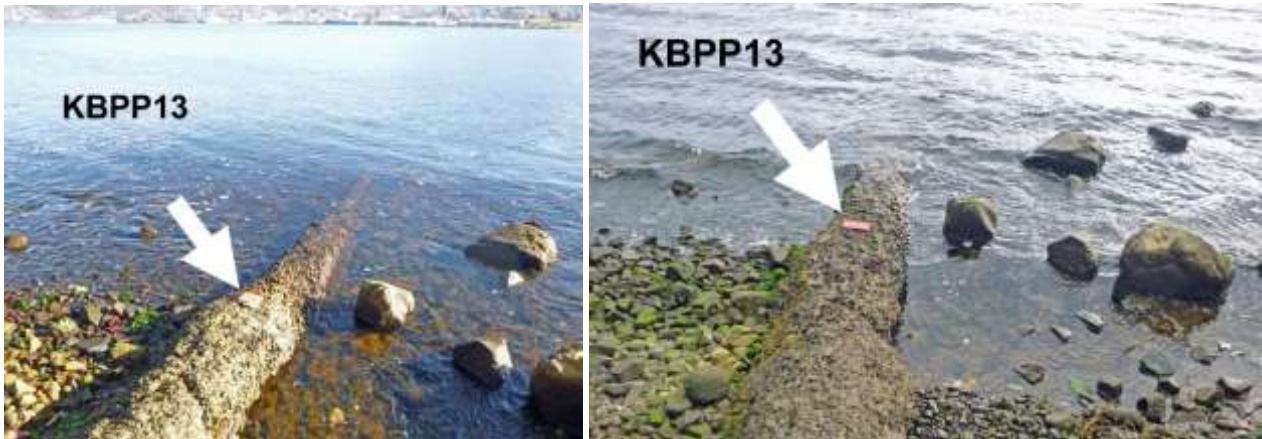
Figure 28: Reference photographs of photo point KBPP13 at Kangaroo Bay (two views). The arrow points at the red notebook marking the standing viewpoint.

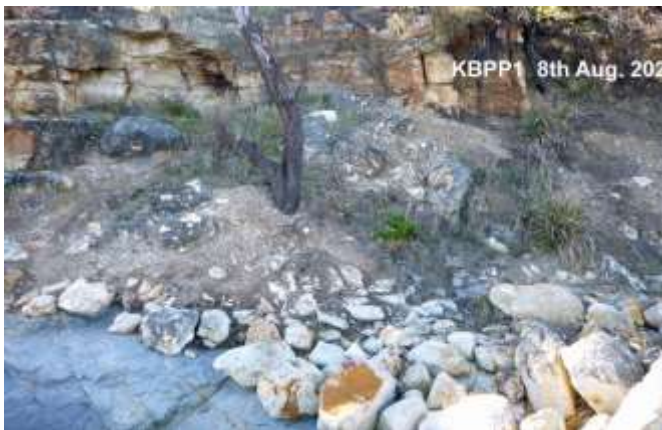
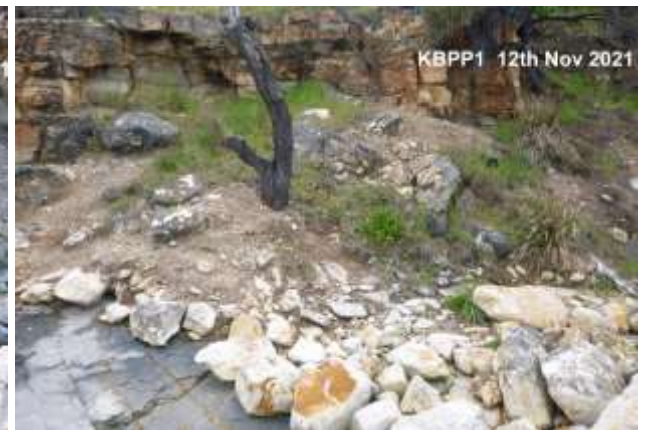
Figure 29: First (8th Aug 2021) and last (12th Nov 2021) photos taken at Kangaroo Bay photo point KBPP1. First photos in LH column, last photos in RH column. Views top to bottom are leftwards, onshore, and rightwards. No significant changes detected between first and last photos.

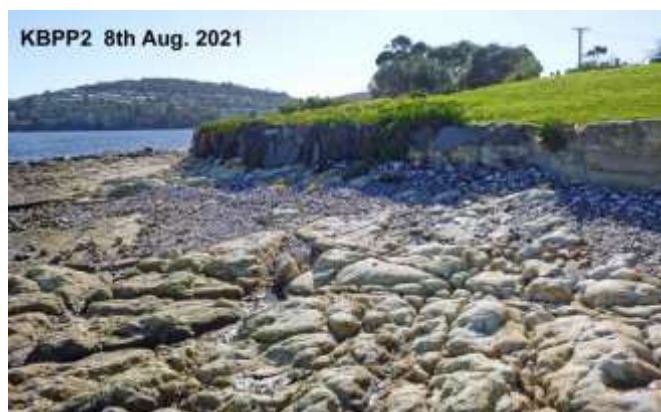
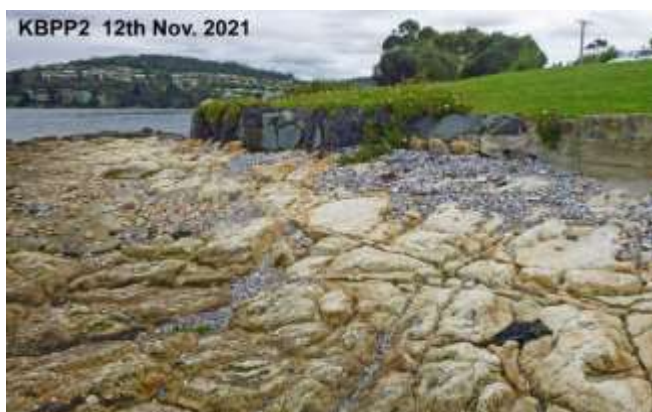
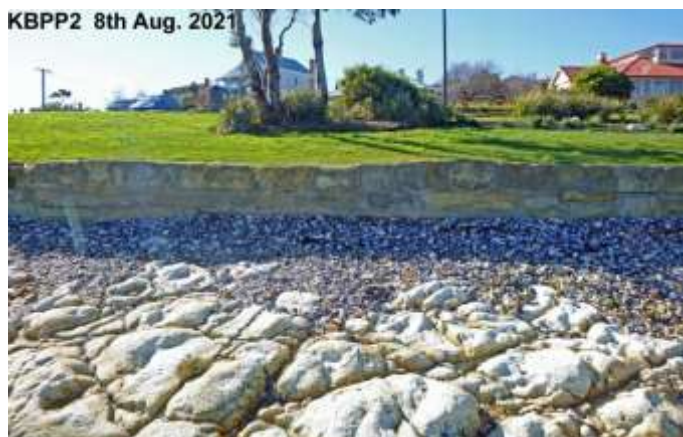
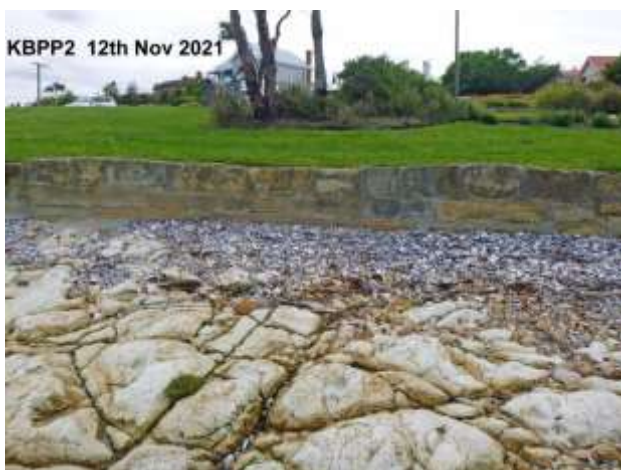
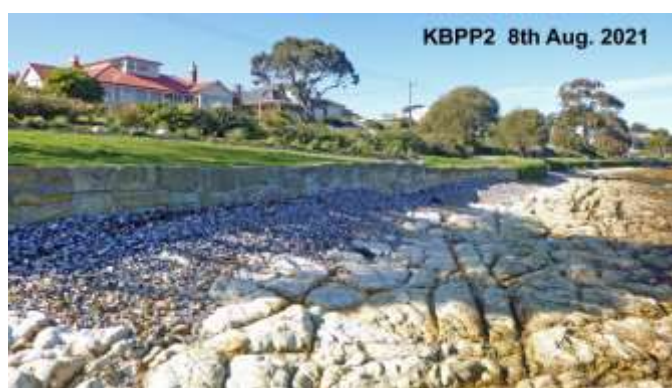
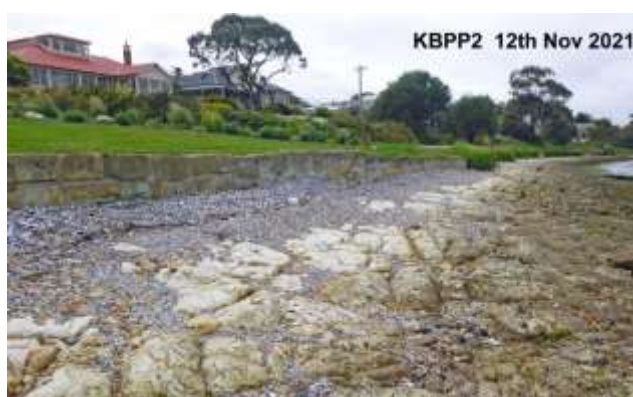
Figure 30: First (8th Aug 2021) and last (12th Nov 2021) photos taken at Kangaroo Bay photo point KBPP2. First photos in LH column, last photos in RH column. Views top to bottom are leftwards, onshore, and rightwards. Some changes in cobble distribution are evident between the first and last photos, with scouring of cobbles off the bedrock platform particularly obvious in part of the left-hand view.

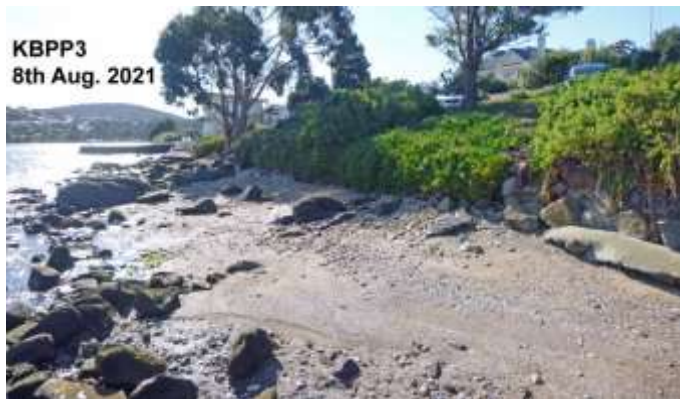
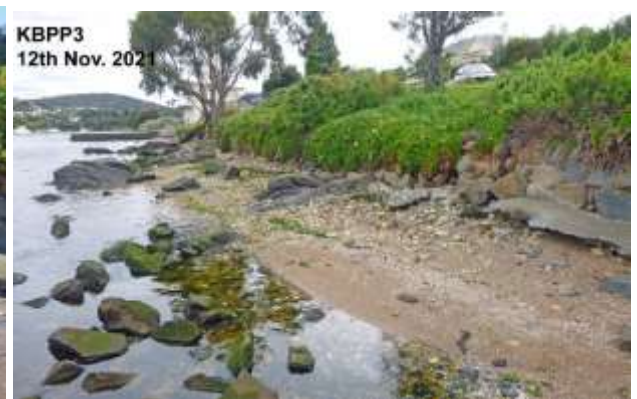
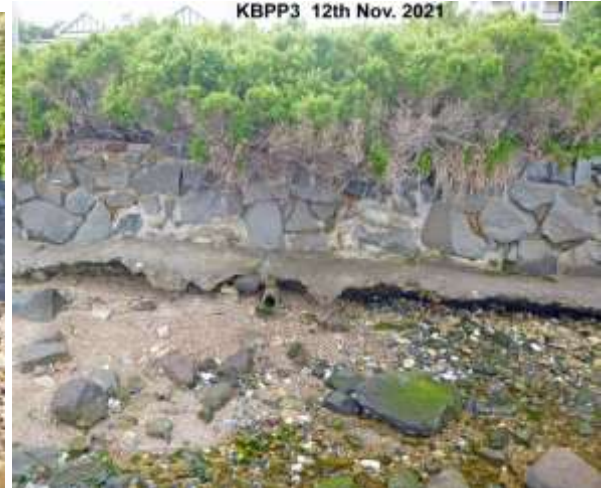
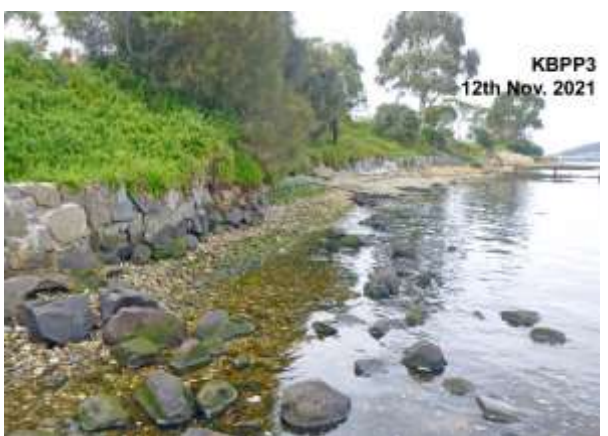
Figure 31: First (8th Aug 2021) and last (12th Nov. 2021) photos taken at Kangaroo Bay photo point KBPP3. First photos in LH column, last photos in RH column. Views top to bottom are leftwards, onshore, and rightwards. Changes between first and last photos are negligible, although a great deal of sand and cobbles at this site could be susceptible to wave action.

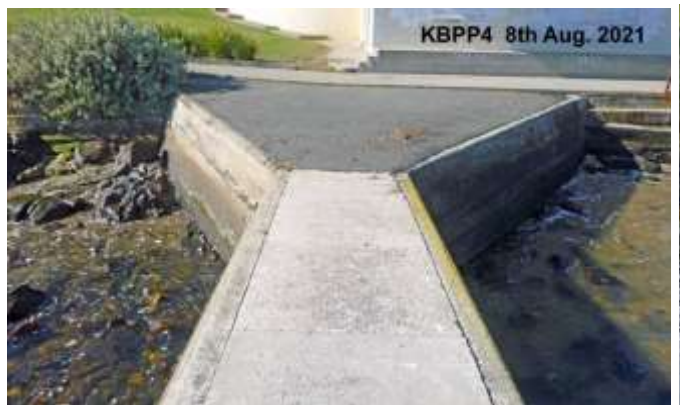
Figure 32: First (8th Aug. 2021) and last (12th Nov. 2021) photos taken at Kangaroo Bay photo point KBPP4. First photos in LH column, last photos in RH column. Views top to bottom are leftwards, onshore, and rightwards. Note that the last photos (12th Nov) were taken at too high a tidal level to allow proper examination of soft shoreline components present at this site. A lower tidal level than shown here is desirable for monitoring photos.

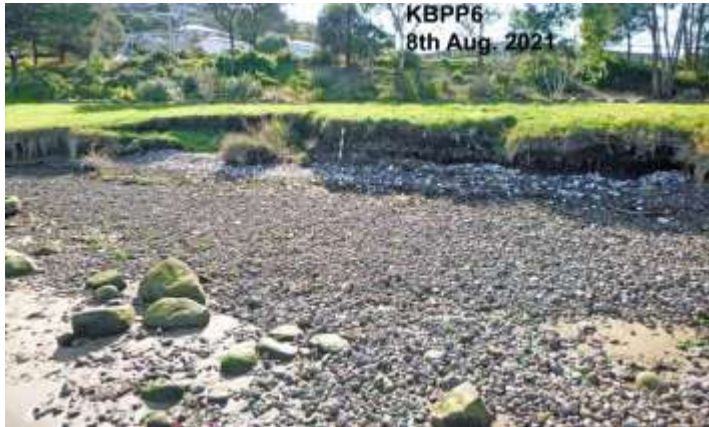
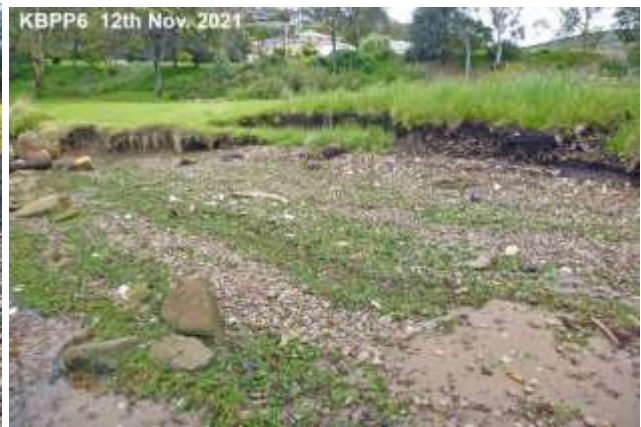
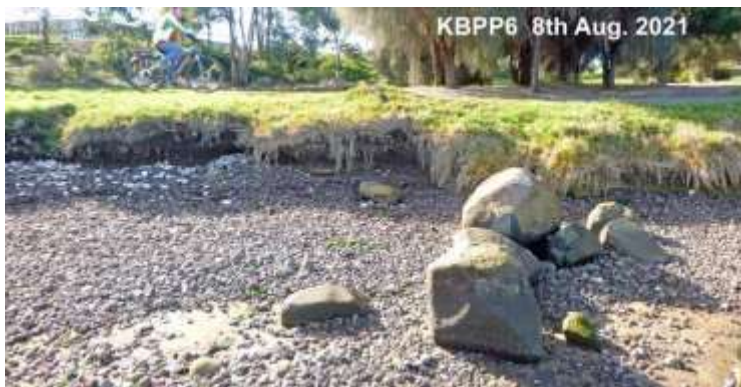
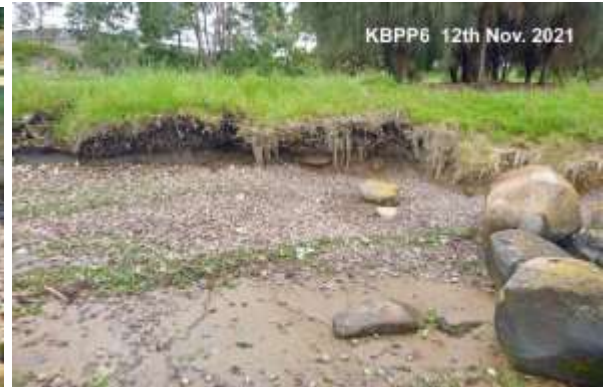
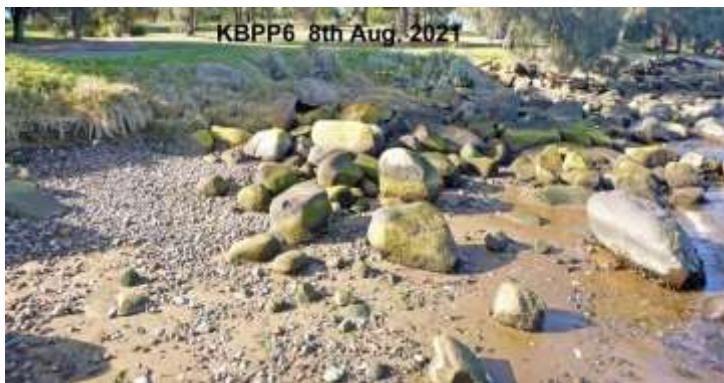
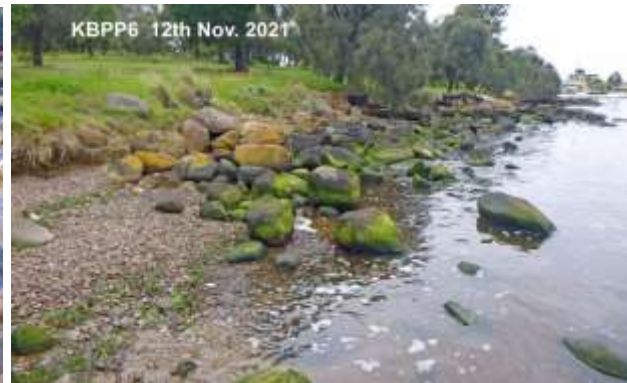
Figure 34: First (8th Aug. 2021) and last (12th Nov. 2021) photos taken at Kangaroo Bay photo point KBPP6. First photos in LH column, last photos in RH column. Views top to bottom are leftwards, onshore, and rightwards. Some removal of cobbles from the lower (foreground) beach face and of shells from the upper beach face is evident in the last photo, together with the presence of larger than normal amounts of seaweed wrack. These changes are indicative of recent energetic wave action, however no significant additional erosion of the soil margin scarp backing the beach face is apparent.

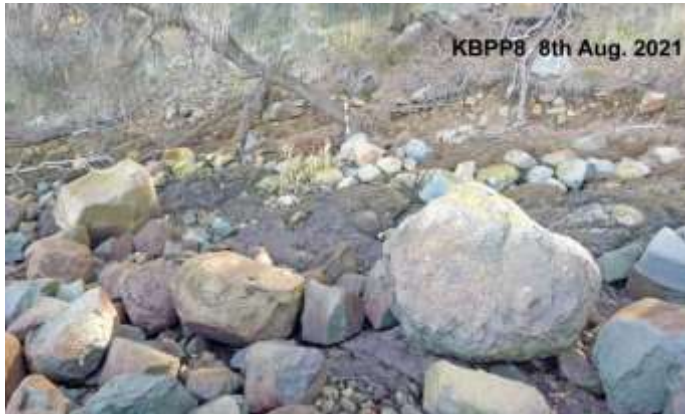
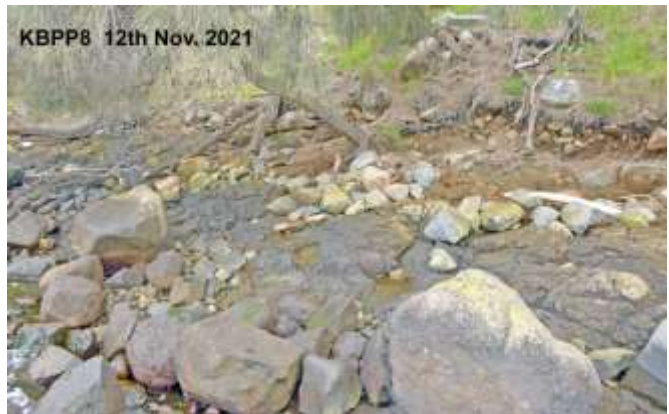
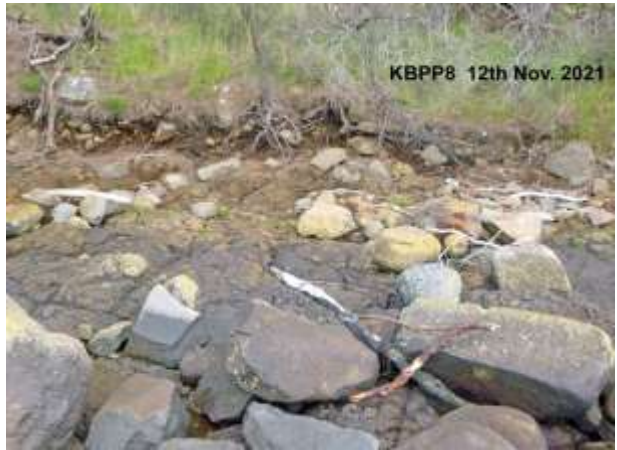
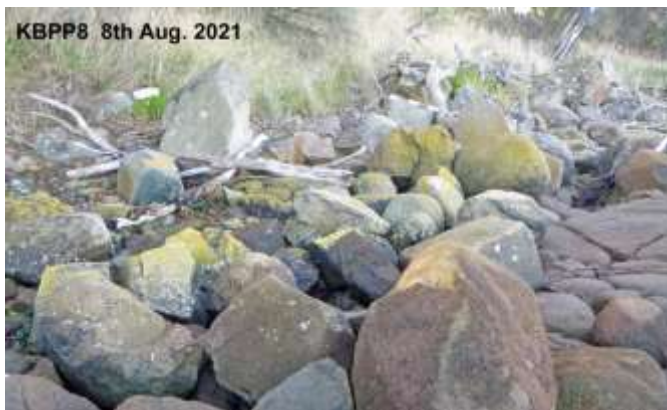
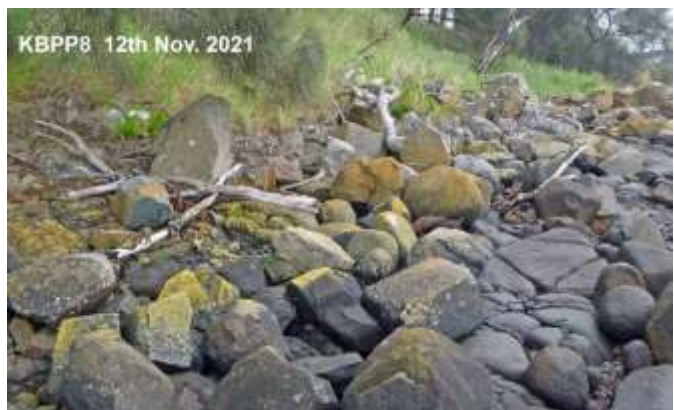
Figure 36: First (8th Aug. 2021) and last (12th Nov. 2021) photos taken at Kangaroo Bay photo point KBPP8. First photos in LH column, last photos in RH column. Views top to bottom are leftwards, onshore, and rightwards. No detectable change.

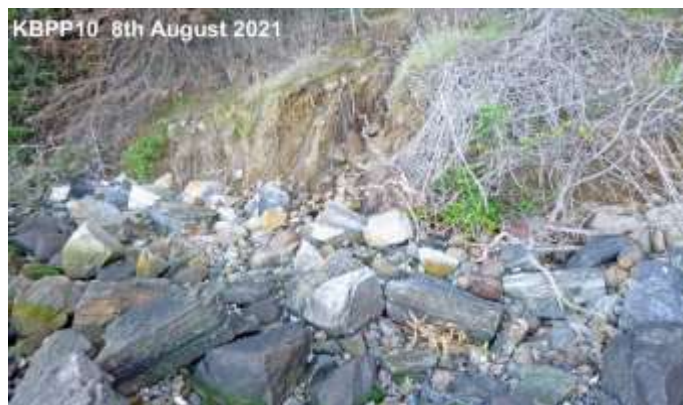
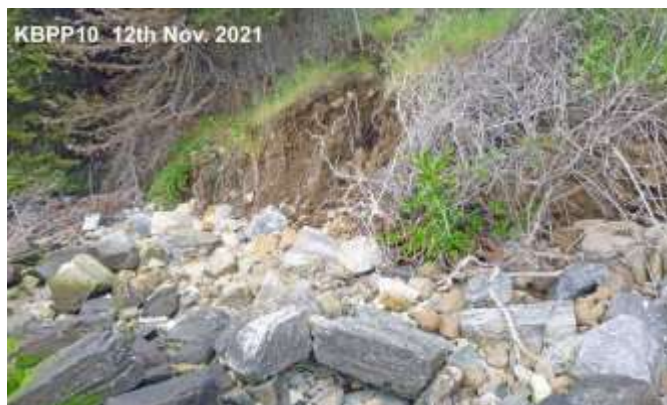
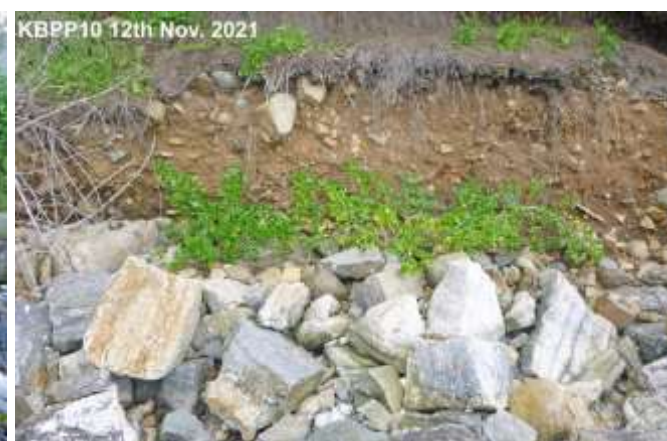
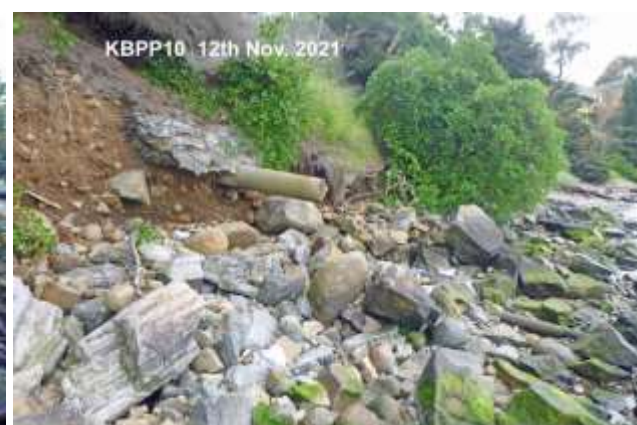
- Gravel-grade artificial fill is exposed to wave attack below the TasWater plant on the north shore of Kangaroo Bay and is actively eroding at and above the High-Water Mark level (see Appendix 1, Figure 38). This erosion predates the ferry and is likely to be attributable to storm waves (possibly swell and or local wind waves) especially at high tide. Although monitoring during this project failed to detect any additional erosion, the evident erodibility of this material indicates that it may be susceptible to erosion by boat wakes under some conditions.

Figure 38: First (8th Aug. 2021) and last (12th Nov. 2021) photos taken at Kangaroo Bay photo point KBPP10. First photos in LH column, last photos in RH column. Views top to bottom are leftwards, onshore, and rightwards. No changes detected between 8th August and 12th November 2021.

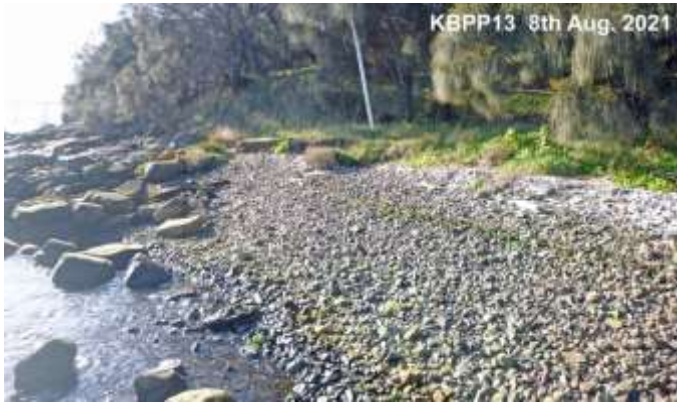
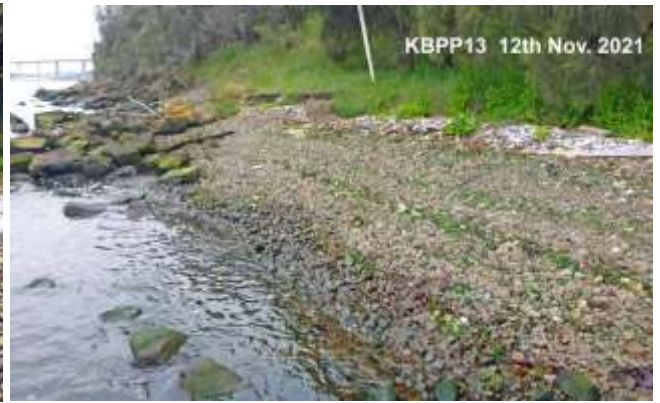
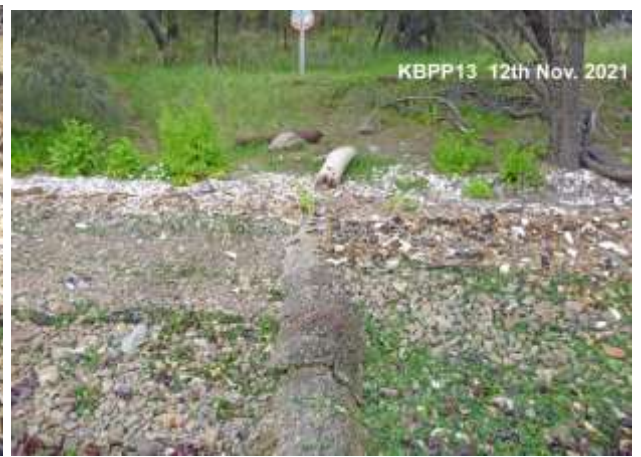
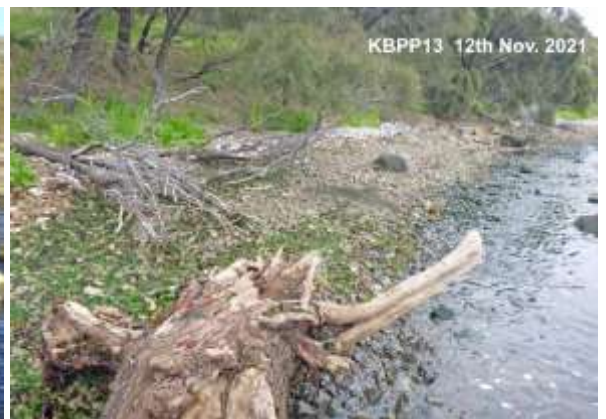
Figure 41: First (8th Aug. 2021) and last (12th Nov. 2021) photos taken at Kangaroo Bay photo point KBPP13. First photos in LH column, last photos in RH column. Views top to bottom are leftwards, onshore, and rightwards. Negligible changes to the cobble beach or soil margin are evident, however the last photos show that several large logs have washed up on this shore; this suggests stronger wave activity prior to the last photo.

It is recommended that the photo monitoring program at Kangaroo Bay be continued at 3-monthly intervals and immediately following any large storm events, particularly with a view to continuing to monitor and better understand the photo point sites where cobble movements were detected in the initial trial program

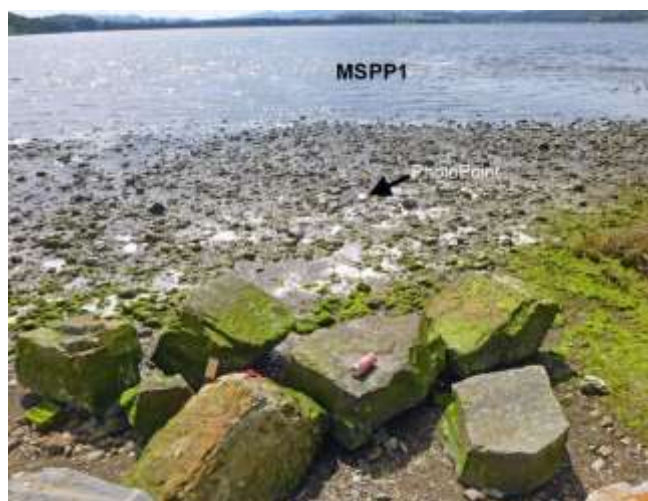
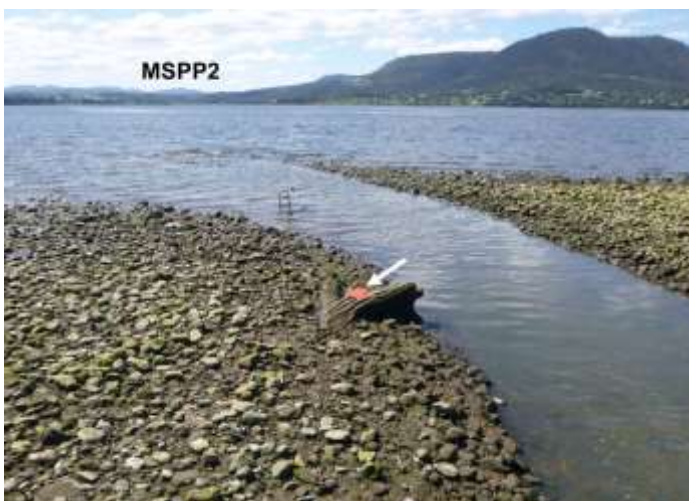
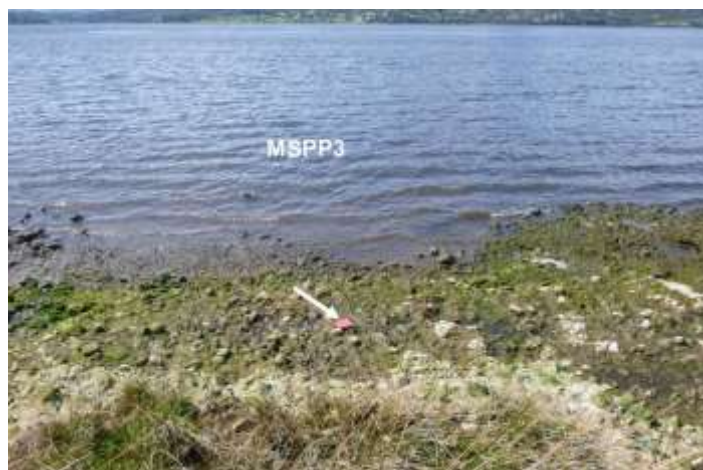
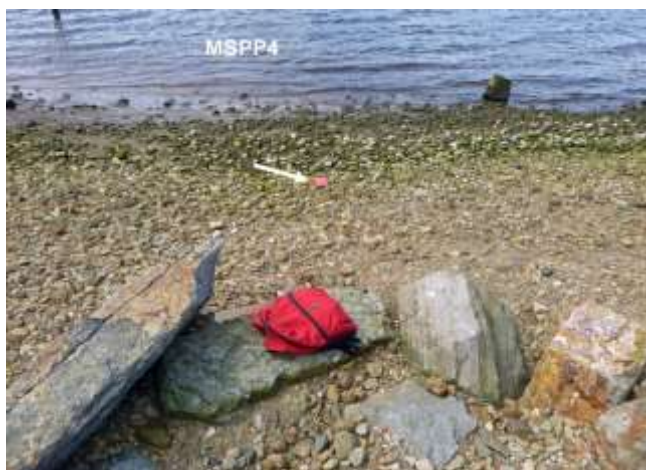
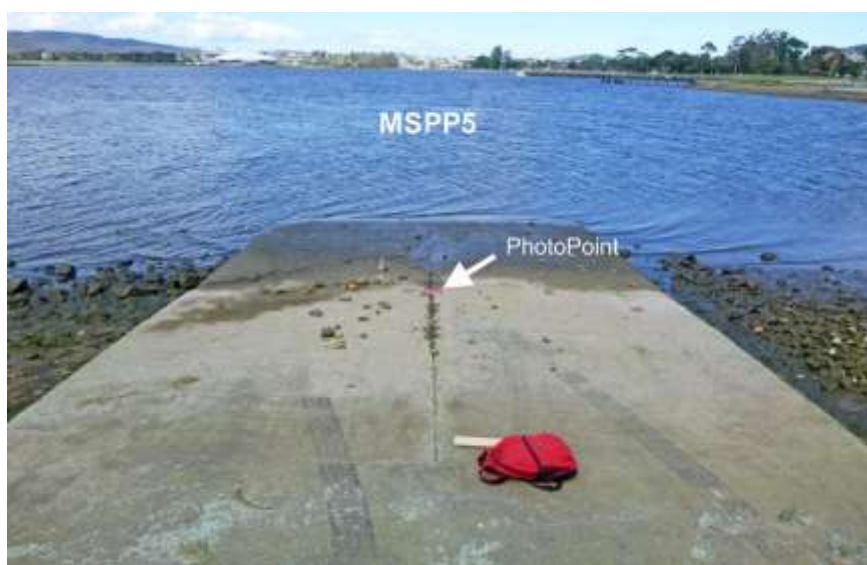
PhotoPoint	UTM co-ordinates of photo point (MGA Zone 55, GDA94 datum, GPS-derived)	Site Description	PhotoPoint Description
MSPP1	521805mE 5259280mN (Lat Long WGS84 = -42.818735 147.266732)	Cobble shore with mobile cobble beaches and beach ridges. Photo point is directly seawards of stormwater drain outlet (blocked with cobbles at time of first monitoring photos)	PhotoPoint is 3.8 metres directly seawards of seawards edge of boulder with coke can in PhotoPoint Reference Photo (see Figure 42).
MSPP2	521893mE 5259247mN (Lat Long WGS84 = -42.81903 147.267819)	Cobble shore with mobile cobble beaches and beach ridges.	Root end of log partly exposed in cobble shore next to stream channel outlet (see Figure 42).
MSPP3	521953mE 5259187mN (Lat Long WGS84 = -42.819563 147.26855)	Exposed semi-lithified cobble deposits (intertidal) with mobile cobble beaches and beach ridges. Near stormwater drain outlet (blocked with cobbles at time of first monitoring photos).	PhotoPoint is 1.3 metres seawards of erosional vegetation line of small "point" (see Figure 42).

MSPP4	521973mE 5259146mN (Lat Long WGS84 = -42.819936 147.268795)	Cobble beach shore with mobile cobble beaches and beach ridges. Photo point is directly seawards of (inferred) stormwater drain outlet (blocked with and buried by cobbles at time of first monitoring photos)	PhotoPoint is 1.7m seawards of seawards edge of boulder with red daypack in PhotoPoint Reference Photo (see Figure 42).
MSPP5	521980mE 5259100mN (Lat Long WGS84 = -42.820349 147.268872)	Cobble beach shore with mobile cobble beaches and beach ridges.	PhotoPoint is in middle of concrete boat ramp, 3.1 metres down (seawards along) central concrete join (groove) from cross-join under red daypack in PhotoPoint Reference Photo (see Figure 42).

Figure 42: Reference photos for Montrose Shore monitoring photo points (viewpoints) MSPP1 to MSPP5 See also details in Table 5. Each photo point / viewpoint is indicated by arrow; see map co-ordinates and further location details in Table 5. Zoom in for better photo details.

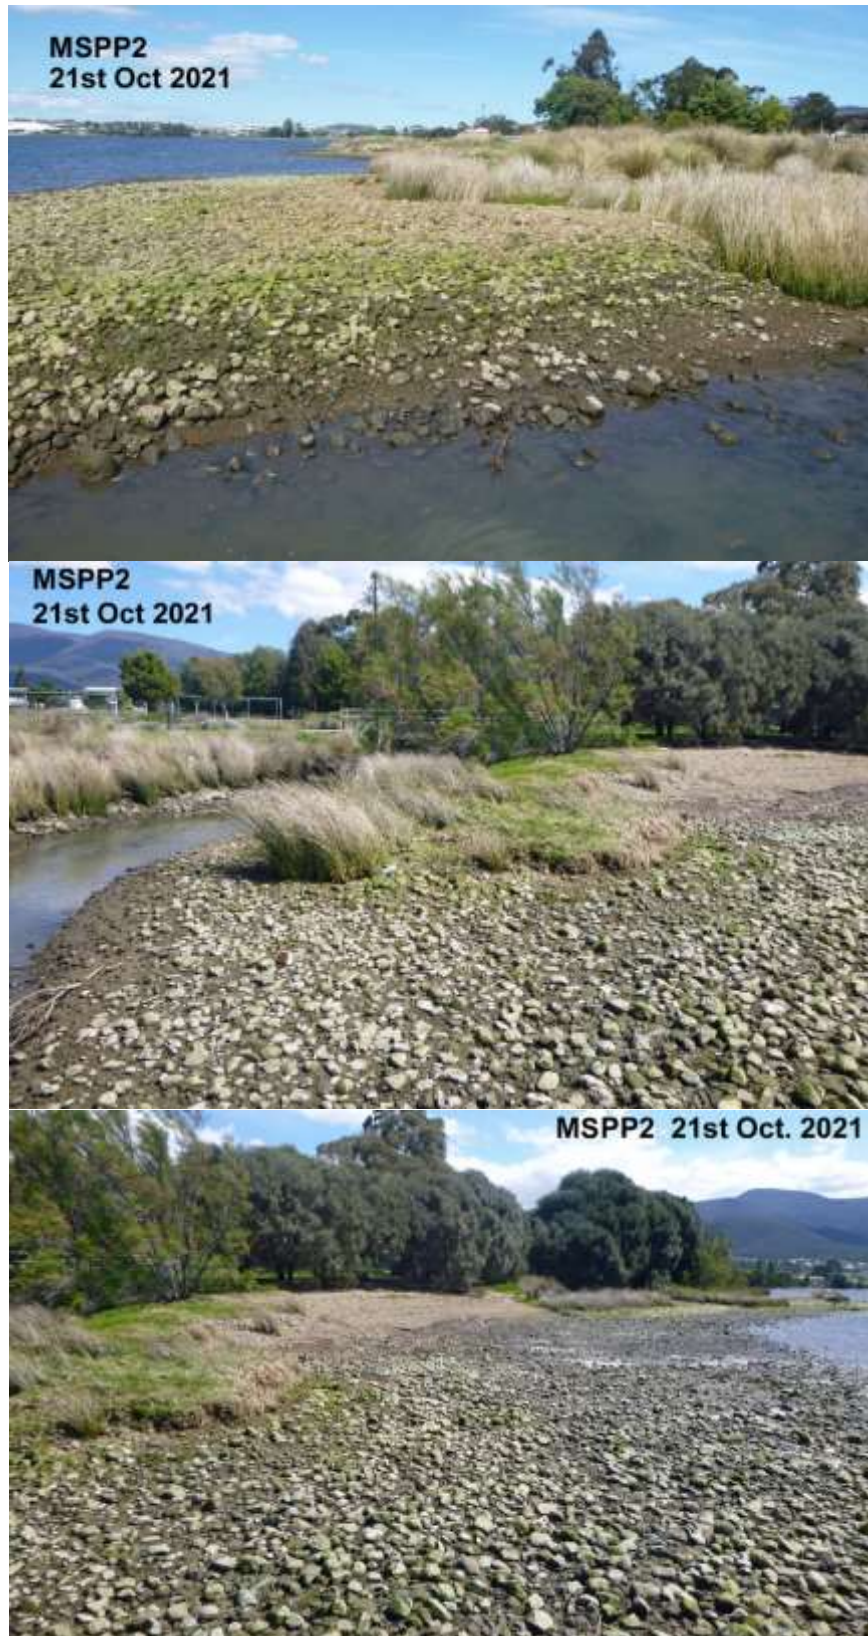
Figure 44: Initial monitoring photos from Montrose Bay photo monitoring point MSPP2. Initial monitoring photos dated 21st October 2021 (views leftwards, onshore, and rightwards). Zoom in for better photo details.
