Monitoring the physical effects of boat wakes on shorelines in the Derwent River Estuary

Report to:
Derwent Estuary Program

By:
Chris Sharples

April 2022

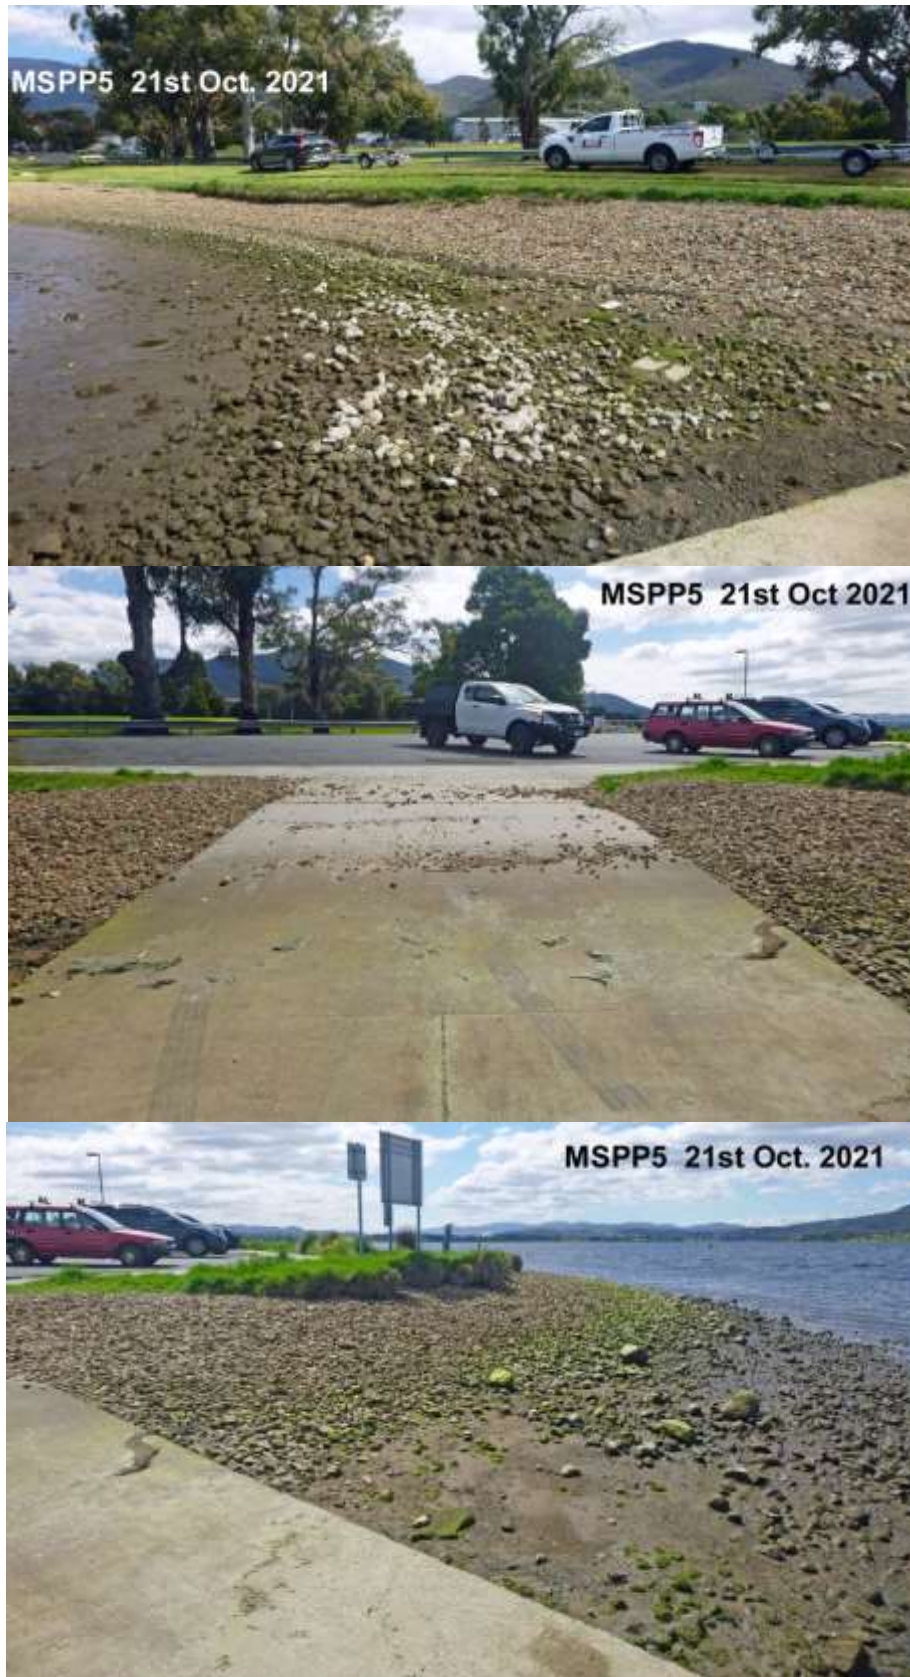
Figure 47: Initial monitoring photos from Montrose Shore photo monitoring point MSPP5. Initial monitoring photos dated 21st October 2021 (views leftwards, onshore, and rightwards). Zoom in for better photo details.
